5 | **The Ephebe from the Via dell'Abbondanza** History of a Restoration

Luigia Melillo

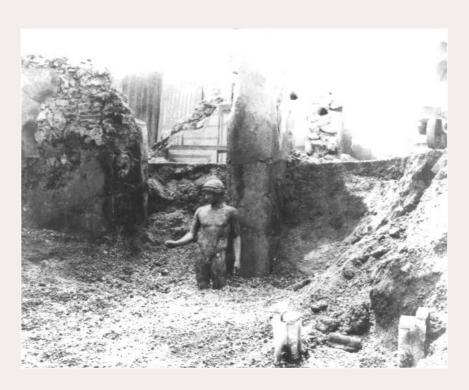
FIGURE 5.2. The Ephebe at the time of its discovery in 1925

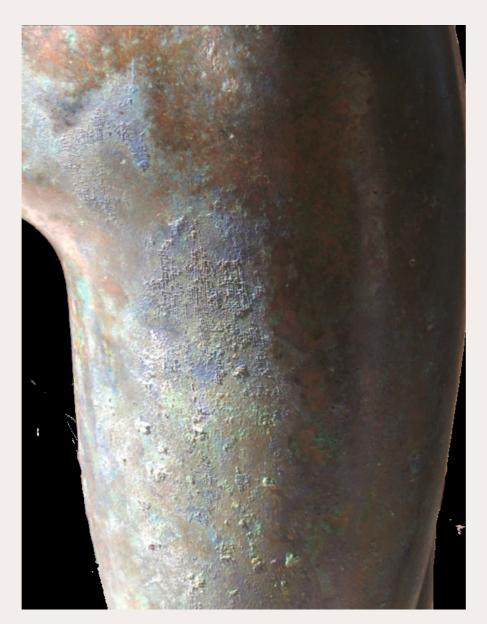
FIGURE 5.3. Remains of the mineralized fabric

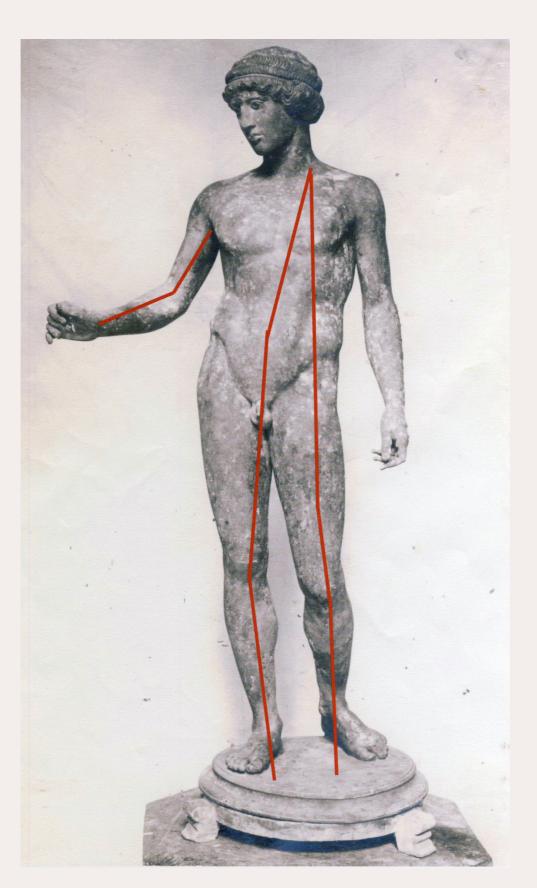
FIGURE 5.9. Arrangement of internal armature inserted in 1925

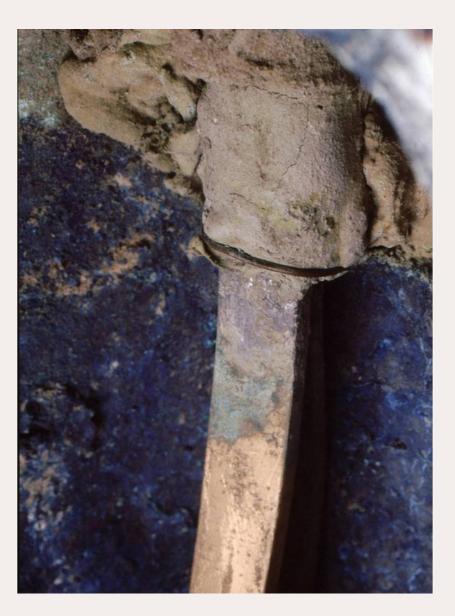
FIGURE 5.10. Upper end of one of the brass bars, wrapped with fabric and attached to the bronze with cement

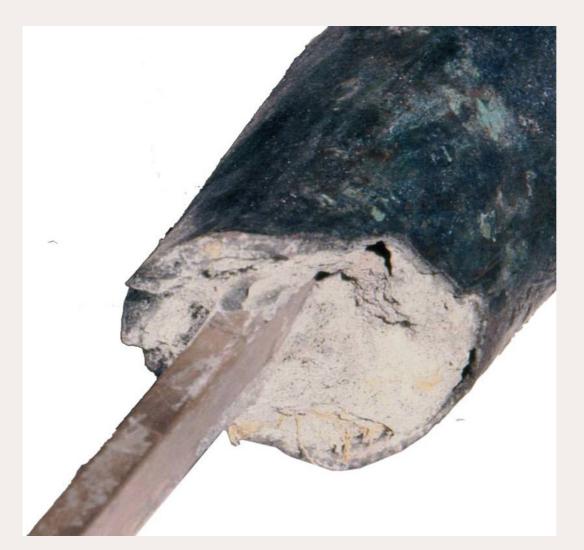
FIGURE 5.11. Ephebe's thigh filled with cement

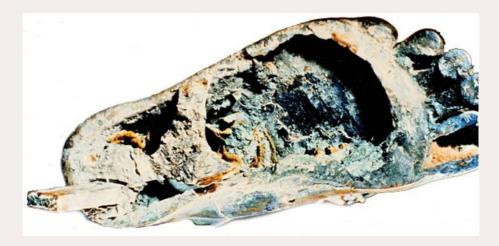
FIGURE 5.12. Remains of sateen found inside Ephebe's right foot

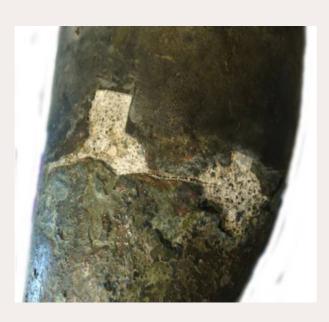
FIGURE 5.14. Alexander I Balas: part of thigh, joined with cement

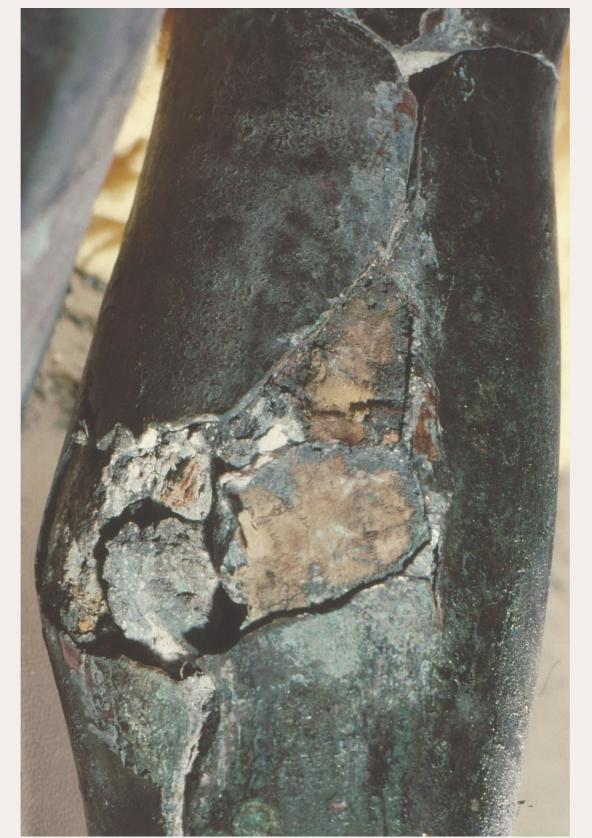
FIGURE 5.15. Right leg of the Ephebe during conservation

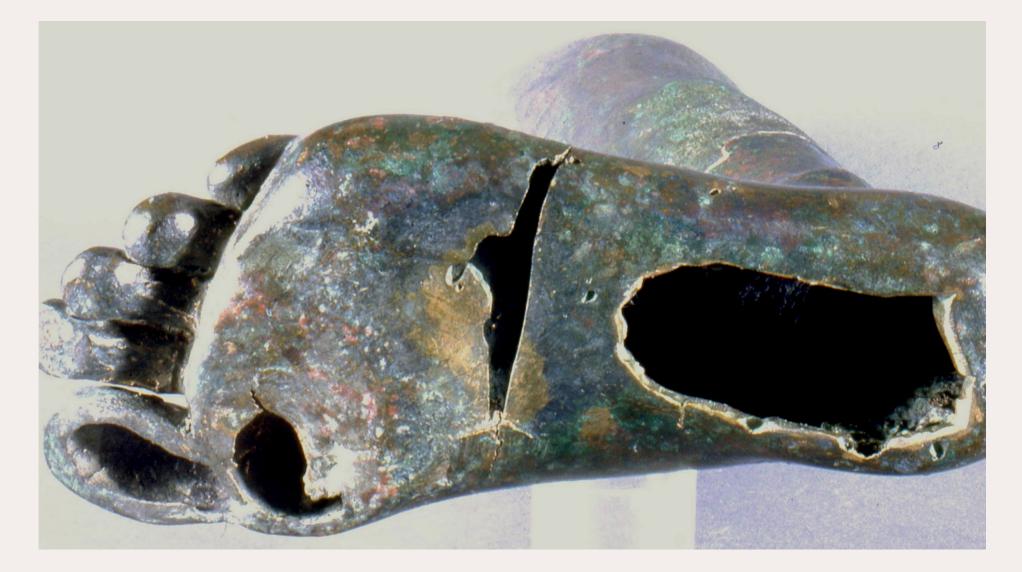
FIGURE 5.17. Underside of Ephebe's left foot, showing enlargement of space for pin at the heel

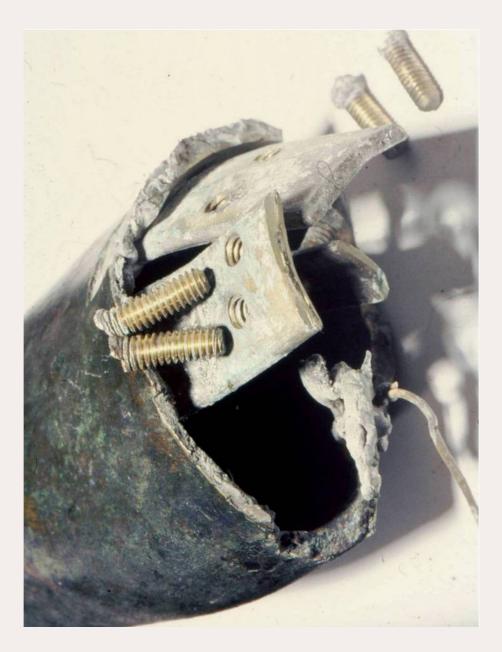
FIGURE 5.18. Brass plates and screws used in the reassembly of right arm

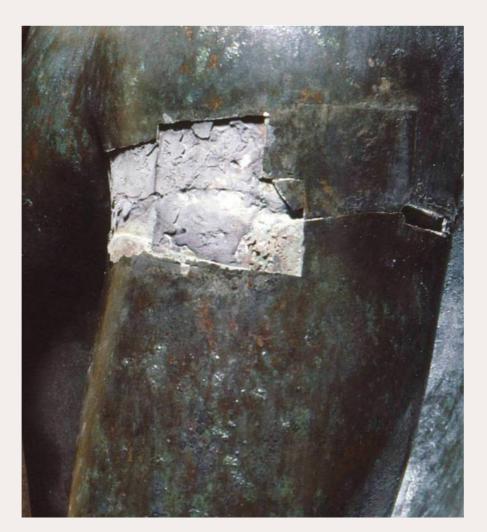
FIGURE 5.19. Join between shoulder and right arm

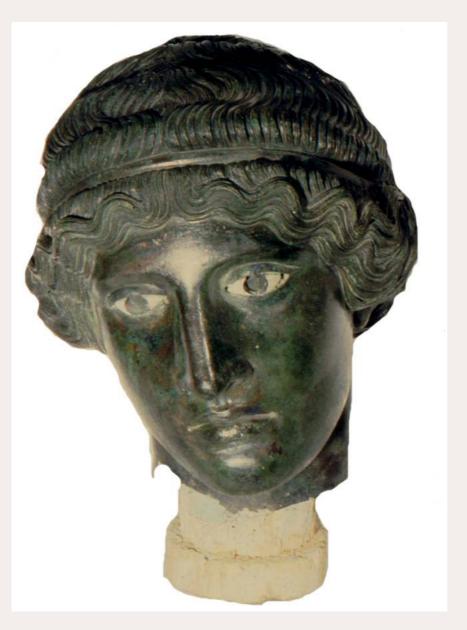
FIGURE 5.20. Wood support inserted into the neck in 1925
