# 6 | The Birth and Second Life of the Minerva of Arezzo

*Salvatore Siano*

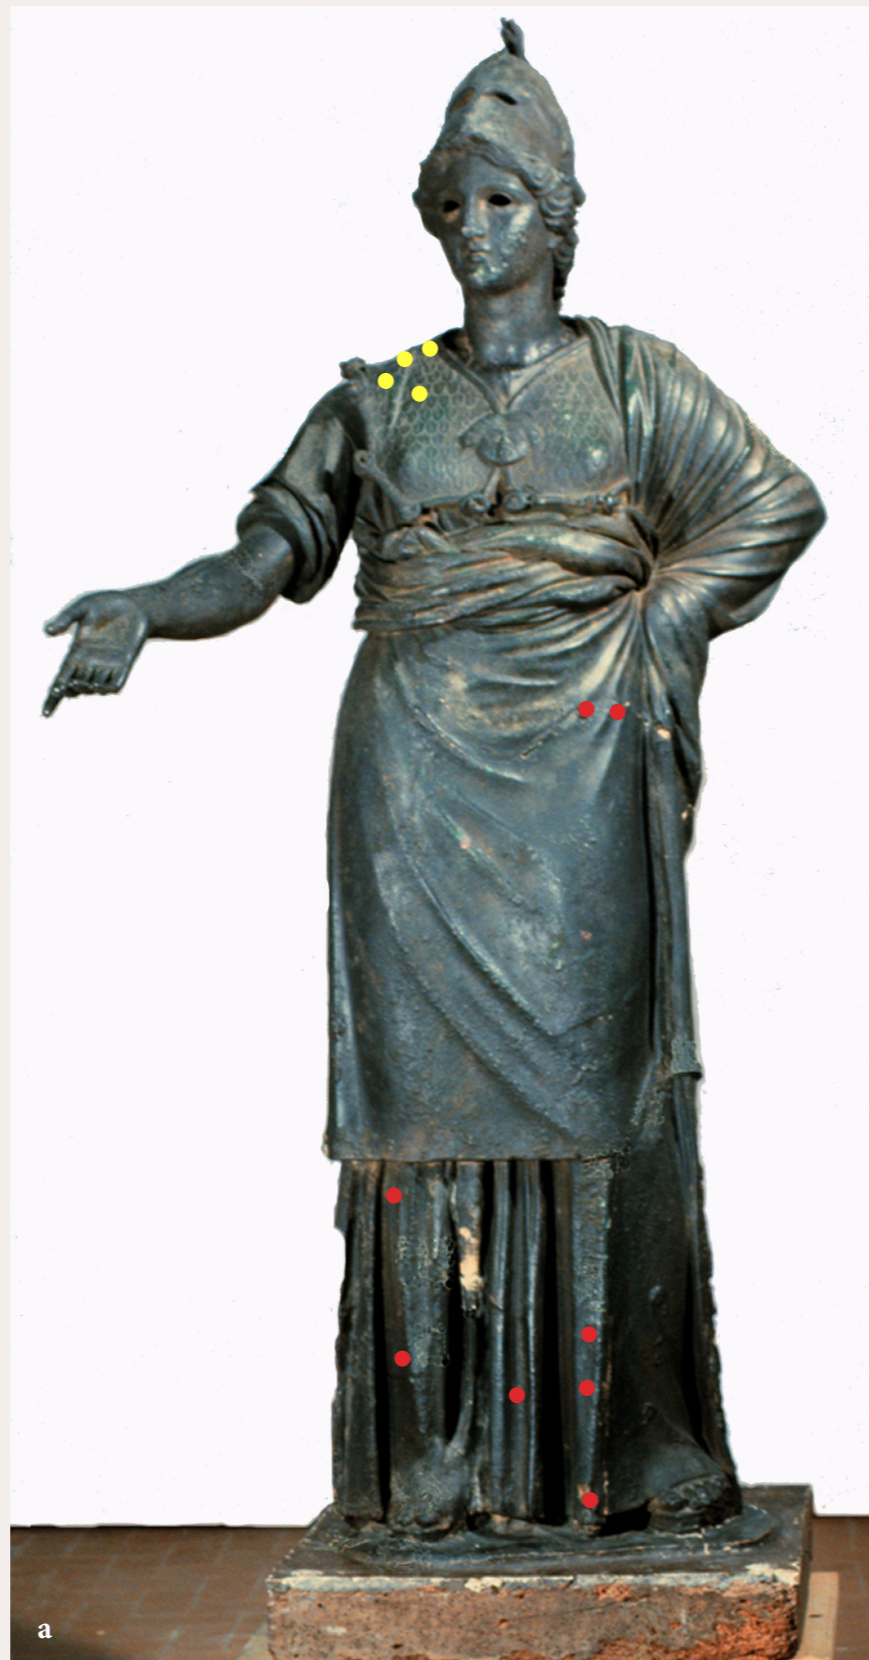
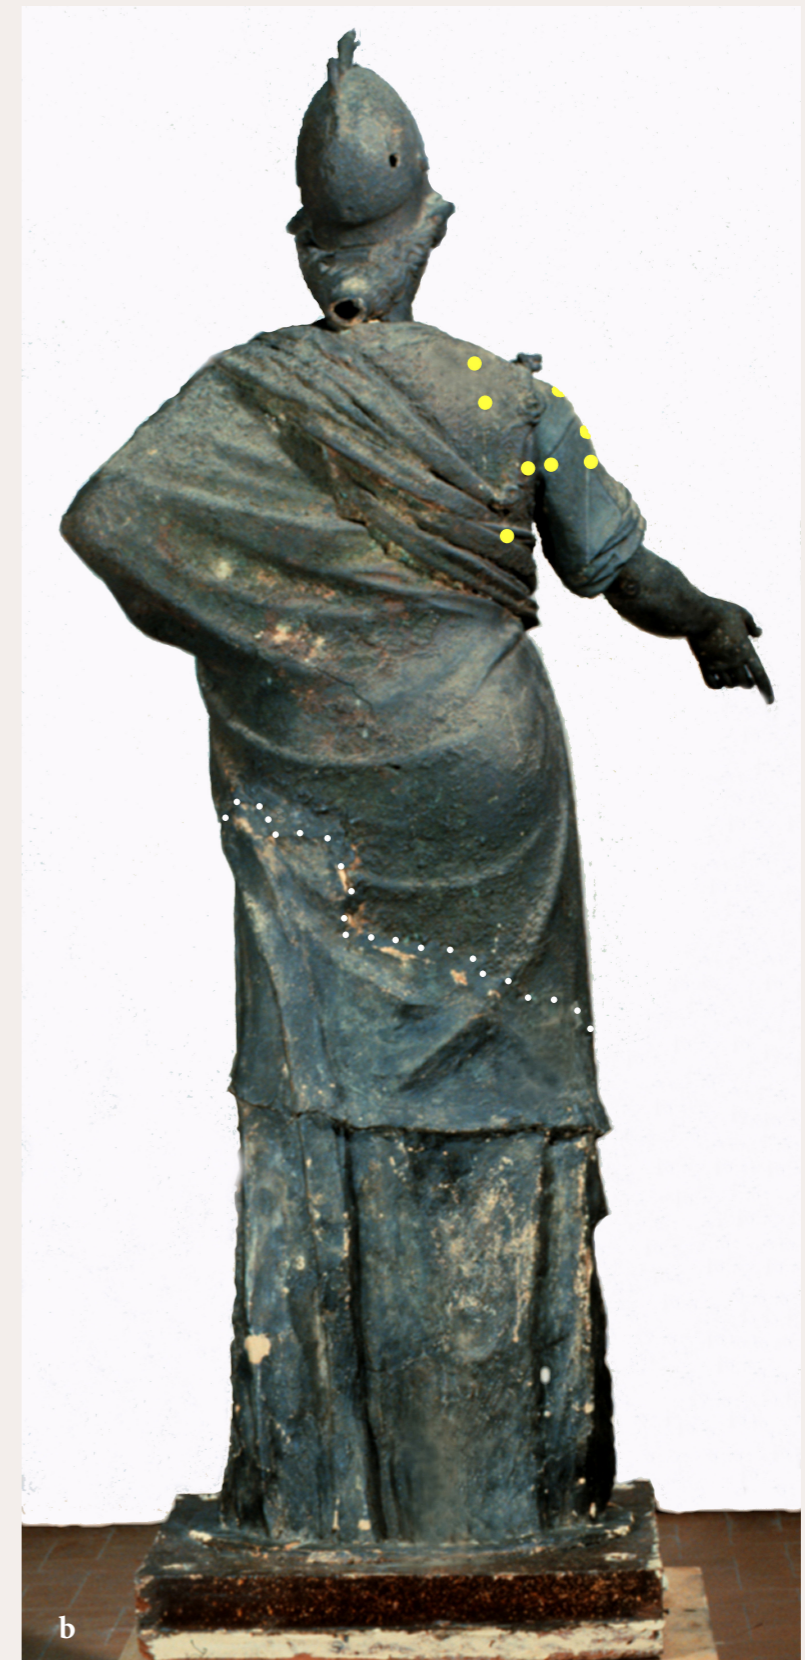
**FIGURES 6.3a–b.** The Minerva before the recent conservation project. Yellow dots: screws. Red dots: nail heads. White dotted line: upper border of area of missing ancient metal

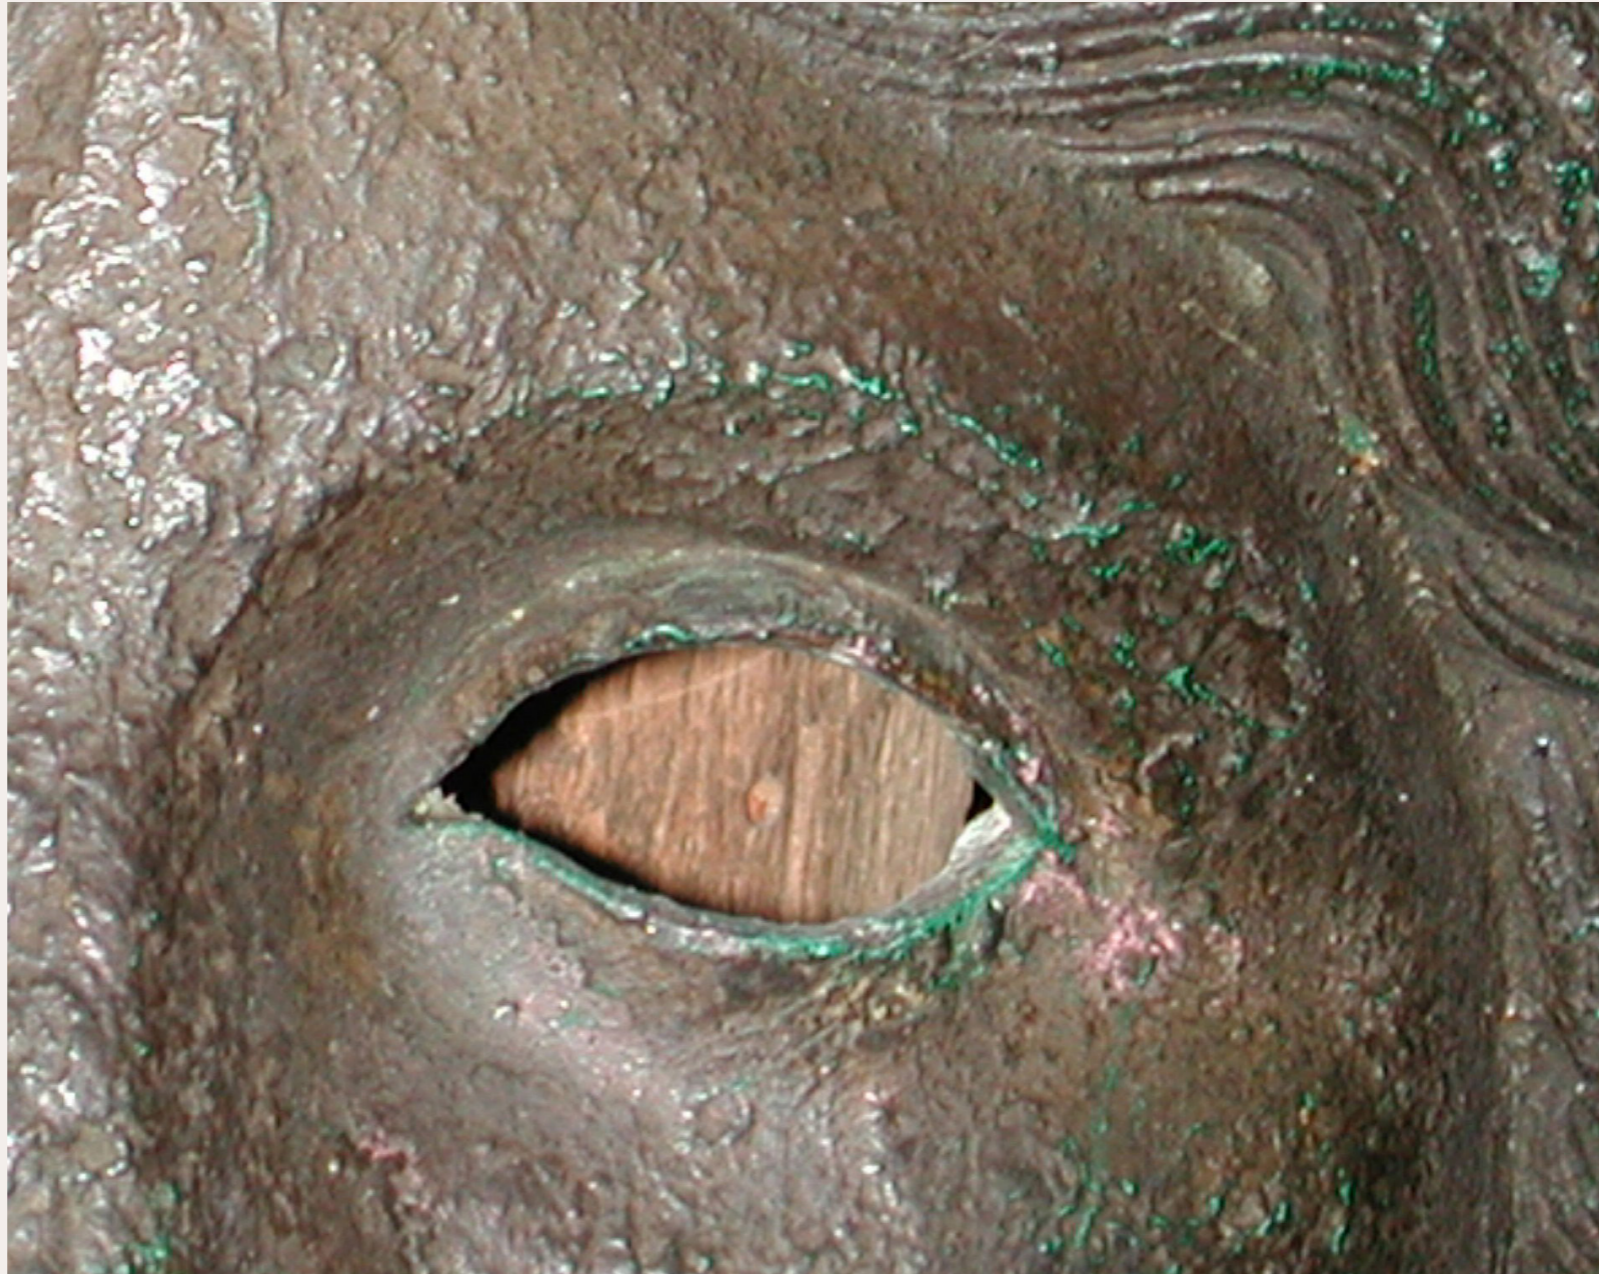
**FIGURE 6.5.** Detail photograph taken before disassembly of the statue, showing the internal wood support visible through the aperture of the left eye, along with details of the dark brown surface

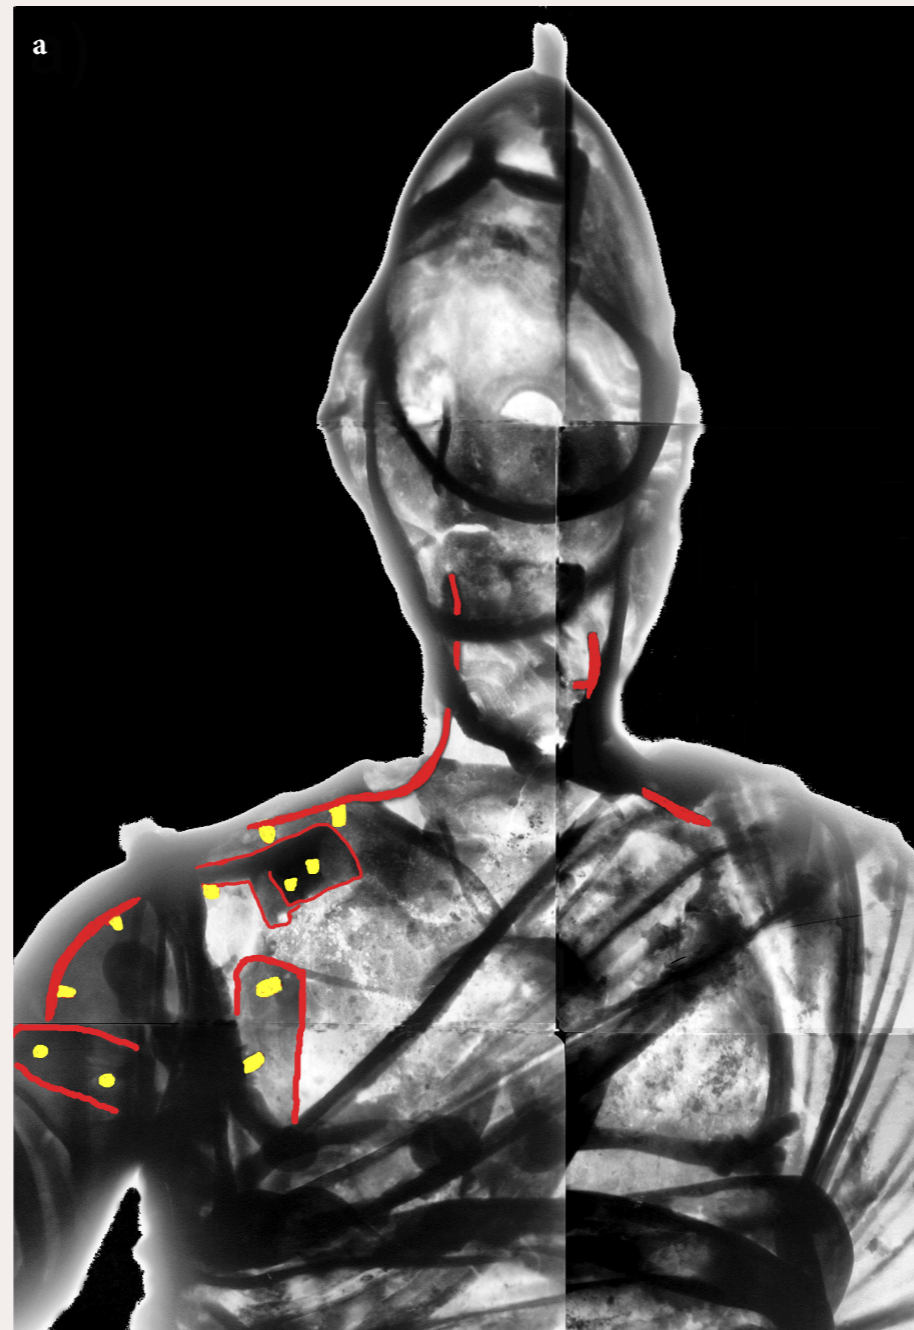
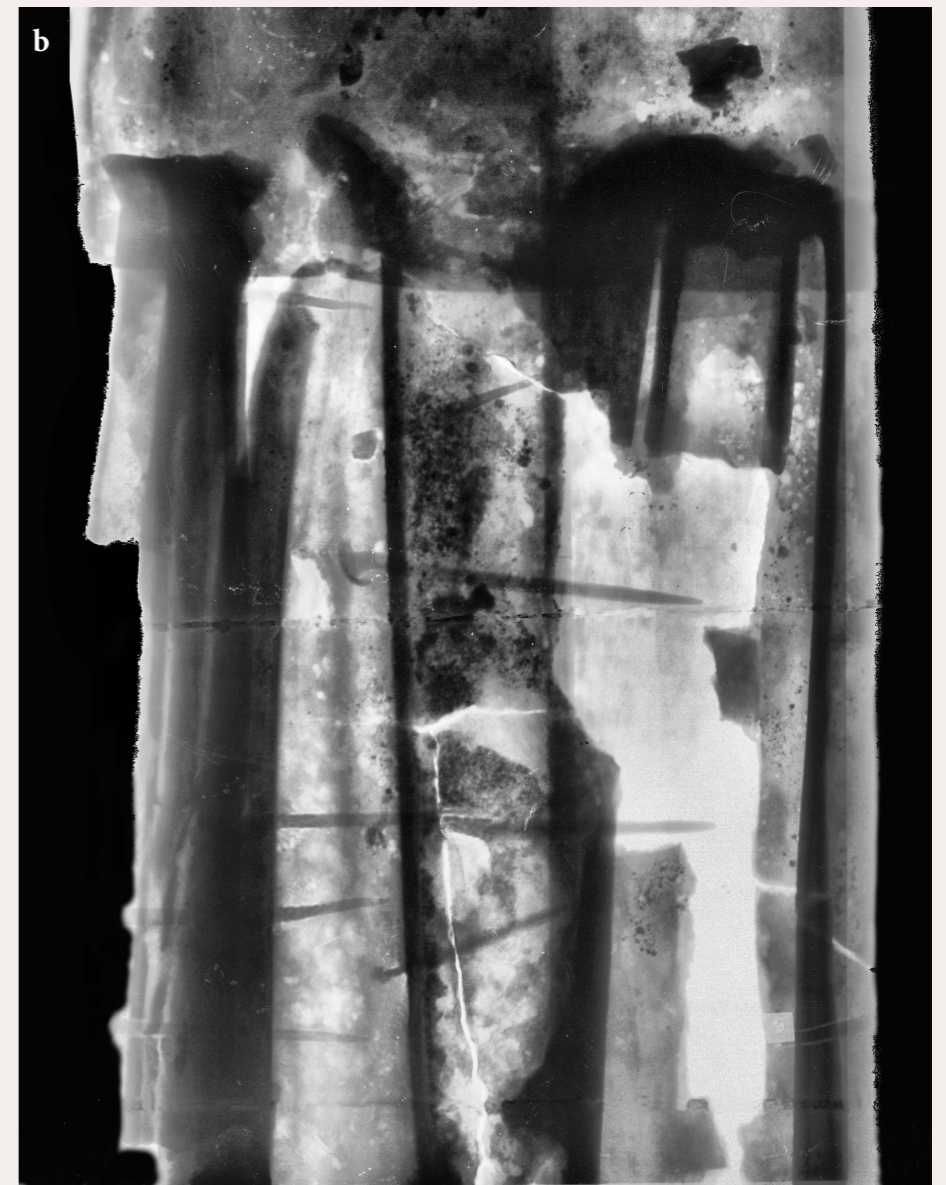
**FIGURES 6.6a–b.** X-radiographs (negative rendering) of the upper (a) and lower (b) parts of the sculpture. In figure 6.6a, iron sheets and screws are highlighted in red and yellow, respectively.

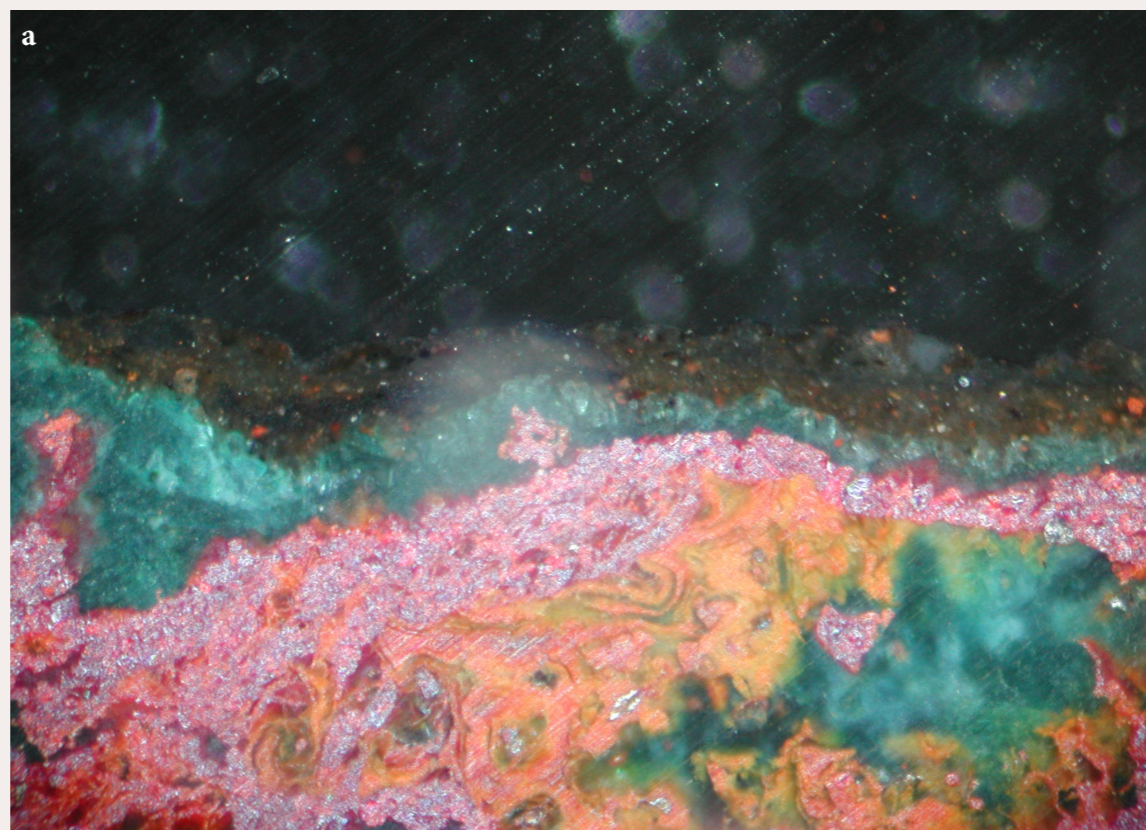
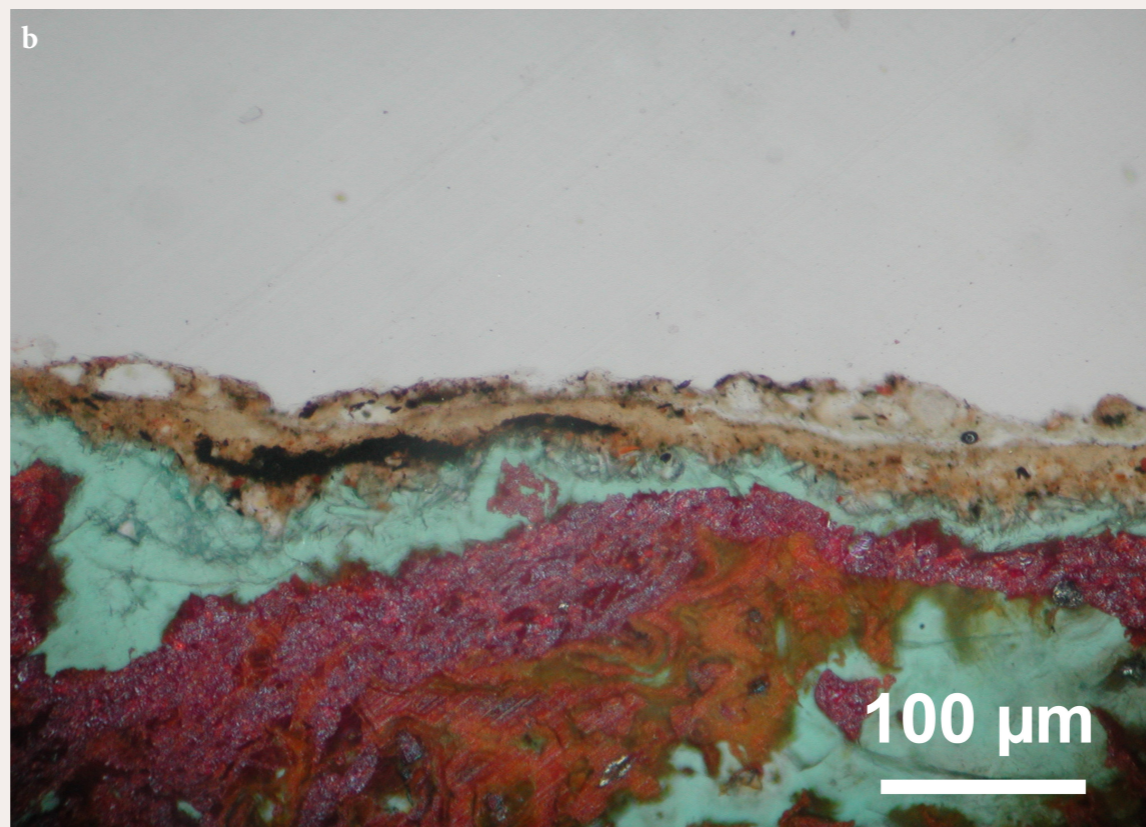
**FIGURES 6.7a–b.** Metallographic cross sections under reflected light showing representative stratigraphy of a corroded bronze surface with two superimposed patination layers (6.7a: black field; 6.7b: bright field)

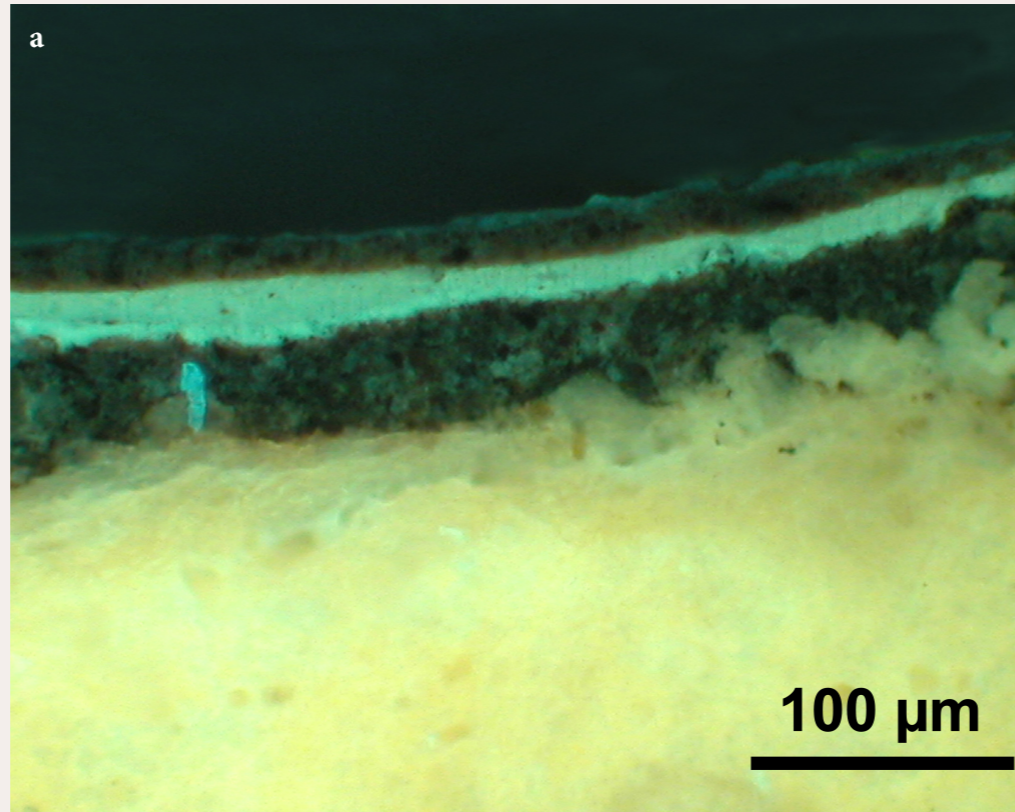
**FIGURE 6.8a.** Cross section of the sample SF<sub>8</sub> (from the base) showing two main patination layers separated by a gypsum layer

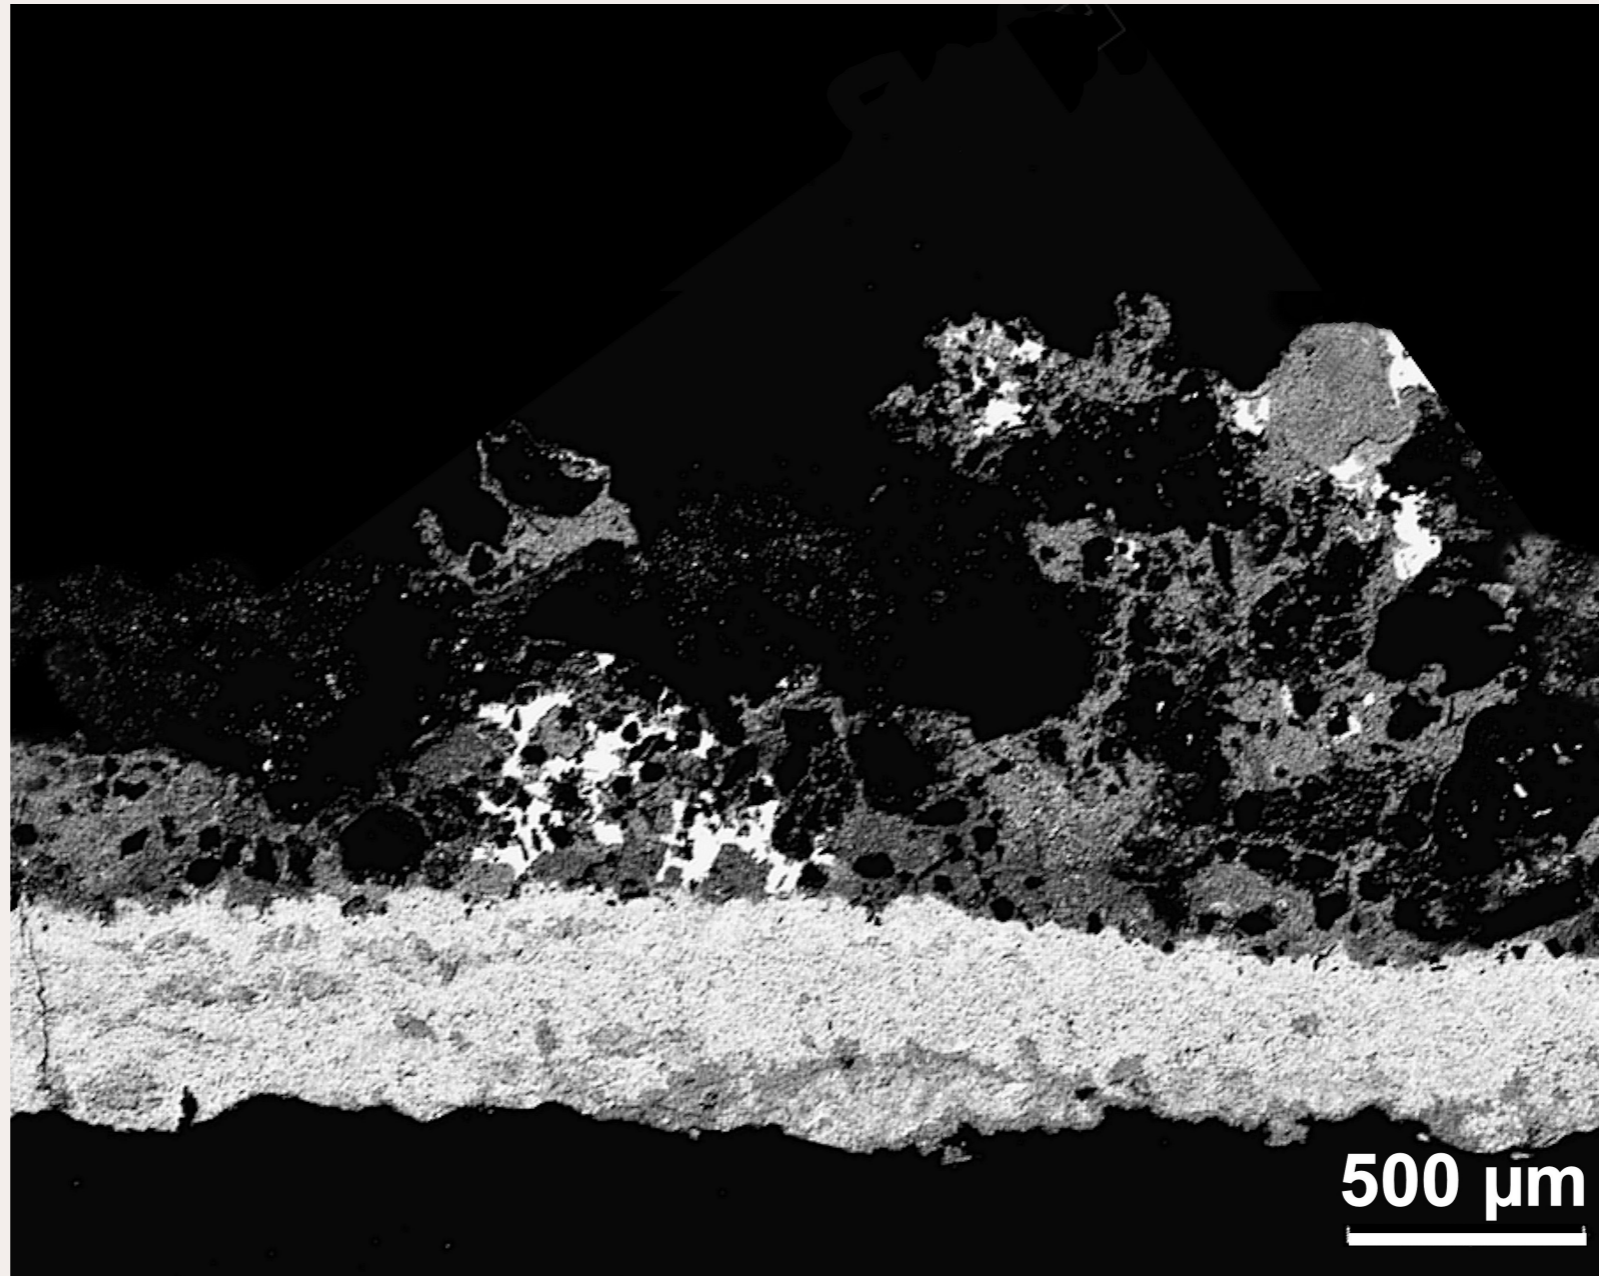
**FIGURE 6.9.** Cross section (SEM, backscattering) of a mineralized metal sample (from the back), with earthy concretions ( $SF_2$ ) embedding lead minerals (white spots)

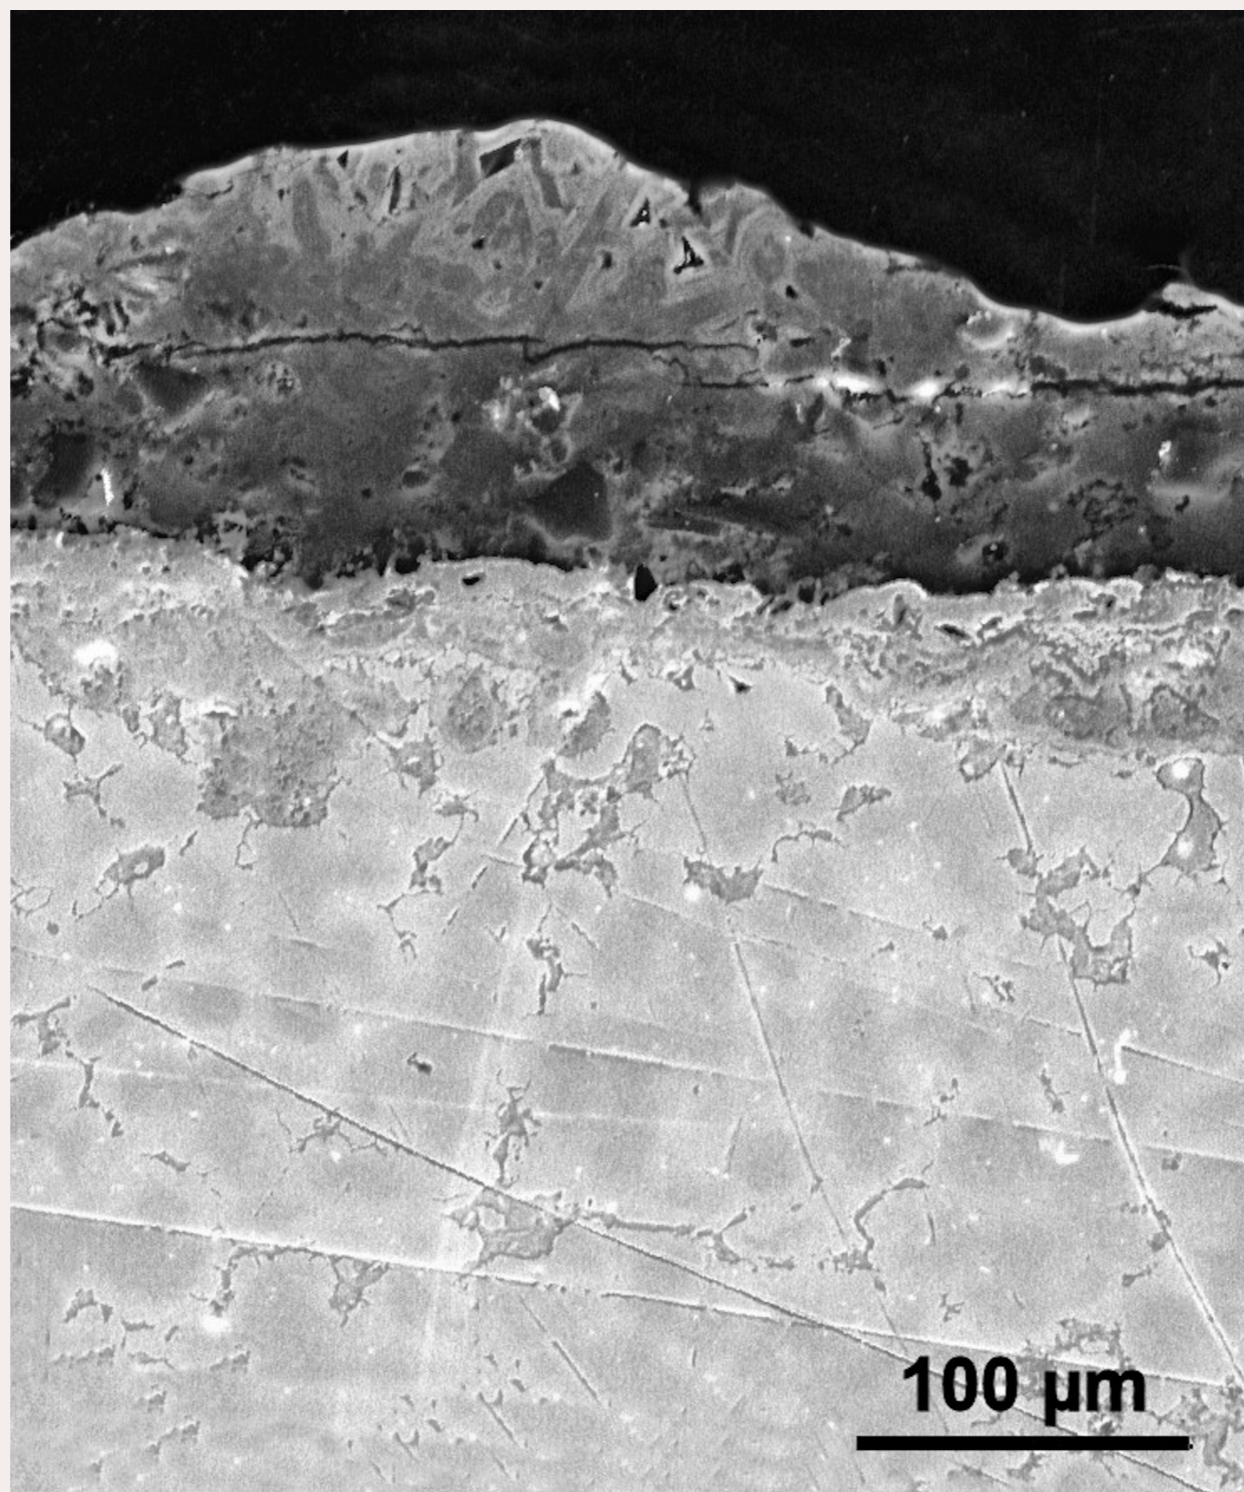
**FIGURE 6.10.** Cross section (SEM) of the sample  $\text{MF}_2$  showing moderate surface corrosion under the earthy concretion

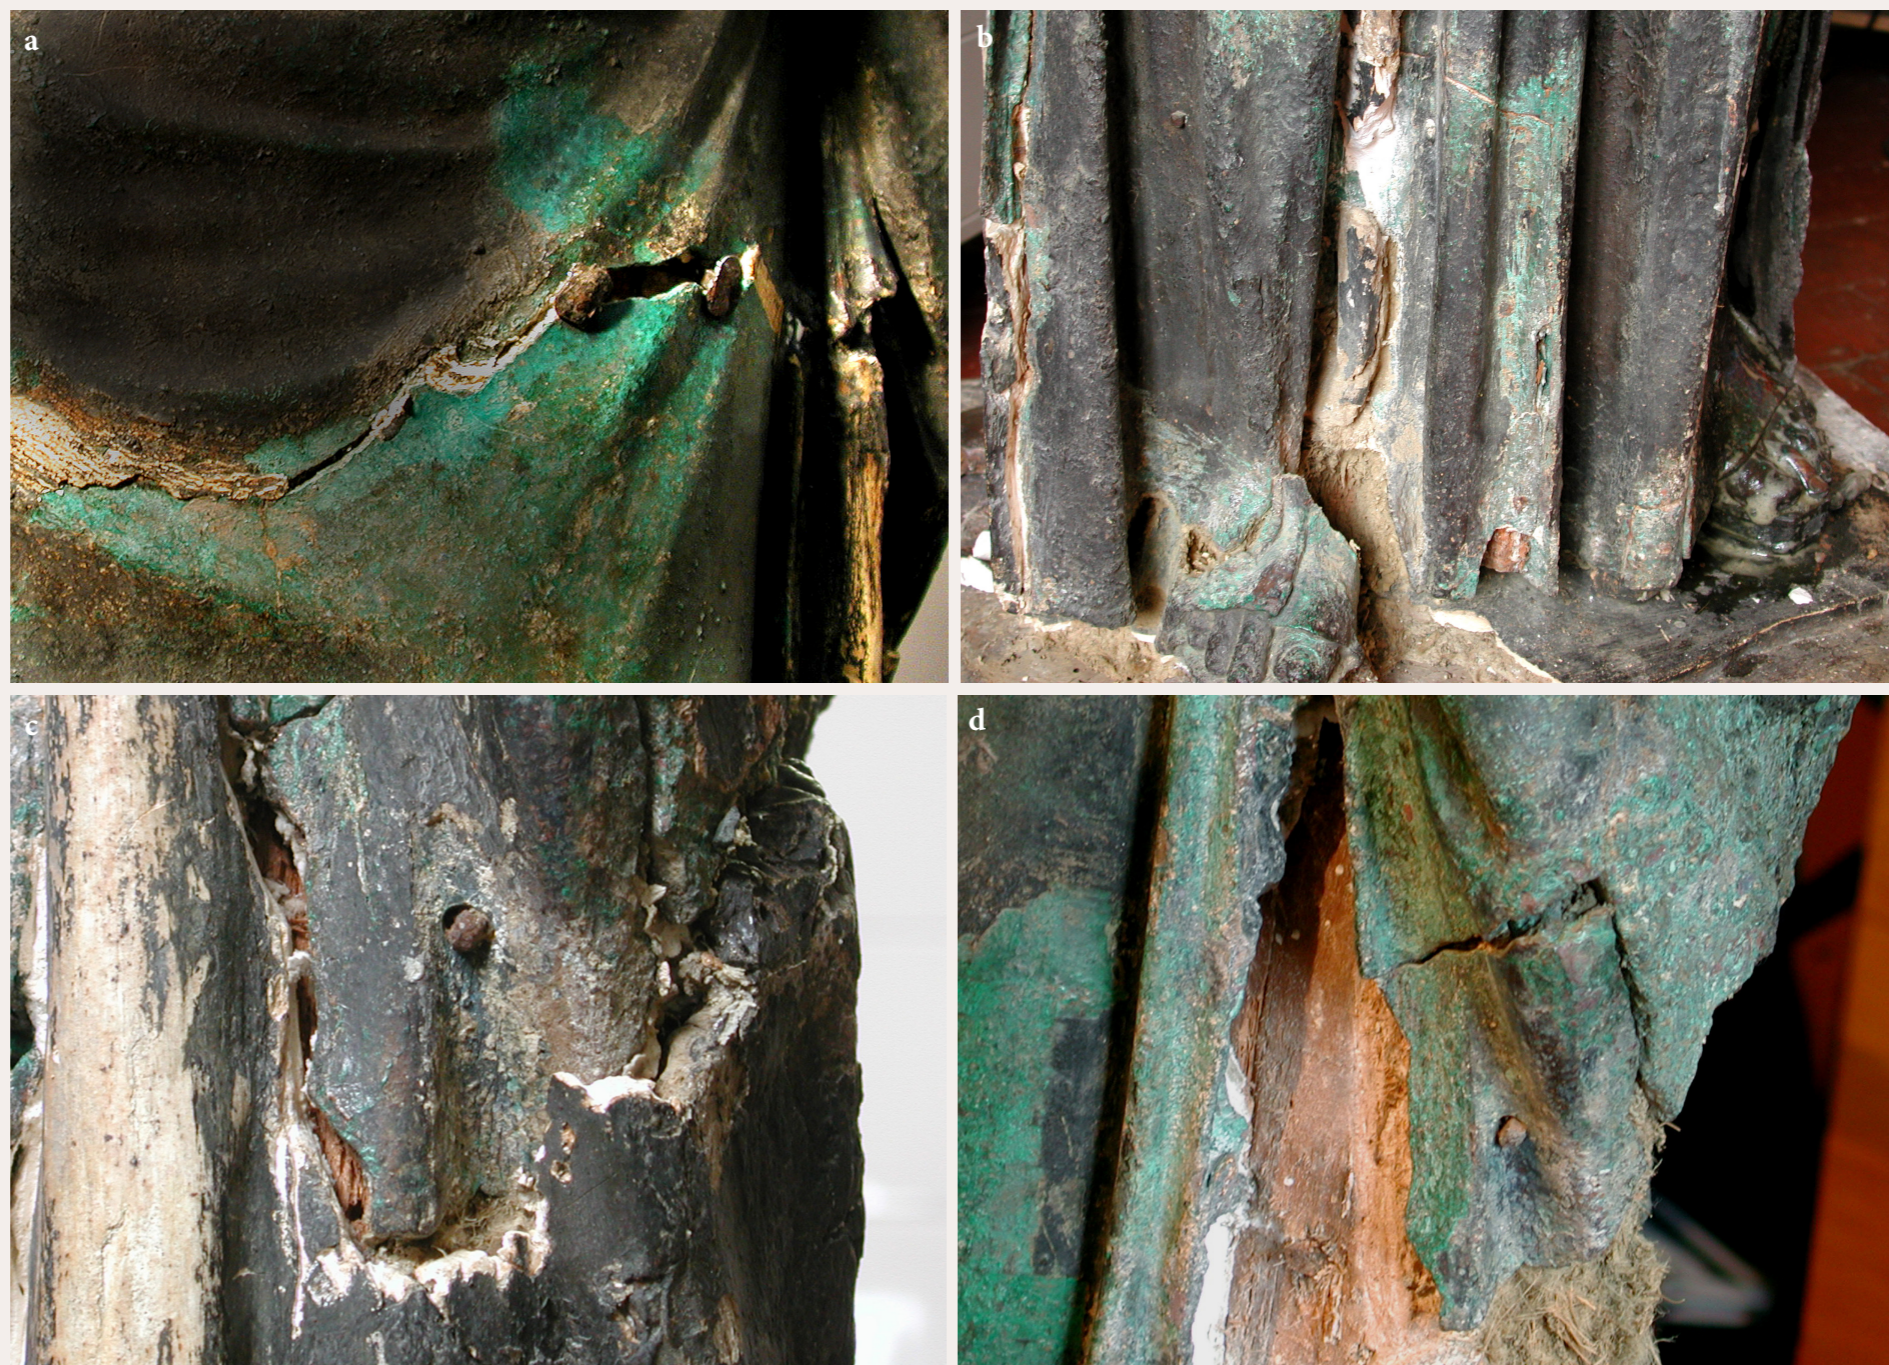
(a) Uncovering of the mineralized bronze surface from the dark patinations in the area of two large nails at the top of the left thigh.

(b) Early phases of the removal of stucco integrations in the area of the right foot.

(c, d) Examples of a fragment of the himation set free from the stucco integrations and nails.

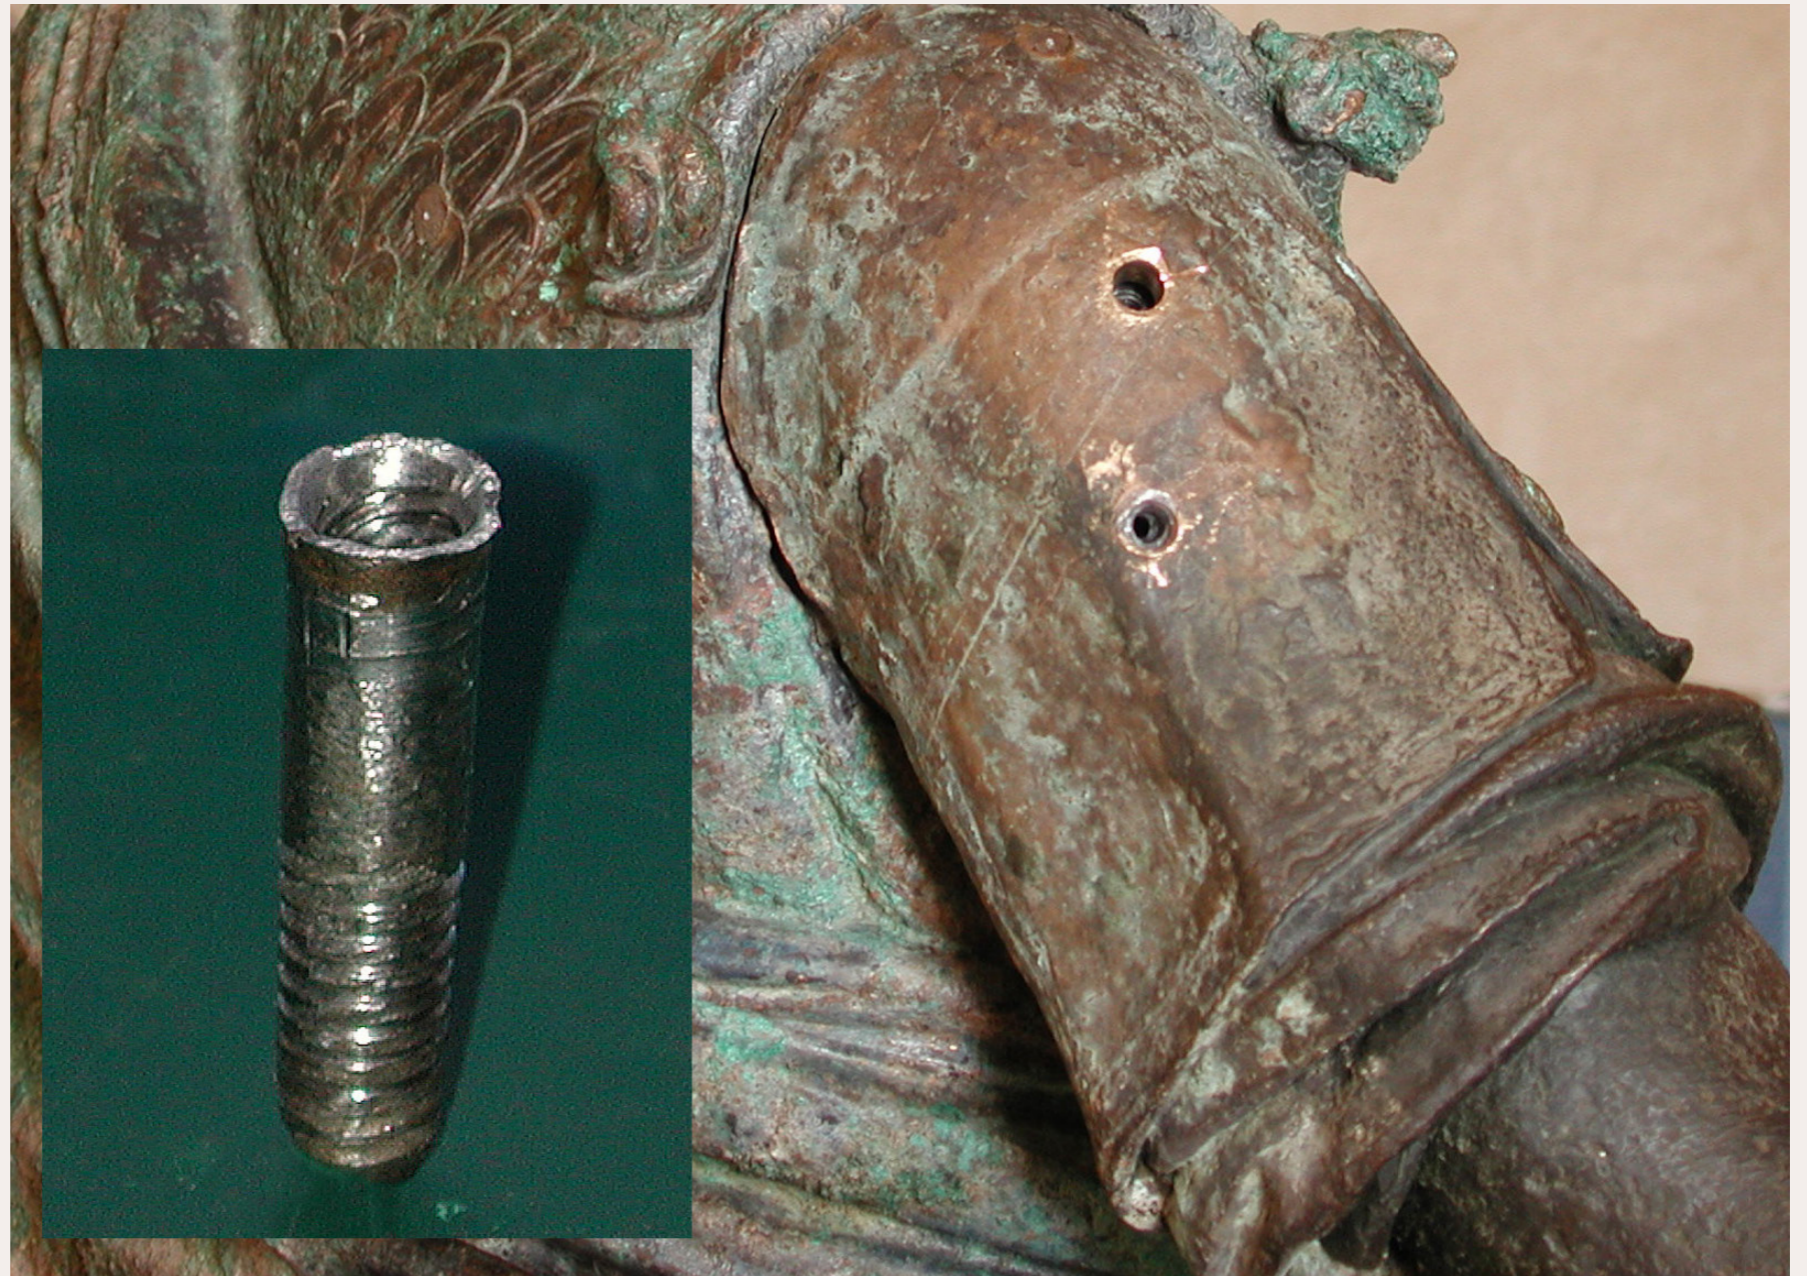
**FIGURE 6.14.** Right arm with screws removed, and detail of one of the screws

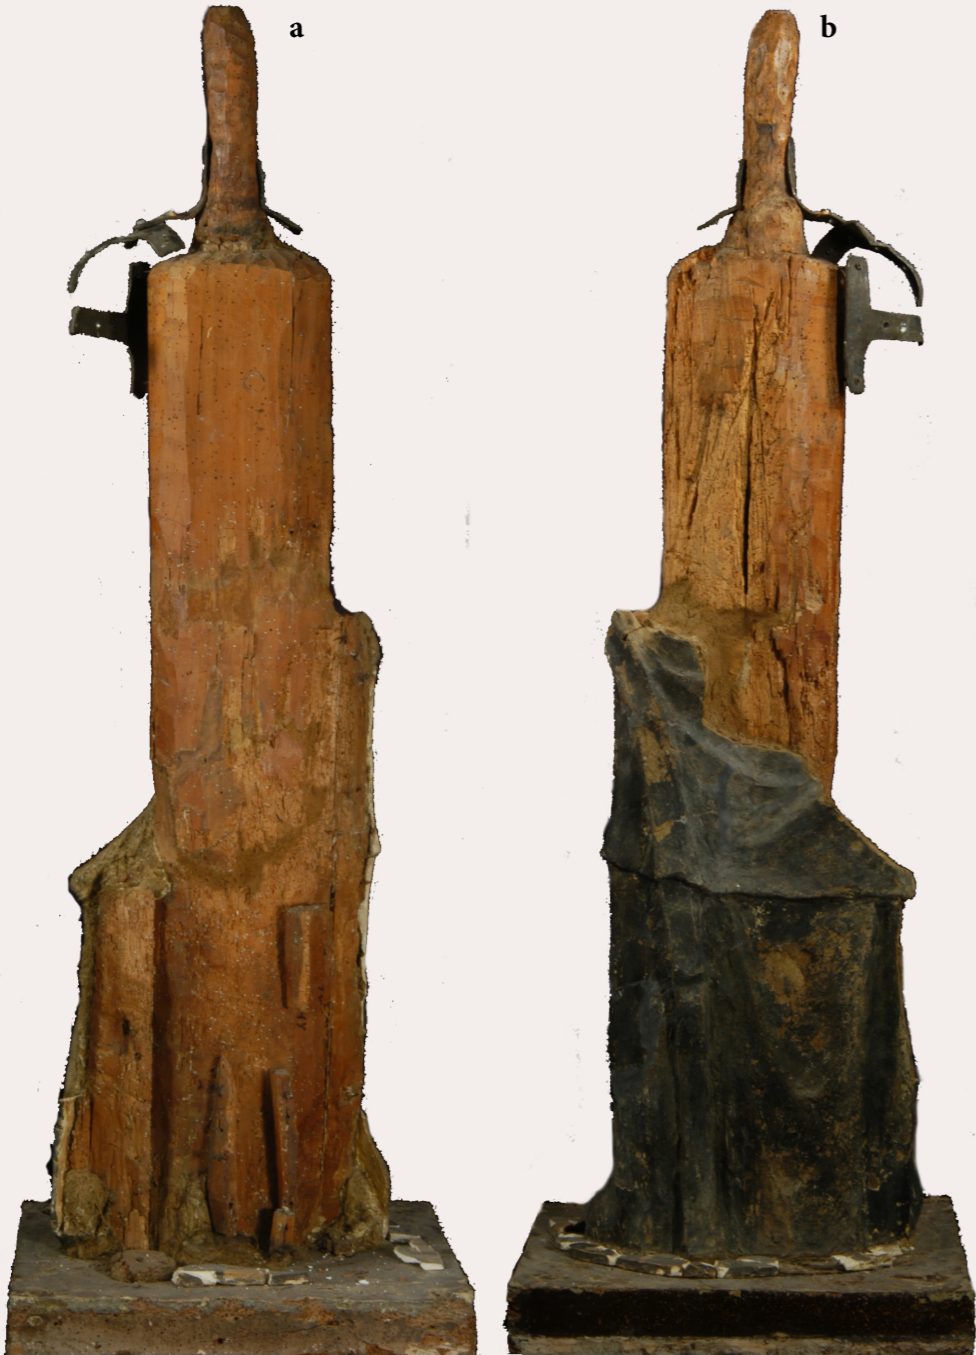
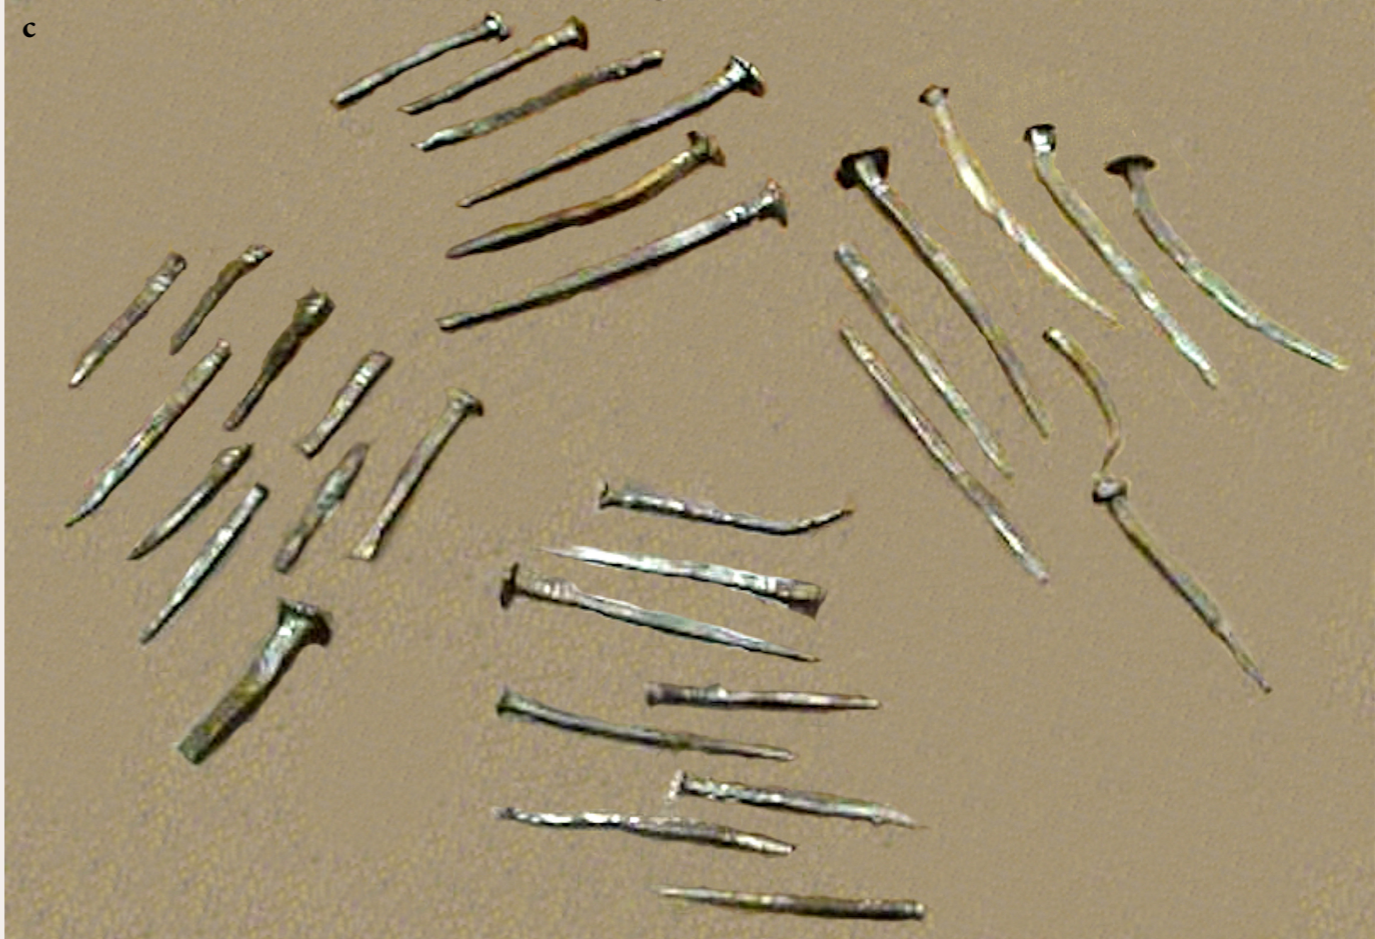
**FIGURES 6.16a–c.** The Minerva’s internal wood support (and Carradori’s iron armatures for the head and right arm) and main stucco integration (a–b); thirty-two of the forty-four fixing nails extracted during the dismounting of the sculpture (c)
