# 6 | The Birth and Second Life of the Minerva of Arezzo

*Salvatore Siano*

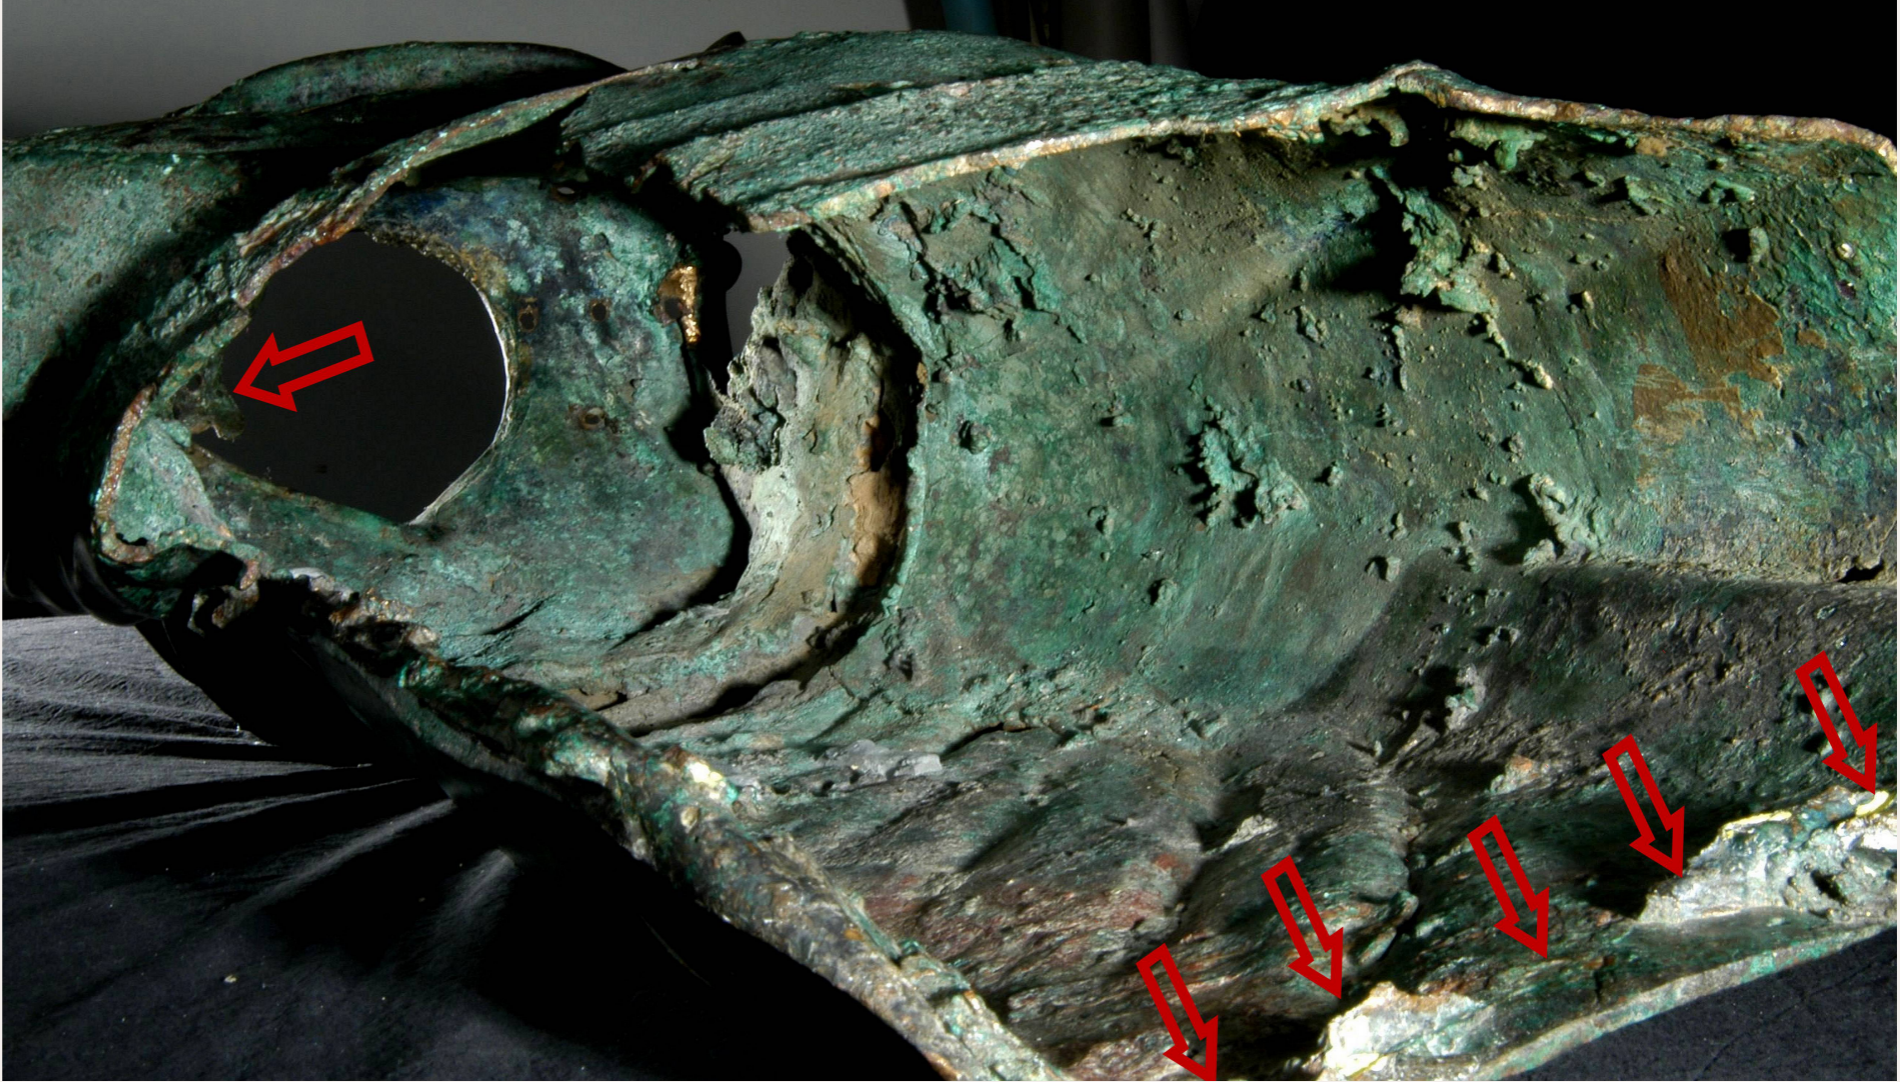
**FIGURE 6.19.** Inner surface of the bust. Arrows indicate hard brazing zones.

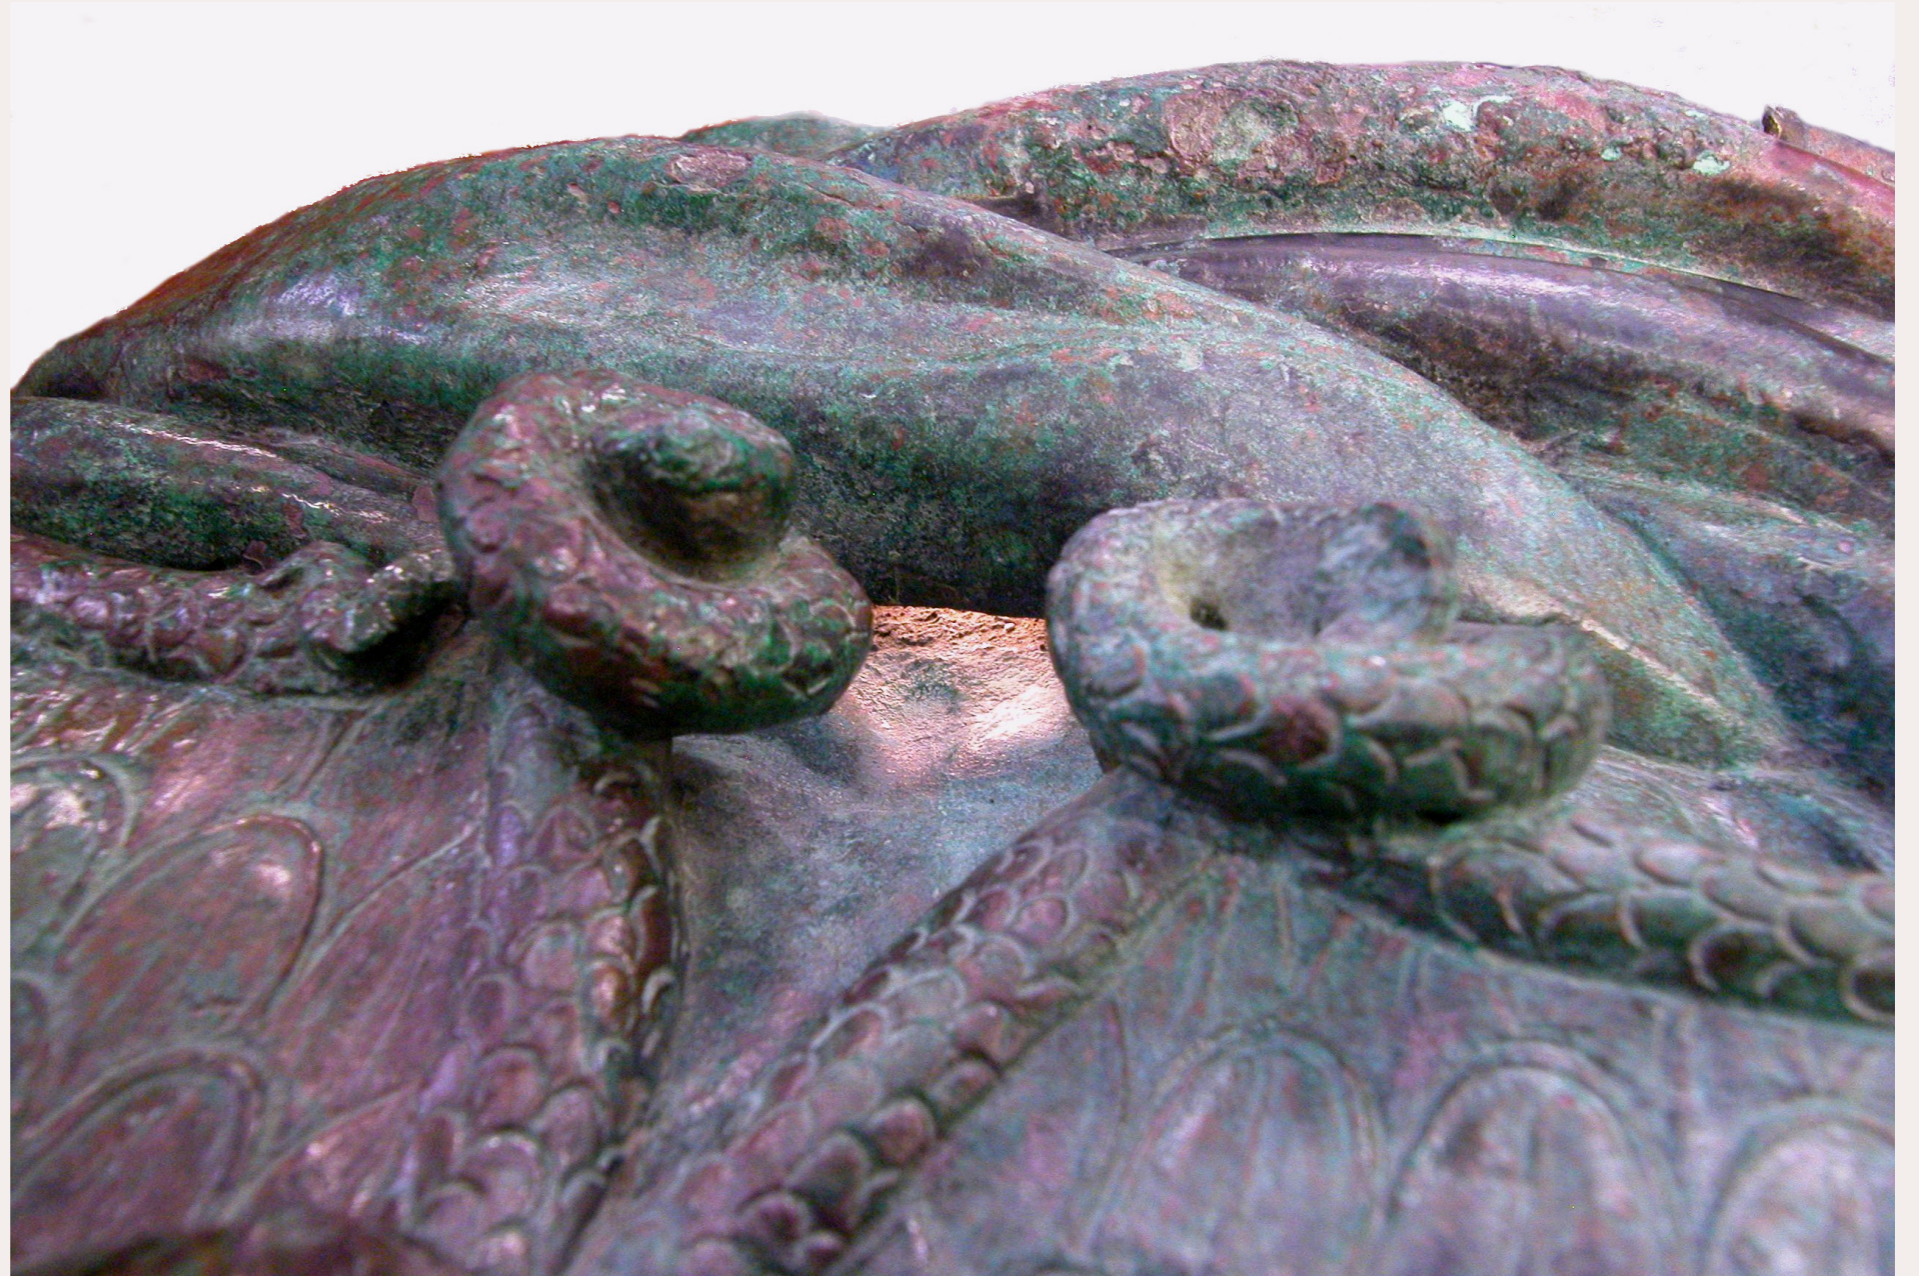
**FIGURE 6.22.** Gap in the drapery on the chest, lit from within
