Proceedings of the 12th Conference of the
International Committee for the Conservation
of Mosaics, Sardinia, October 27–31, 2014

The Conservation and Presentation of Mosaics: At What Cost?

*Proceedings of the 12th ICCM Conference
Sardinia, October 27-31, 2014*

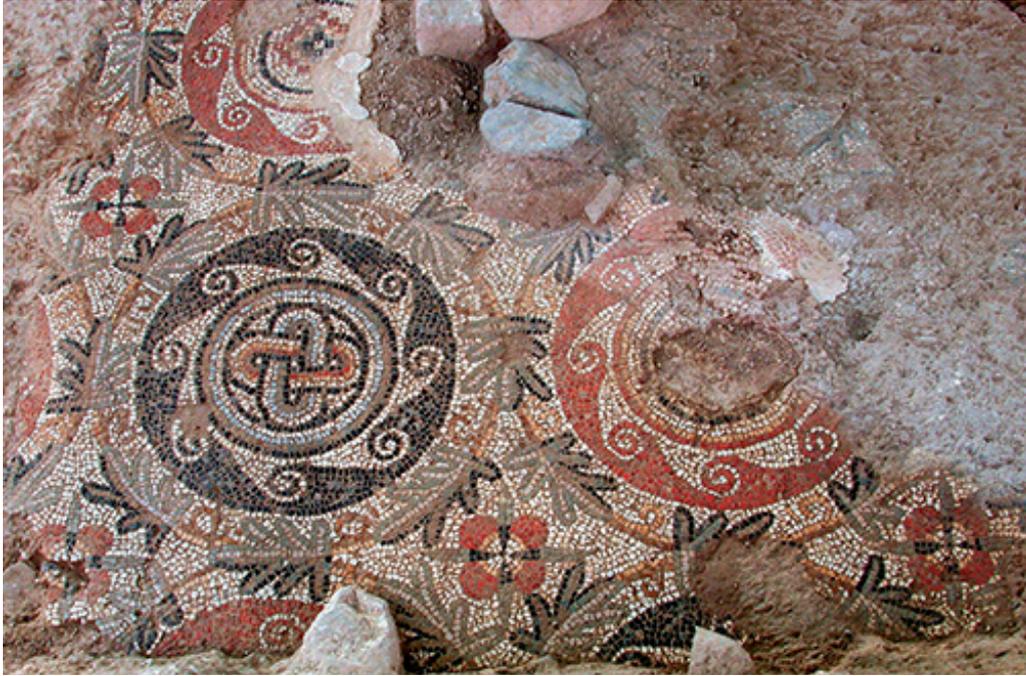
Figure 3 Settimo San Pietro, mosaic with a foliate pattern.
Photo: S. Angiolillo, 1981

Last, a refined late-era composition discovered in the countryside around Settimo San Pietro near Cagliari is of particular interest (fig. 3). Composed of tangential circles, it is bordered by a vine with leaves and tendrils (Angiolillo 2011). An almost exact equivalent is found in two mosaics, in Carthage and Majorca, however, they differ from the Sardinian example in the choice of decorative motifs. The extent of the differences is sufficient to justify a suspicion that this case represents a transmission of ideas rather than the work of African craftsmen directly.

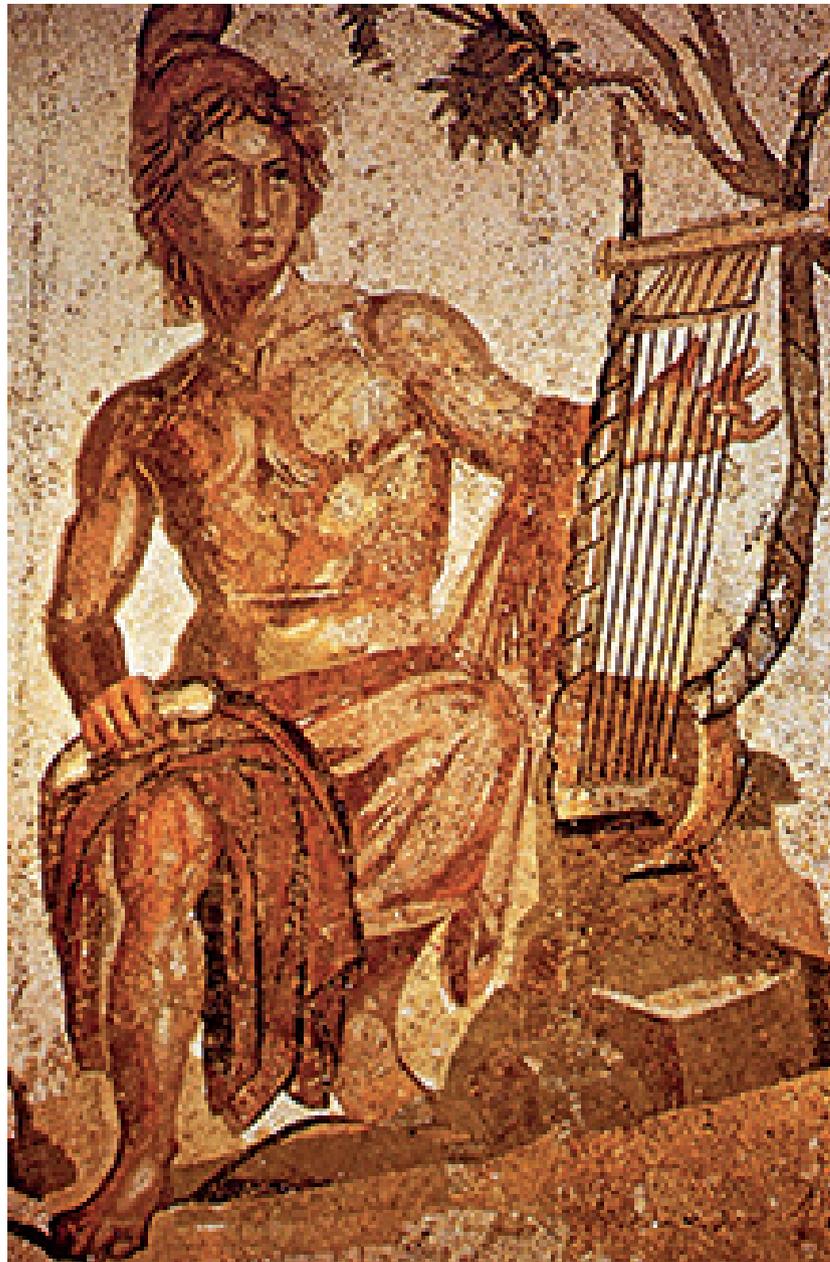
Figure 4 Cagliari, Orpheus mosaic. Photo: S. Angiolillo, 1981

break in continuity, and a round chin. The play of light and shadow is repeated in the animals, but here the craftsmen, less influenced by sophisticated models, have worked in a more schematic and flattened form, with large, juxtaposed areas of color. Another mosaic similar in composition was discovered in the same building but now is known only from a very brief description: Hercules with his club and lion skin standing in the center, surrounded by animals and trees. The fact that these two floors stand almost alone in the otherwise abundant Sardinian patrimony, and the close stylistic relations that link the Orpheus mosaic in particular with the coeval African

production, has suggested the possibility of the presence of African craftsmen.

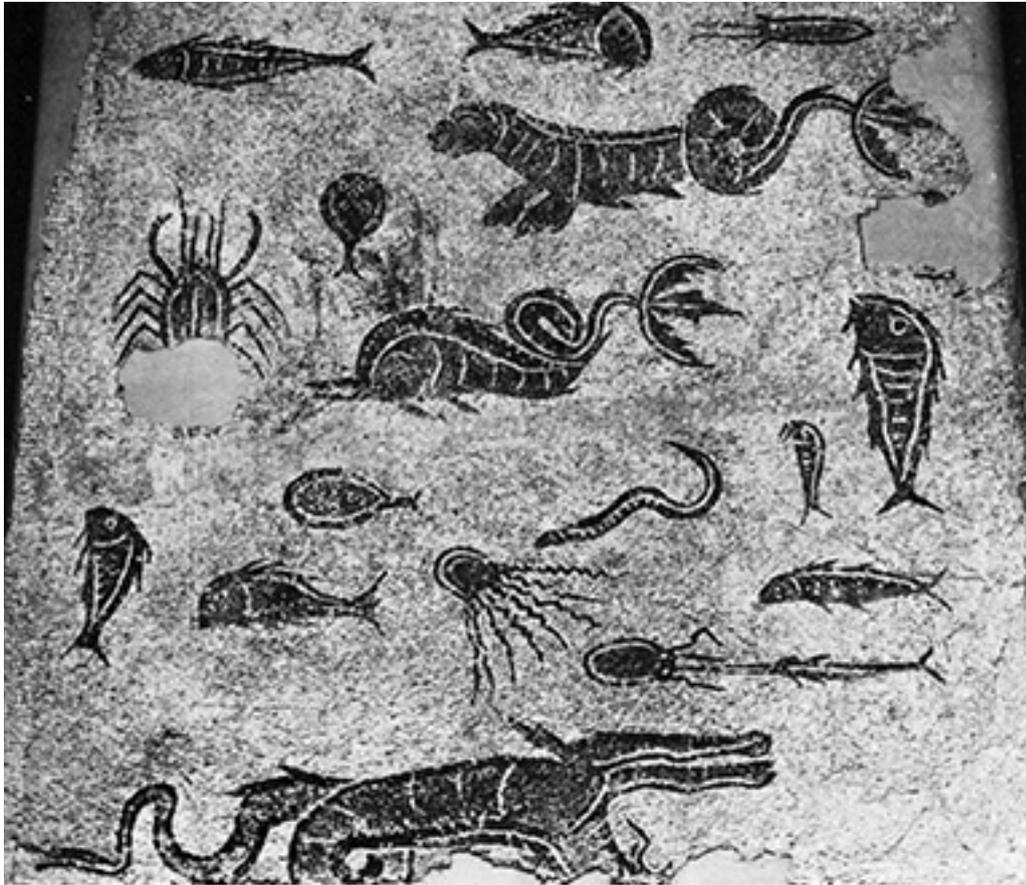
Figure 5 Porto Torres, marine mosaic. Photo: S. Angiolillo, 1981

At Porto Torres, until a few decades ago, the figurative mosaic was found only in the typology of the black-and-white marine mosaic (fig. 5), in two examples from the second and third centuries, respectively (Angiolillo 1981: plates 153, 154). While still falling within the Rome-Ostia tradition, these mosaics present technical features and iconographic rarities that warrant attribution to a local workshop. Black is used for outlines, while brown is used to render bodies. The animals are spaced evenly in parallel rows. The seal is depicted

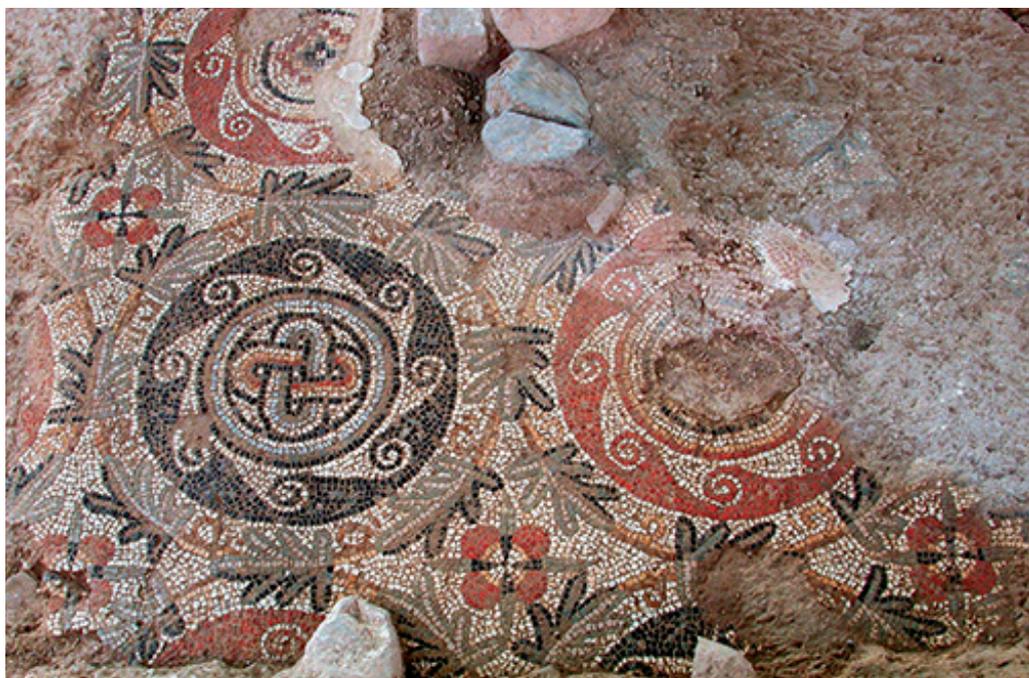
Figura 3 Settimo San Pietro, mosaico a trama vegetalizzata.

Particolarmente interessante è infine una raffinata composizione di età tarda, rinvenuta nelle campagne di Settimo San Pietro (fig. 3), vicino a Cagliari, con cerchi tangenti, la cui circonferenza esterna è segnata da un tralcio di vite con foglie e viticci (Angiolillo 2011). Essa trova una corrispondenza pressoché esatta in due mosaici, rispettivamente di Cartagine e di Maiorca, che però differiscono dall'esemplare sardo per la scelta dei motivi decorativi, tanto da far sospettare che non di medesime maestranze africane si possa parlare in questo caso, ma di trasmissione di modelli.

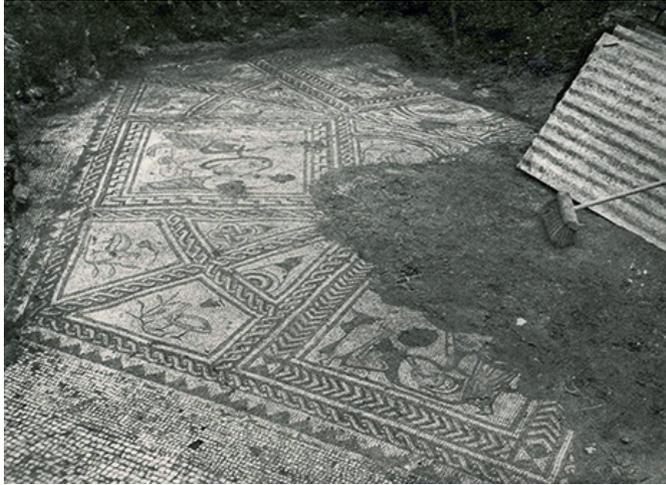
Figure 1 Room W mosaic excavated in the Durley Hill Cemetery, 1922–24.
Photo © Roman Baths, Bath & North East Somerset Council

All the rescued pieces were cut roughly into panels following the mosaic design and mounted onto concrete reinforced by iron bars and packed in wooden boxes. This action was fortuitous as we know that the town council, which ran the cemetery, was actively encouraging the robbing of the Roman walls so successfully that by 1926 all visual evidence of the villa had disappeared (Witt 2008: 12).

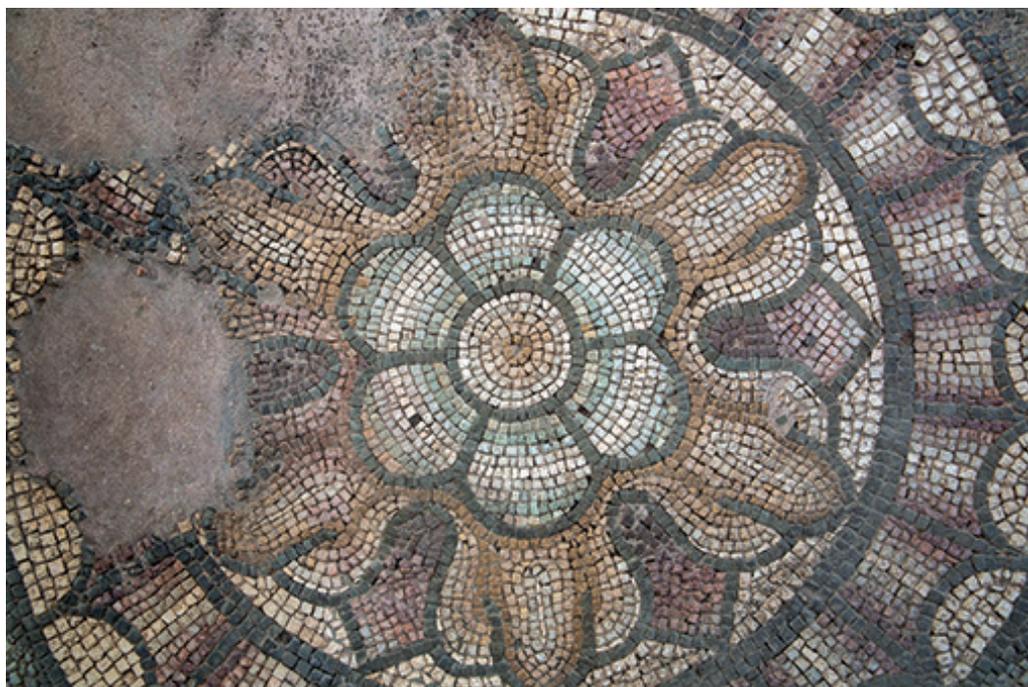
Figure 5 Detail of Room J mosaic.
Photo © Roman Baths, Bath & North East Somerset Council

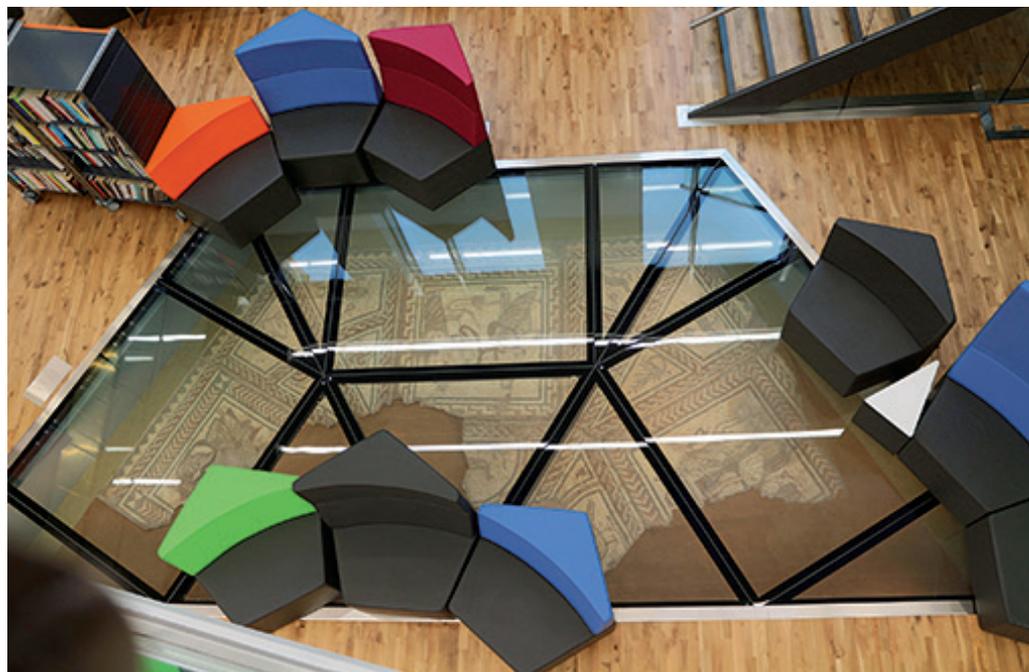
Figure 6 Room W mosaic panels as displayed. Photo © Roman Baths, Bath & North East Somerset Council

The specially constructed pit for the Room W mosaic was provided with ventilation holes to prevent buildup of condensation; as a contingency, there is space for fans to be fitted in the future. In August 2014 the mosaic panels were positioned in the display pit on a hydraulic lime-bound mortar bed. Some additional adjustments in level were made where necessary using inert spacing blocks and packers to rectify the differences in thickness of the twentieth-century concrete. Where each panel abutted the next, a mortar fill was inserted

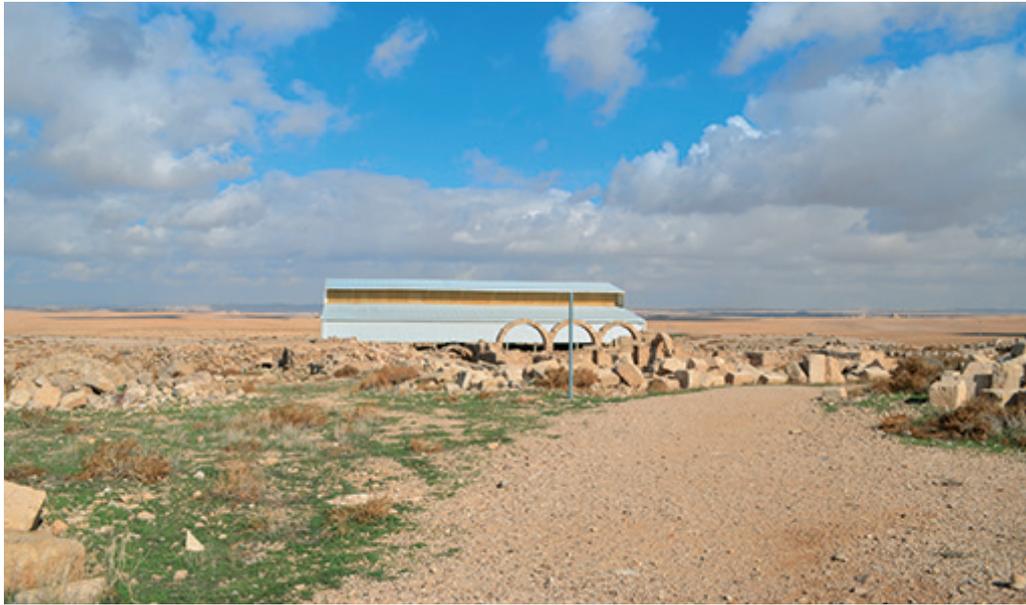
Figure 1 General view of the site, including the complex of Saint Stephen with the new protective shelter. Photo: S. Chlouveraki

The discovery of the mosaics of Saint Stephen immediately placed this complex among the most important monuments in Jordan. Piccirillo (1993: 6) compares this discovery to that of the mosaic map of Madaba one century earlier. Soon after their discovery, a shelter, provided with elevated walkways, was erected above the complex in order to protect the mosaics while offering public access to the best-preserved and most outstanding mosaics of the site. The shelter protected the mosaics effectively for more than fifteen years; in 2009 it was replaced by a new structure (see fig. 1).

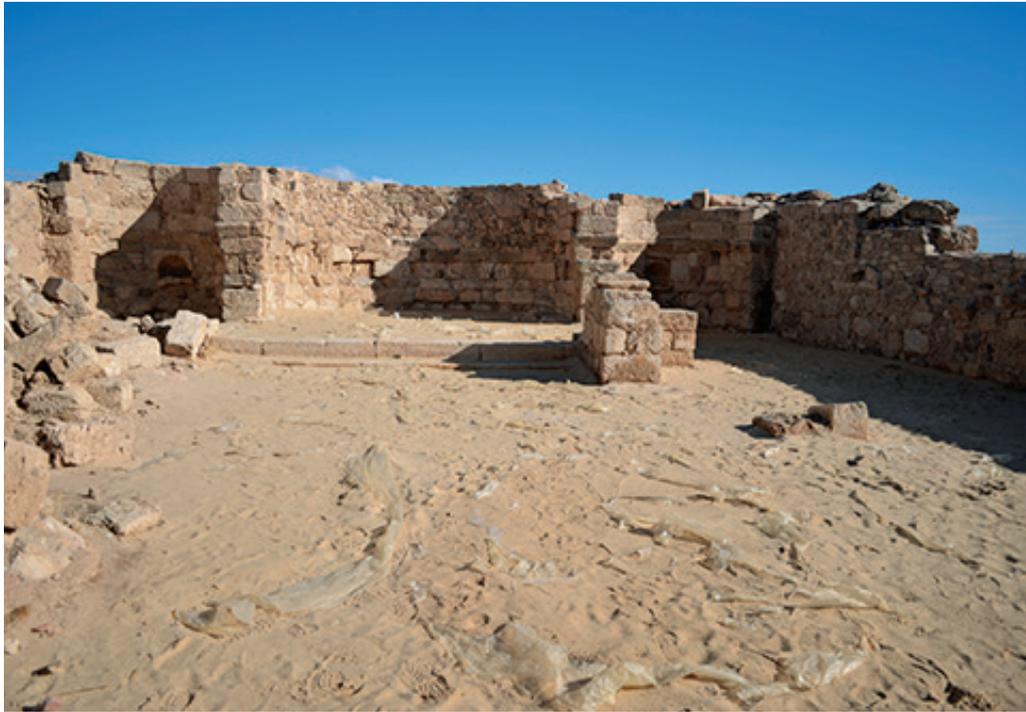
Figure 3 Temporary reburial of the mosaics of the Church of the Lions, December 2012.

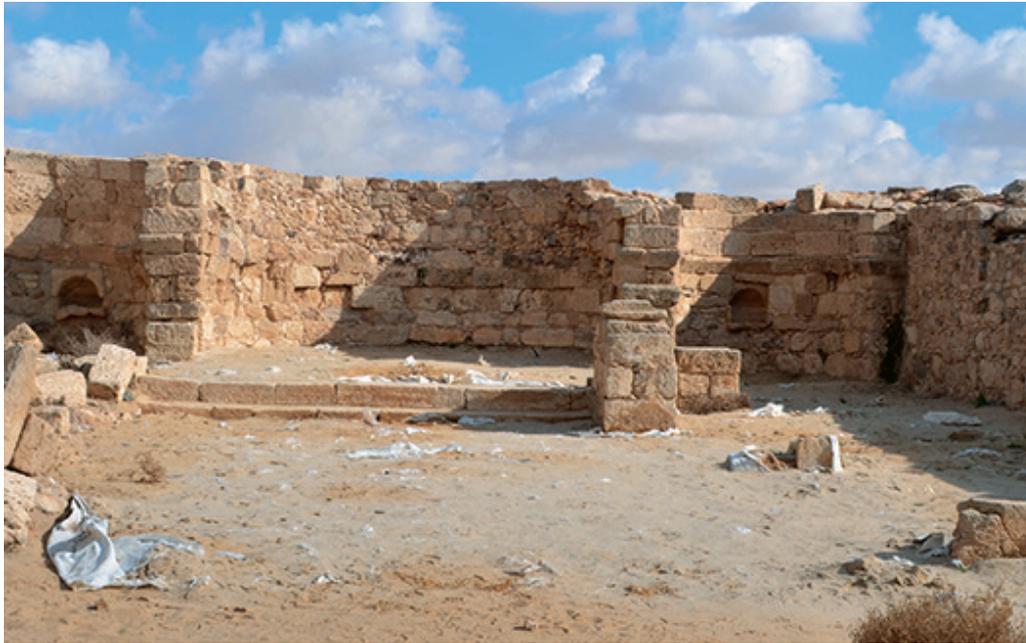
Figure 4 Condition of the mosaics of the Church of the Lions, December 2014, almost a year after the revision of the reburial.

very effective in protecting the mosaics, especially when compared to the current condition of the mosaics of the nearby Church of the Rivers, where no further action was taken to protect the mosaics (figs. 5, 6).

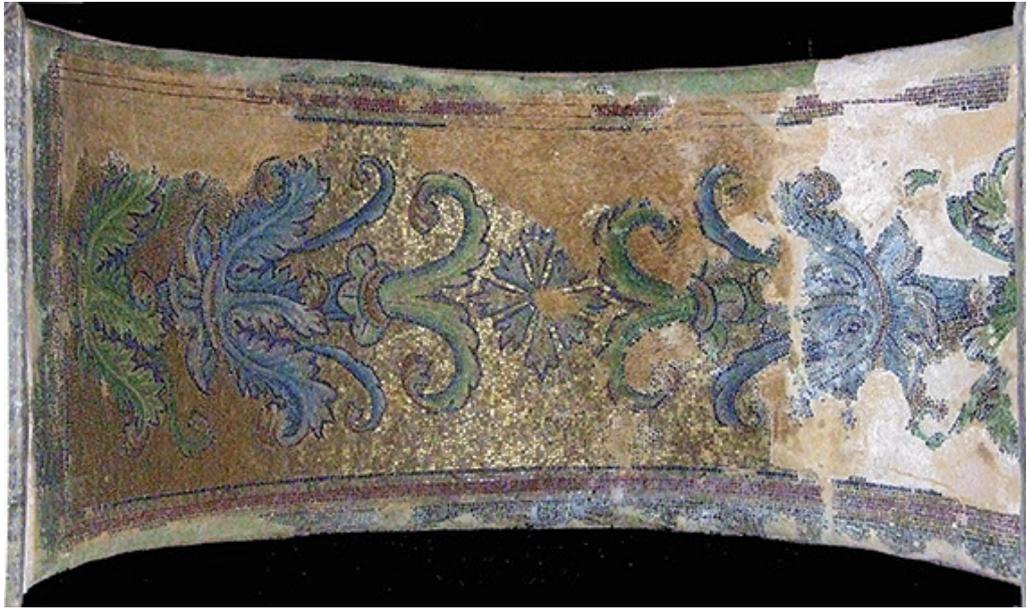
Figure 5a Mosaic from arch B1 before conservation. Photo: Courtesy Ephorate of Byzantine Antiquities of Thessaloniki

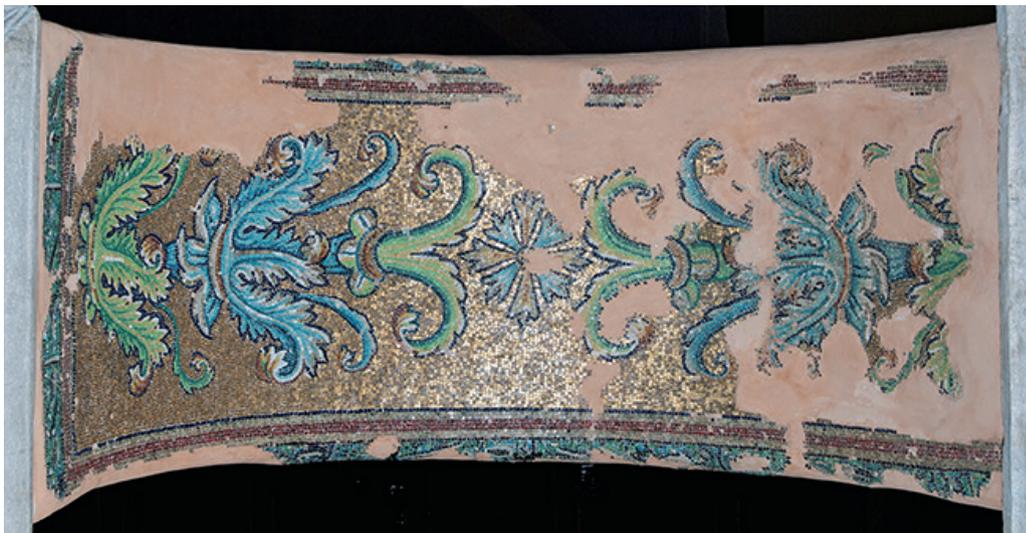
Figure 5b Mosaic from arch B1 after conservation. Photo: Courtesy Ephorate of Byzantine Antiquities of Thessaloniki

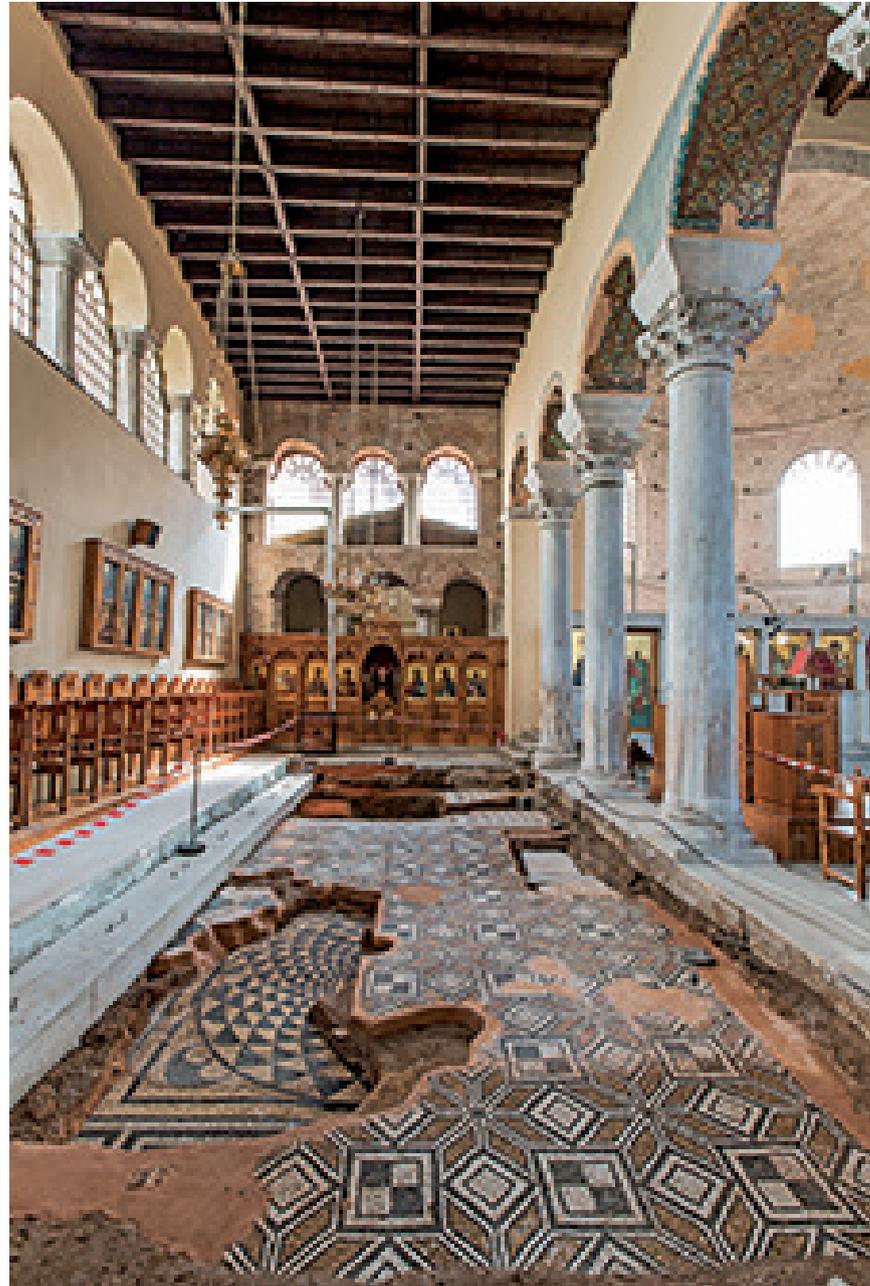
Figure 6 The three layers of flooring from the Roman bath (second to fourth centuries) under the north aisle. Photo: Courtesy Ephorate of Byzantine Antiquities of Thessaloniki

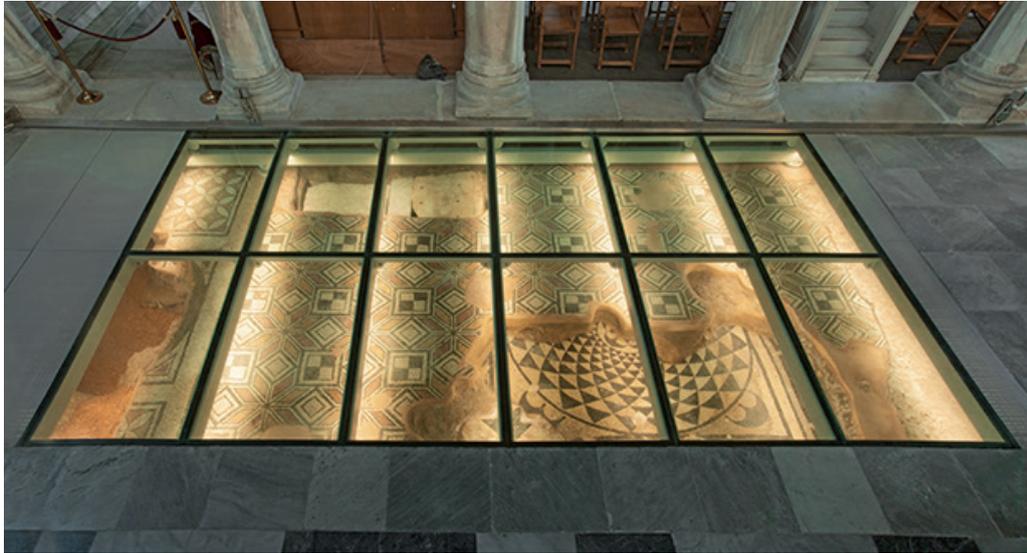
Figure 7 Walk-on glass installed over the exposed flooring of the Roman bath. Photo: Courtesy Ephorate of Byzantine Antiquities of Thessaloniki

stages. Covering the excavation with walk-on glass proved to be the only way to accommodate the coexistence of the antiquities with the needs of present-day life. Thus, with the help of custom-designed electric lighting, the visitor, the churchgoer, the schoolchild, and the expert will be able to see not only the find but its construction details and colors as well (fig. 7). The bearing system for the glass panels was designed on the basis of a static study using geotechnical data collected for that purpose. Trapped and recurring humidity will be removed by a mechanical forced-air ventilation system. In

order to regulate the humidity of the air in the trench, so as to protect the mosaics and prevent the glass panels from misting over, this microclimate was monitored for a year and a half, which led to the design and the incorporation of a ventilation and air circulation system in the installation. The whole structure is flush with the floor in the north aisle for unobstructed walking and creates no sense of insecurity. The solution is reversible and fully compatible aesthetically with the immediate archaeological environment. This part of the project cost €80,695.76. The positive impression this made led those

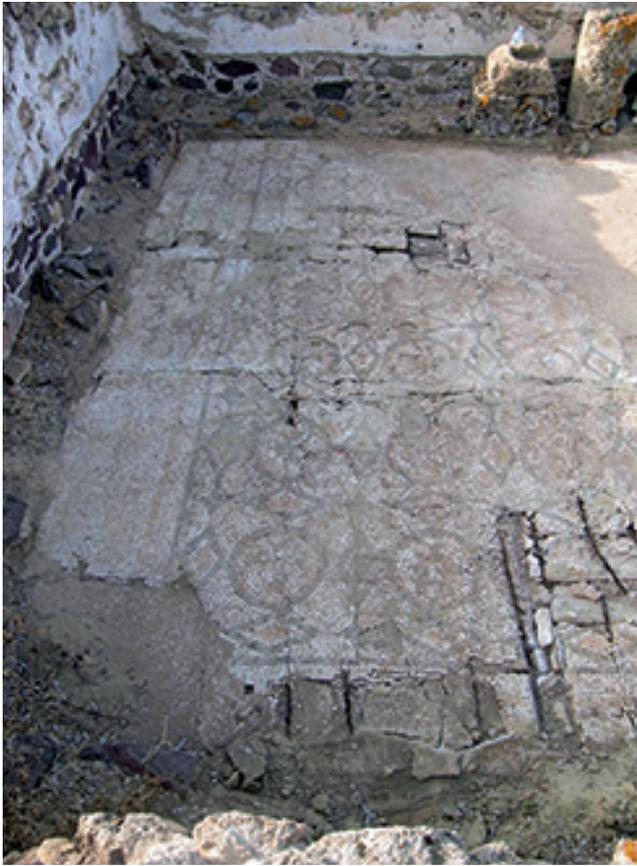
Figura 2 Piccole Terme Apodyterium: presenza di ferri ossidati (il copyright è detenuto dagli autori e le immagini sono degli autori)

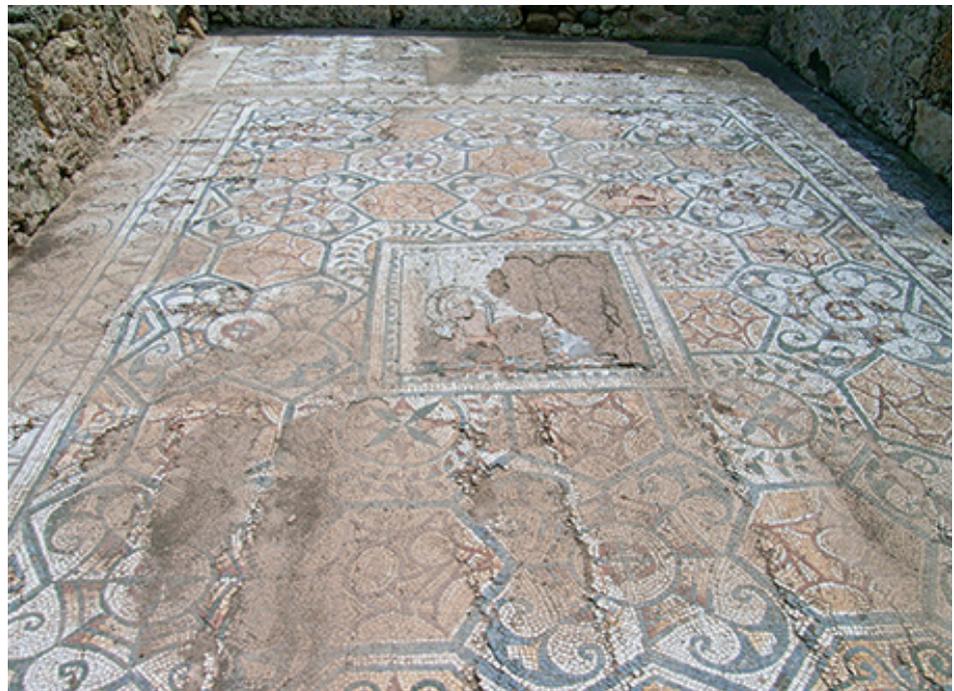
Figura 3 Casa dell'Atrio Tetrastilo, vano D: deformazione del tessellato, presenza di lesioni, deformazioni (il copyright è detenuto dagli autori e le immagini sono degli autori)

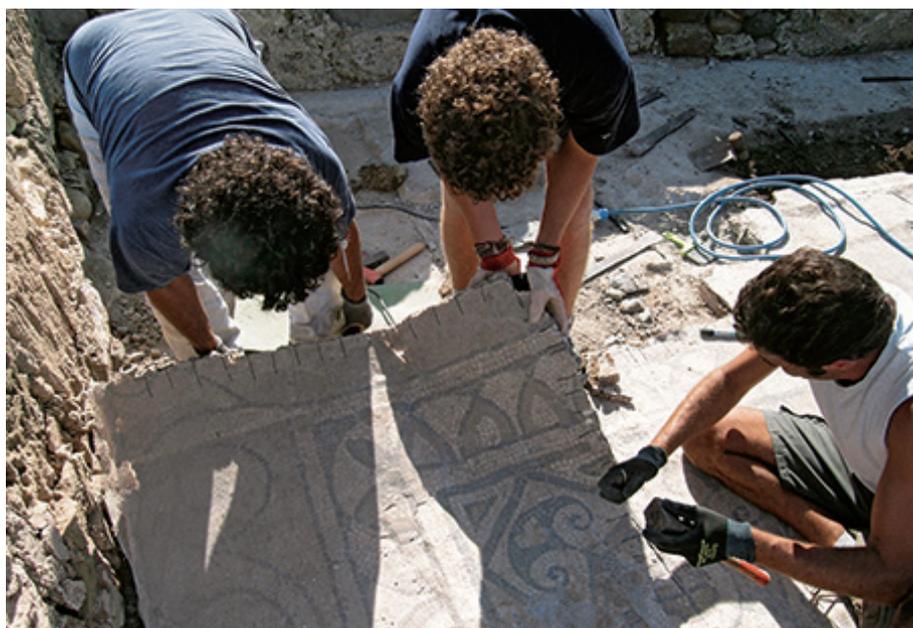
Figura 4 Casa dell'Atrio Tetrastilo, vano D: fase di stacco del mosaico (il copyright è detenuto dagli autori e le immagini sono degli autori)

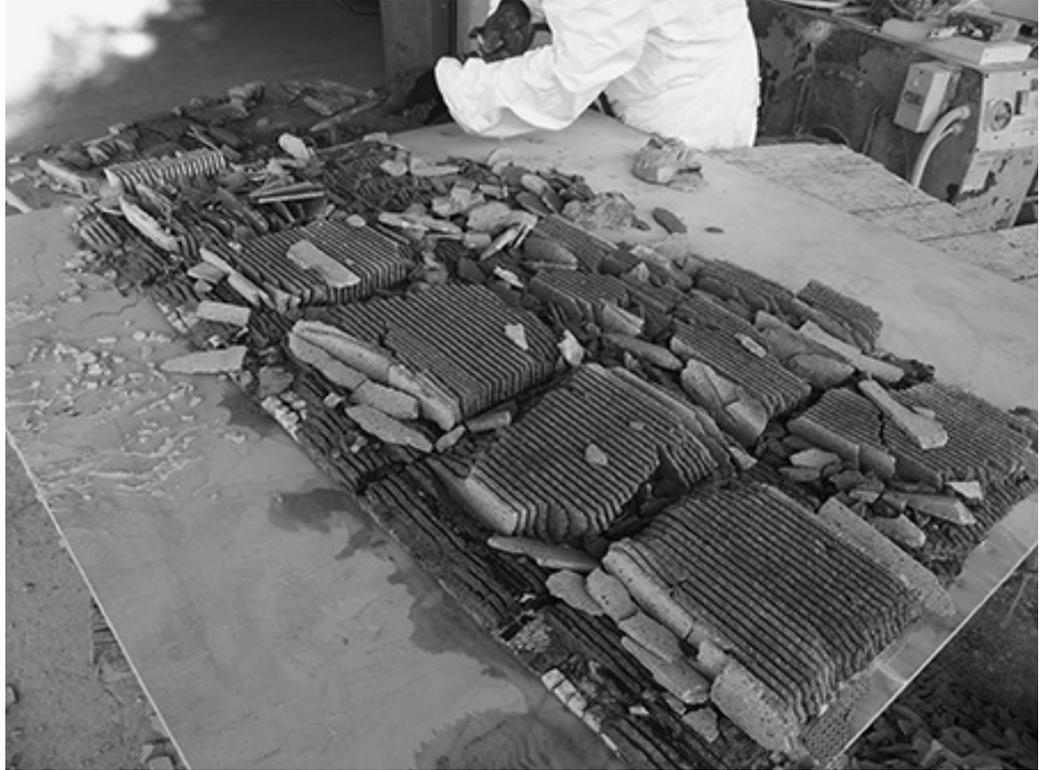
Figura 5 Rimozione meccanica del cemento dal supporto con tagli regolari eseguiti da sega circolare (il copyright è detenuto dagli autori e le immagini sono degli autori)

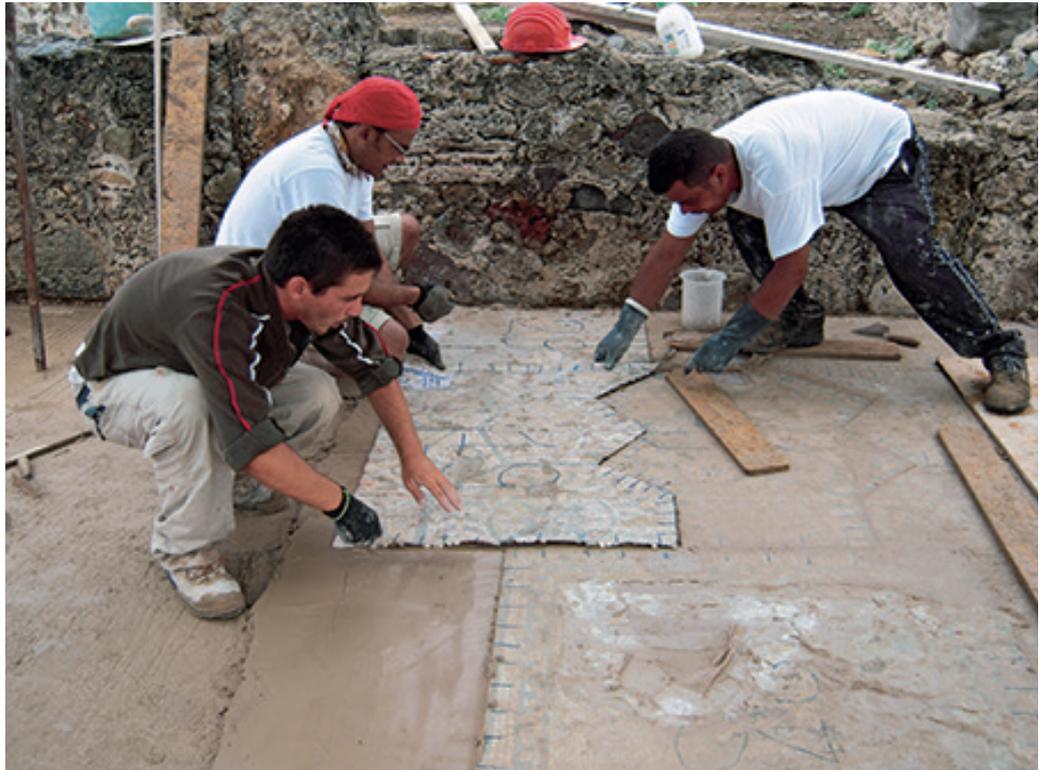
Figura 6 Casa dell'Atrio Tetrastilo, vano D: fase di rimontaggio del mosaico (il copyright è detenuto dagli autori e le immagini sono degli autori)

- documentazione (Rilievo 1:1; redazione di tavole grafiche tematiche e di fotografie per registrare lo stato delle superfici e gli interventi effettuati);
- trattamento biocida;
- raccolta e ricollocazione delle tessere distaccate;
- pulitura della superficie;
- rimozione dei mosaici dal sito (velinatura delle superfici a mosaico mediante applicazione di tessuto, taglio dei blocchi, stacco, sollevamento e trasporto in laboratorio) (fig. 4);
- rimozione del cemento e dei ferri di armatura (fig. 5);
- realizzazione di nuovi massetti in calce idraulica, previa demolizione della struttura in calcestruzzo del sottofondo;
- riapplicazione del mosaico in situ sui nuovi massetti (fig. 6);

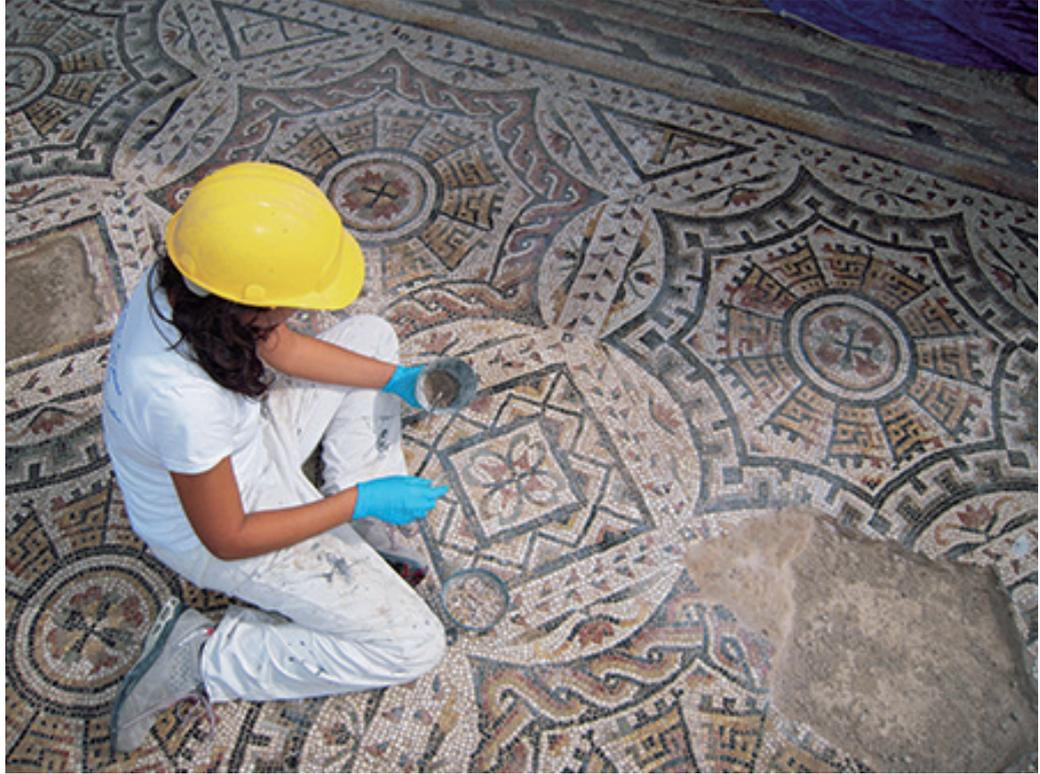
Figura 7 Casa dell'Atrio Tetrastilo, vano F: integrazione di piccole lacune (il copyright è detenuto dagli autori e le immagini sono degli autori)

- rimozione delle tele applicate e pulitura definitiva;
- integrazione delle lacune (fig. 7);
- ripristino della malta interstiziale (“boiaccatura”);
- applicazione di un protettivo superficiale per limitare i fenomeni erosivi (fig. 8);
- consolidamento delle strutture murarie, ancora parzialmente rivestite di intonaco, marginali ai pavimenti mosaicati.

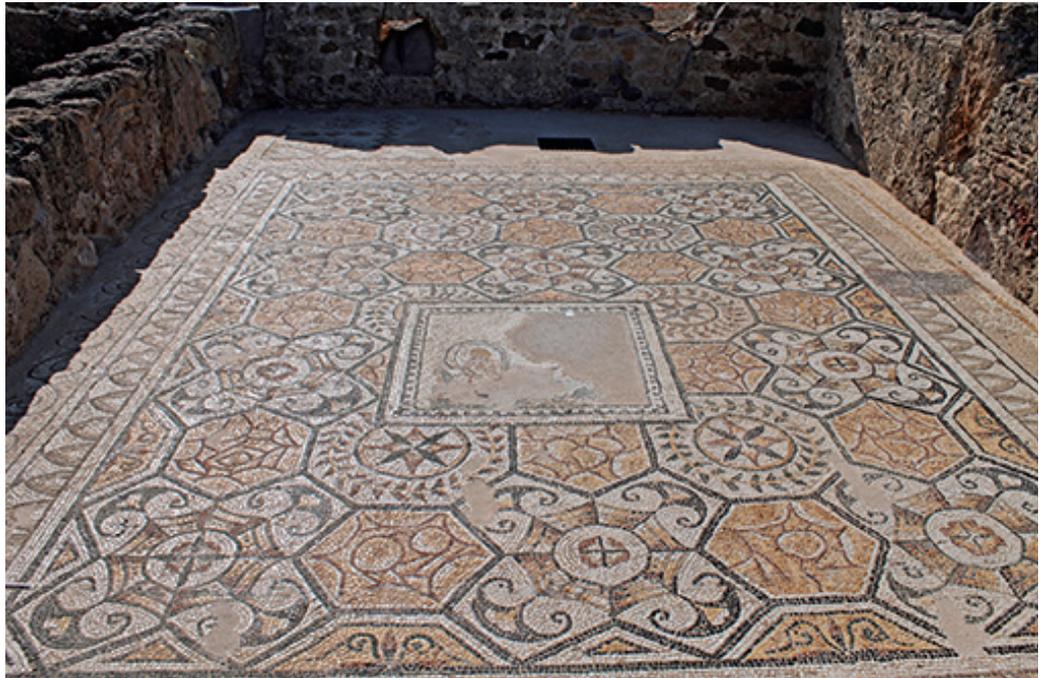
Figura 8 Casa dell'Atrio Tetrastilo, vano D: il mosaico dopo il restauro (il copyright è detenuto dagli autori e le immagini sono degli autori)

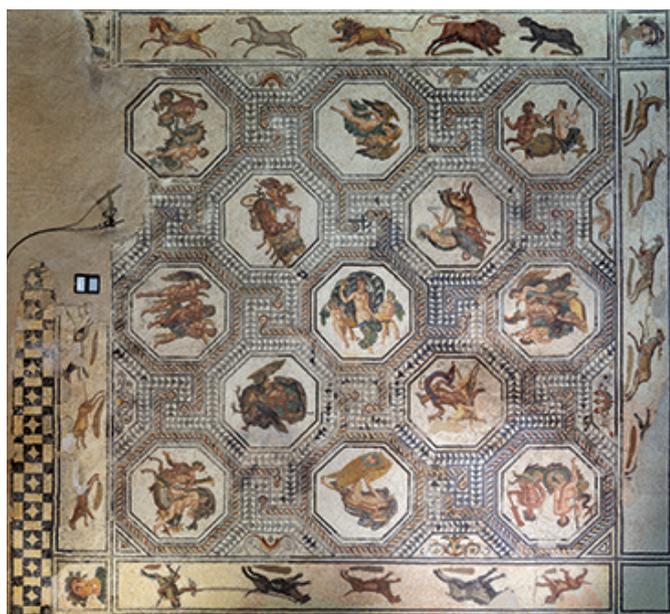
Figure 4 Orthophotographie digitale de la mosaïque dite « aux Divinités » (M8), géoréférencée dans une application SIG.

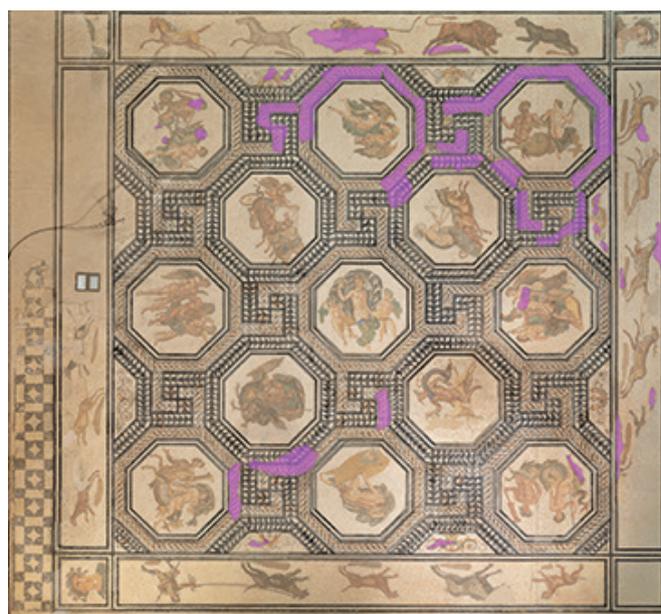
Figure 5 Figure 4 à laquelle un document décrivant des travaux de restauration de 1898 est superposé. Les informations contenues sur le plan de 1898 ont été vectorisées dans une application SIG. Dessin: Noé Terrapon, SMRA, sur la base du plan Archive Cantonale Vandoises, AMH B 271, B 1065

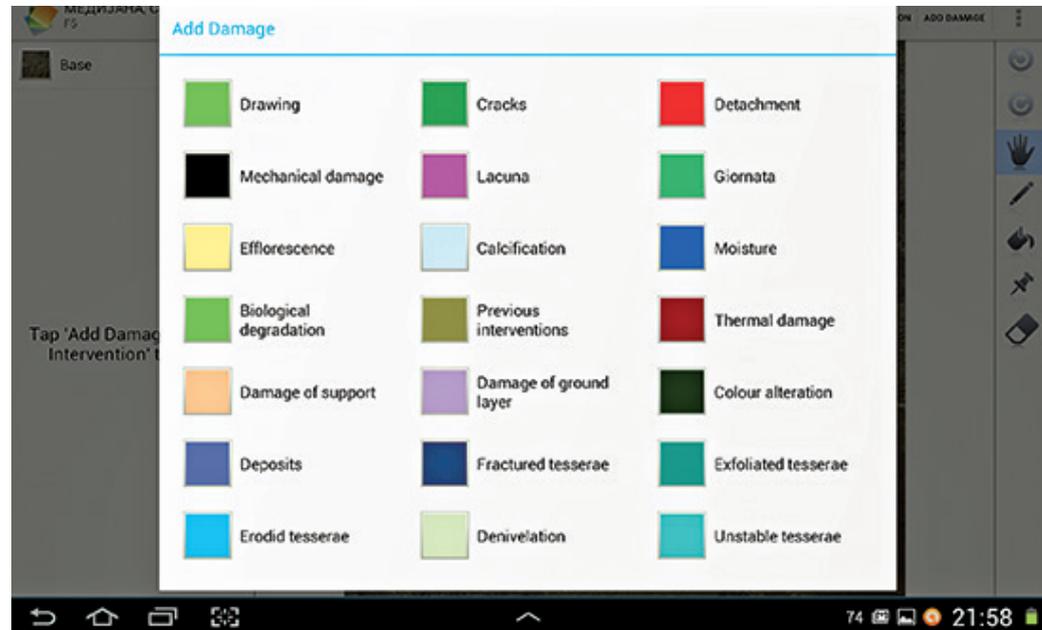
Figure 3 View mode screen with different layers

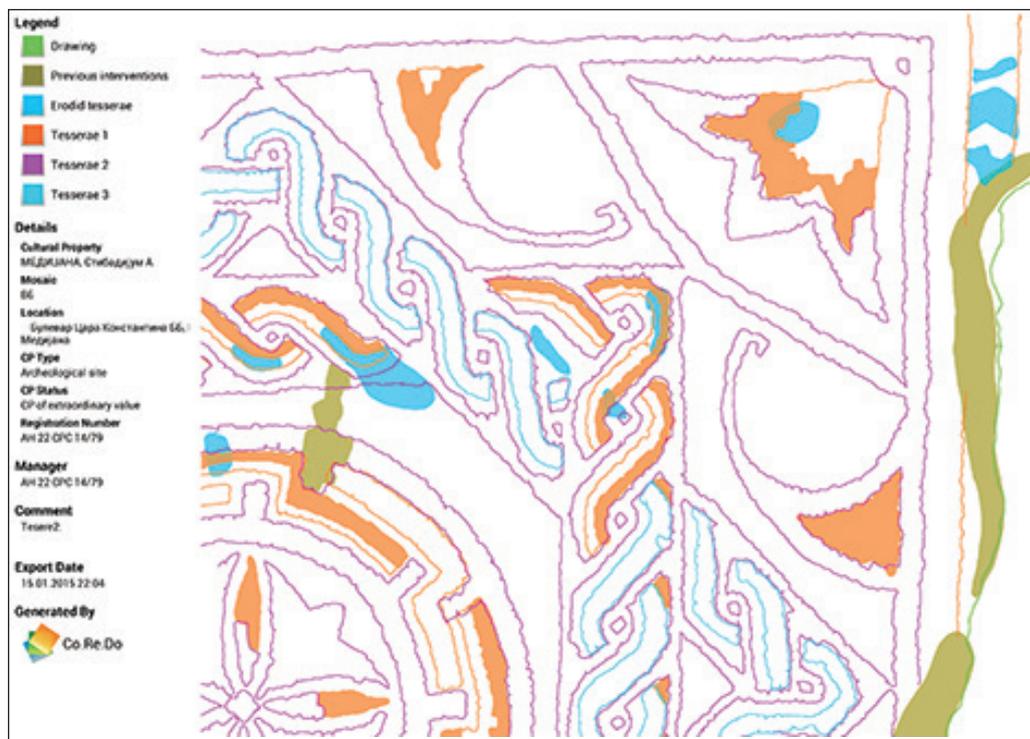
Figure 5 Exported document as a line drawing

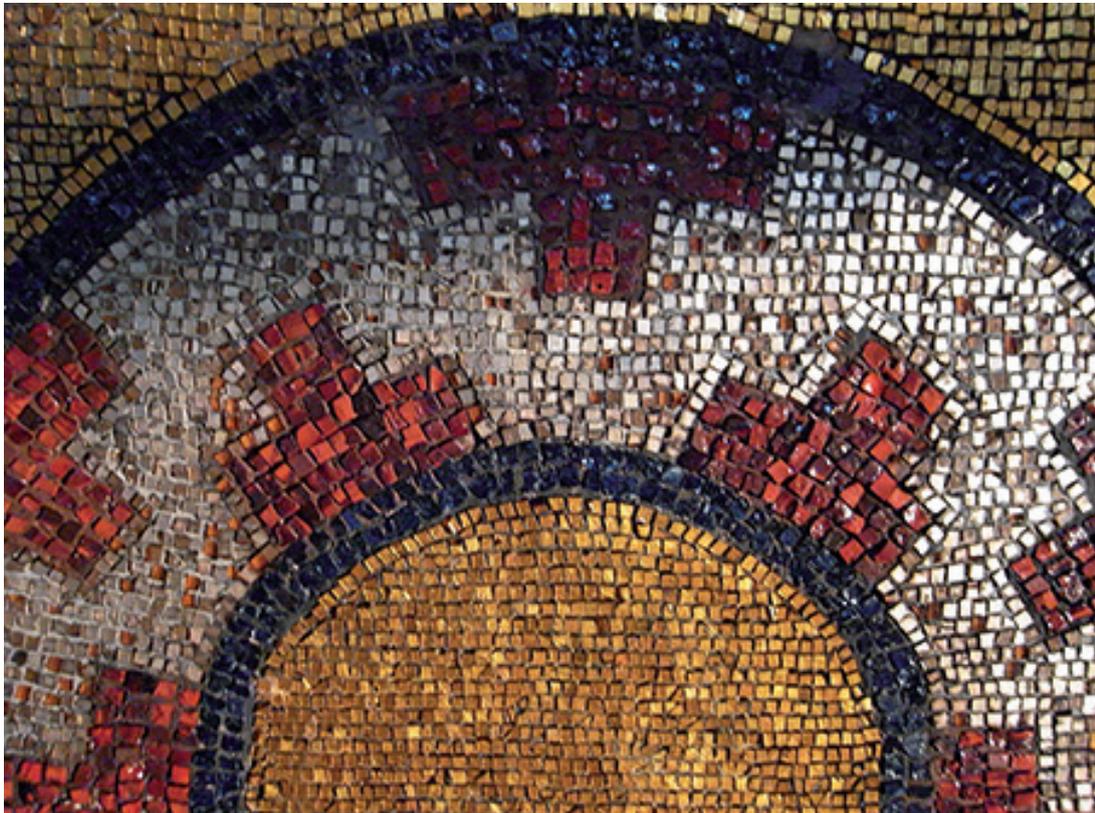
Figure 2 Sixth-century dome mosaic, December 7, 2009. Photo: J. Sasaki

The average sixth-century mosaic tessera was 7.2 mm long × 6.4 mm wide (160 total points measured); that is, vertically long rectangular gold tesserae were mostly used. The average fourteenth-century tessera was 7.0 mm long × 7.3 mm wide (159 total points measured); that is, horizontally long rectangular gold tesserae were mostly used. These results suggest

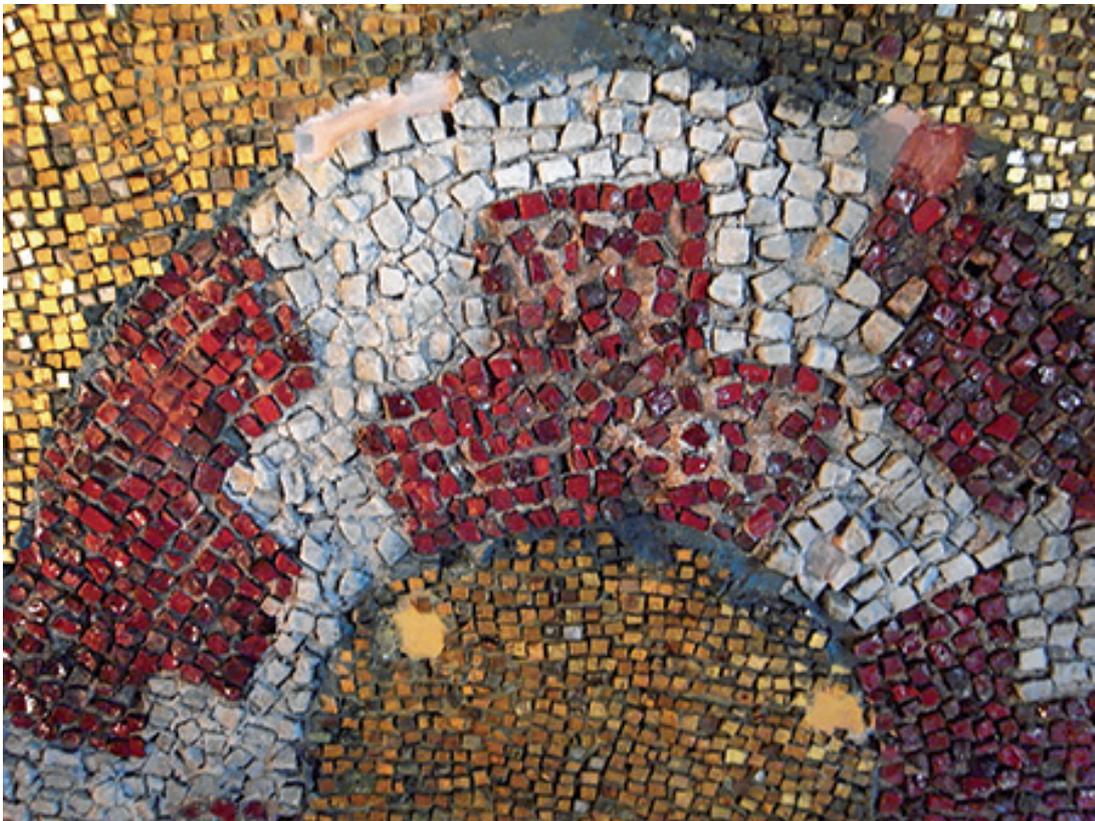
Figure 3 Fourteenth-century dome mosaic, December 7, 2009. Photo: J. Sasaki

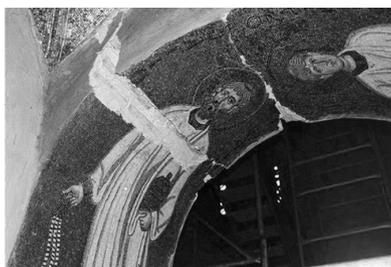
Figure 1 Large loss of tessellatum area after the earthquake. Photo: © Hellenic Ministry of Culture and Sports

In the first phase, the damage to the mosaics was assessed and documented. They suffered from loss of tesserae (fig. 1), an extensive network of cracks; surface irregularities such as rises and bulges (fig. 2), loss of cohesion between preparatory layers; and detachment between mosaic layers and the wall. The first aid treatment included collecting loose tesserae and detached fragments and facing the areas of rises and cracks (fig. 3), along with the documentation process. The first dilemma arose when surveying for the structural strength of the building revealed that, in order to ensure the stability of the dome, metal supports had to be introduced in four vaulted areas that had mosaics. This meant that detachment of these mosaics was inevitable, as the stress to the mosaics between the metal supports and the walls might cause them further damage. Another mosaic panel was also detached, to repair the heavily damaged masonry underneath (Delinikolas et al. 2003).

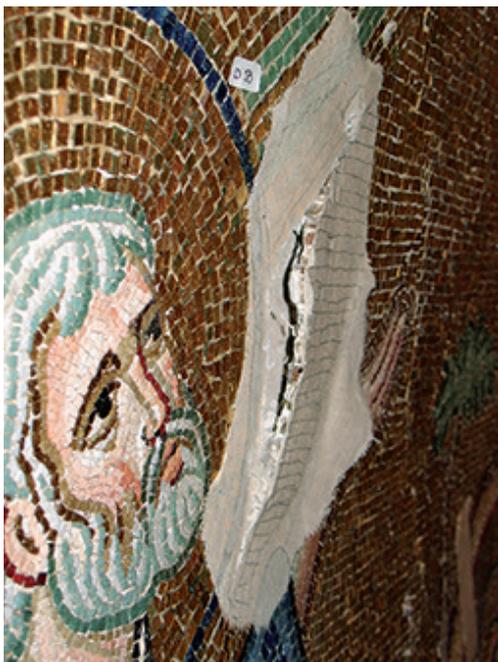
Figure 2 Bulge in the mosaic surface after the earthquake. Photo: © Hellenic Ministry of Culture and Sports
