Proceedings of the 12th Conference of the
International Committee for the Conservation
of Mosaics, Sardinia, October 27–31, 2014

The Conservation and Presentation of Mosaics: At What Cost?

*Proceedings of the 12th ICCM Conference
Sardinia, October 27-31, 2014*

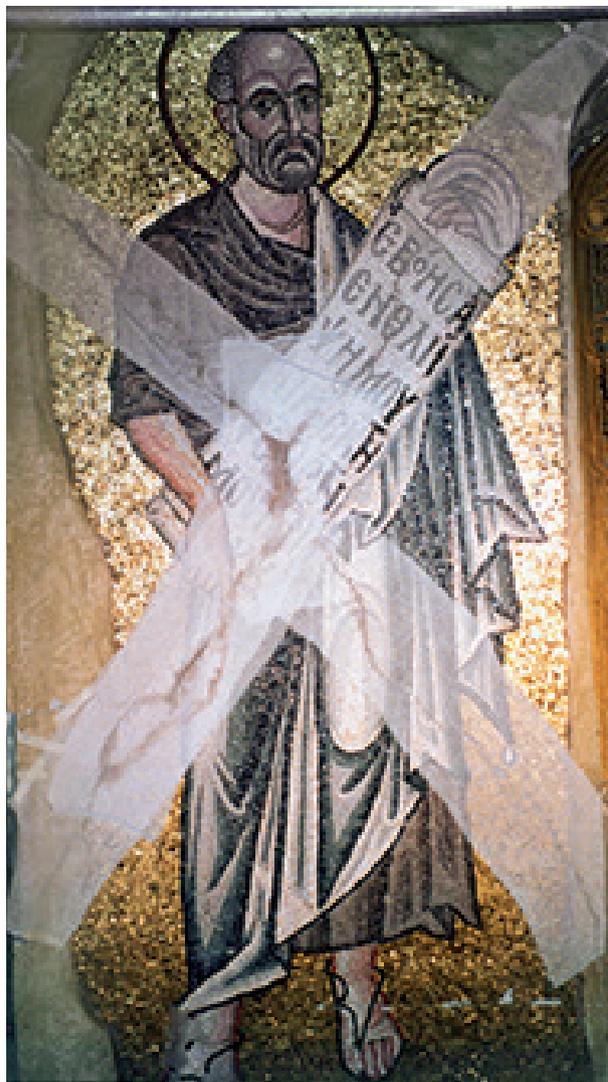
Figure 3 First aid treatment to the Prophet Iona mosaic. Photo: © Hellenic Ministry of Culture and Sports

The last intervention that was performed was the re-laying of the mosaic panel depicting the prophet Ionas that had been removed in the first phase because the substrate had suffered great damage or had collapsed. After the masonry was consolidated and supported the detached and treated mosaic panels were put back in their original place.

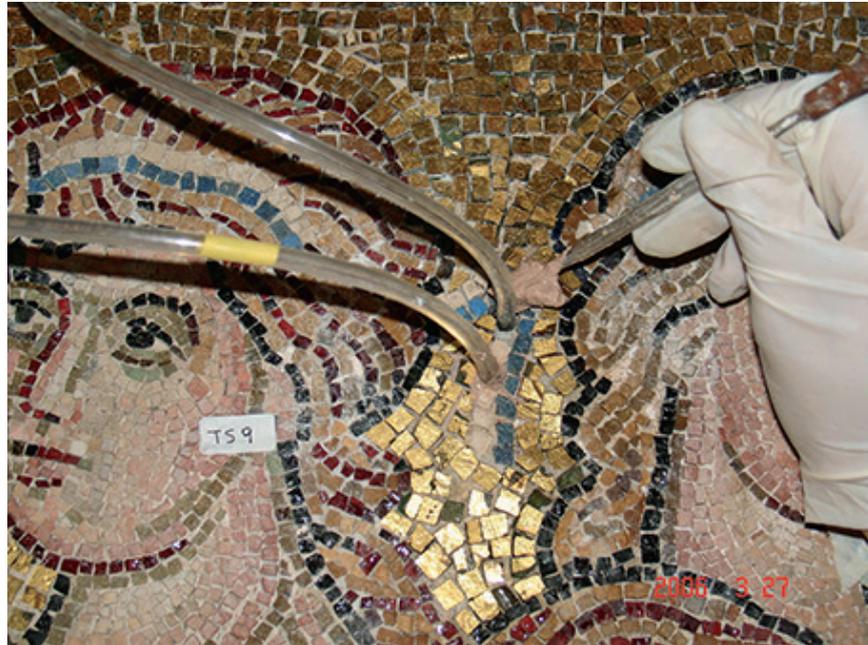
Figure 5 Detail of a loss before restoration. Photo: © Hellenic Ministry of Culture and Sports

The aesthetic presentation of the mosaics motivated a discussion about whether or not to color the interstices between tesserae where new mortar was introduced. Taking into account that the majority of the mosaics had already been restored in the nineteenth century and that many losses were refilled with original or new tesserae, it was decided to proceed with limited restoration, with mortar (colored or not) to small losses (figs. 5, 6), with respect to the authenticity of the mosaics and the historic restoration, and with color to interstices in areas with dark tesserae (Anamaterou et al. 2013). The masonry will not be covered with mortar in the area of losses, except in the case of the dome, which will be covered for structural purposes.

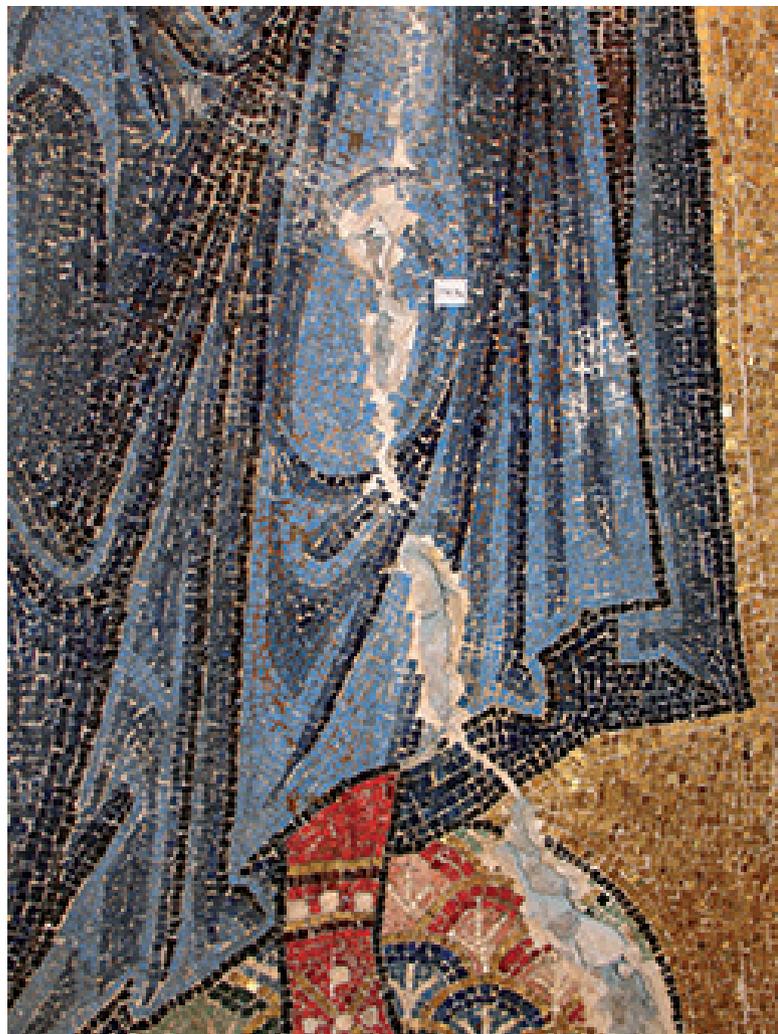
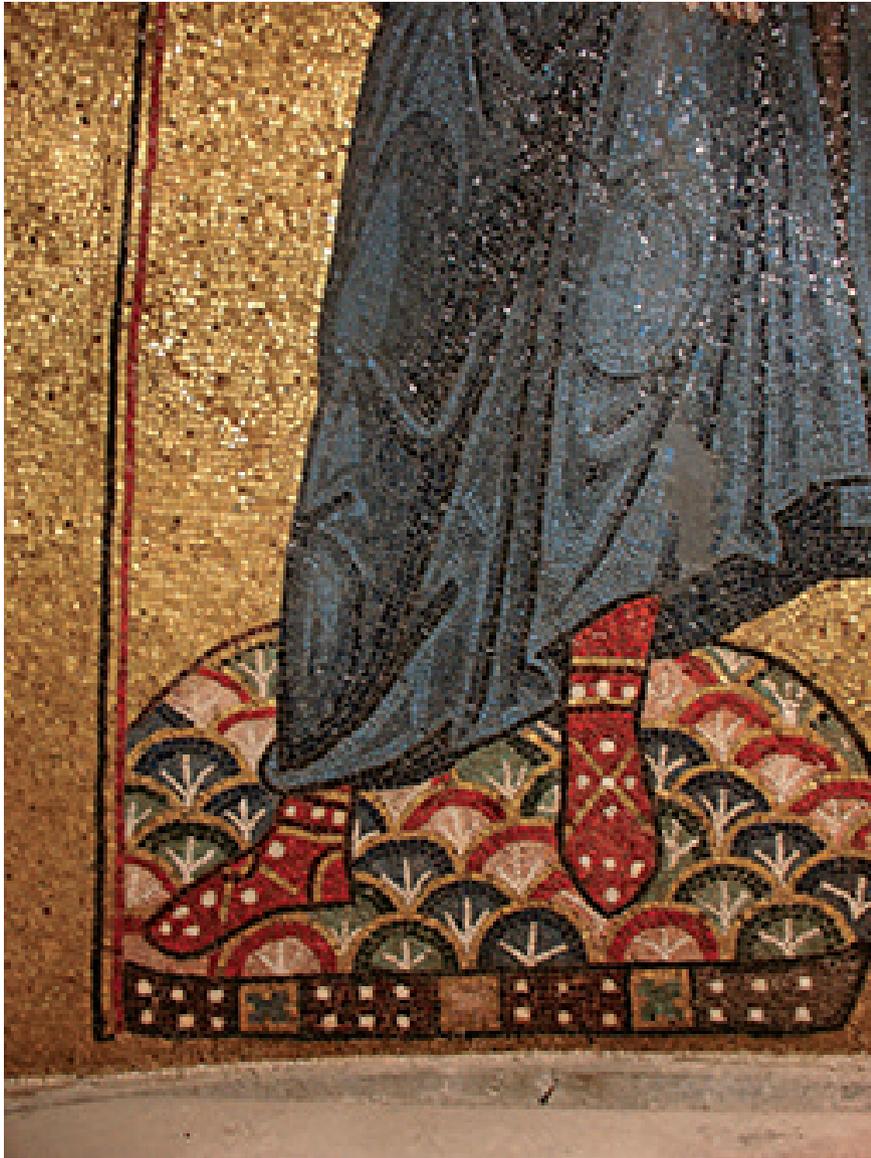
Figure 6 Detail of a loss after restoration. Photo: © Hellenic Ministry of Culture and Sports

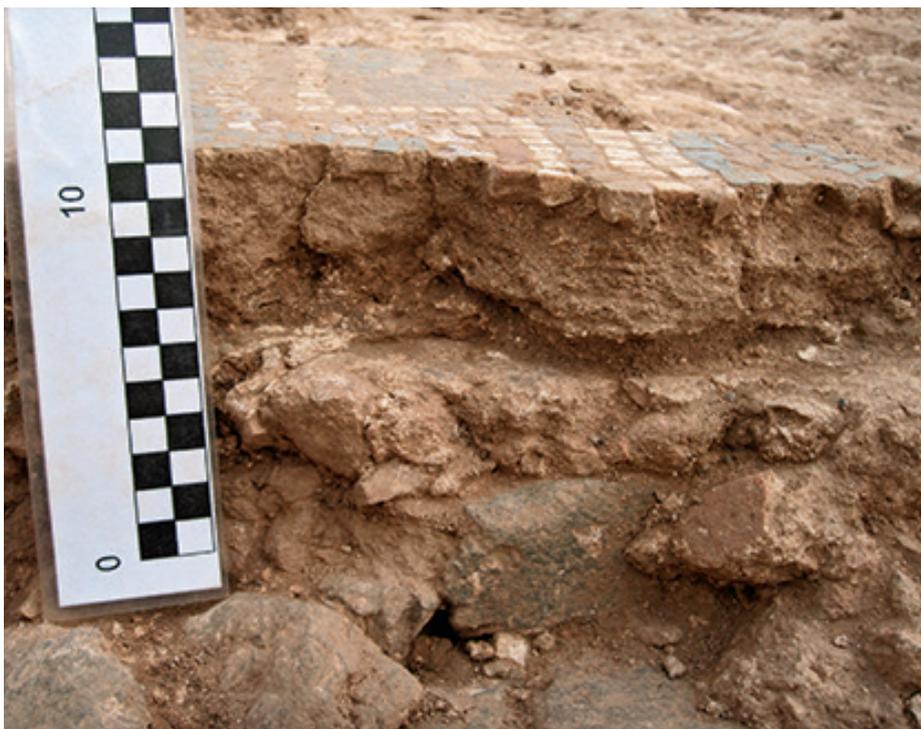
Figure 4 Detailed view of the stratigraphy of the *opus tesellatum* atop the earlier *opus signinum* pavement. Photo: Silvia Lobet

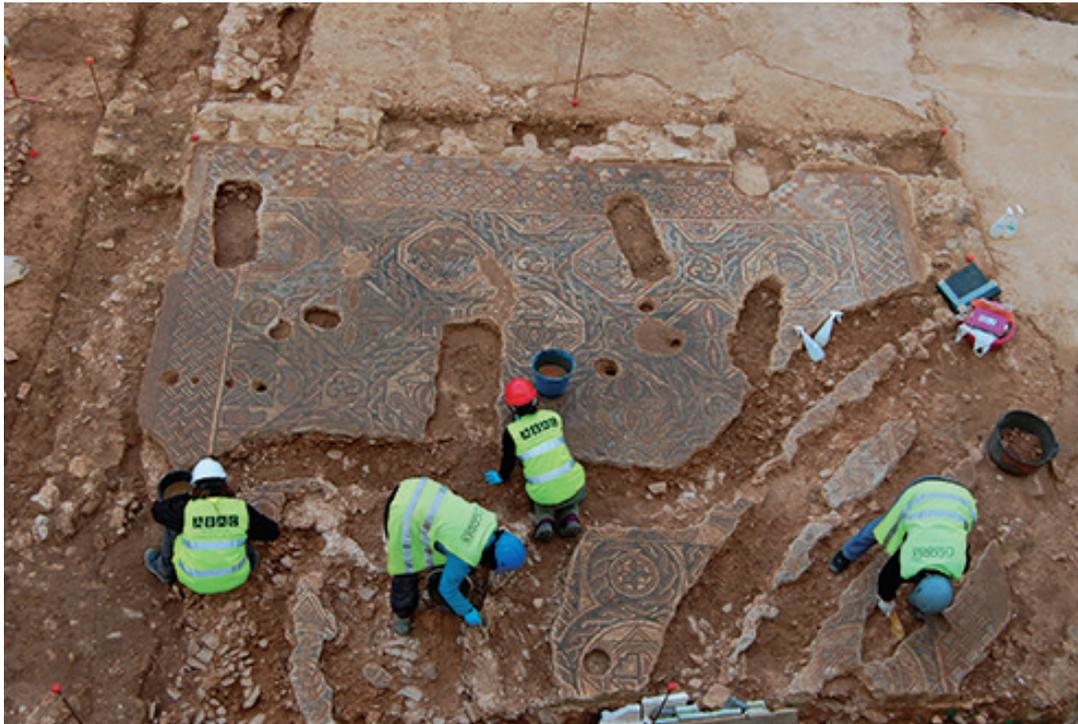
Figure 5 Aerial view of the cleaning work on the part of the opus tessellatum excavated in 2014.

much quicker immediately after the mosaic was discovered because the ground moisture made the encrustation easier to remove, also allowed us to monitor the drying process (fig. 5). During that time we recovered 32 fragments of different sizes, each of which was identified with a letter. The excavation also unearthed 140 fragments or groups of small fragments whose position had shifted—likely due to the plowing—each of which was assigned a coordinate. By sieving the soil from all the m² quadrants, we recovered approximately 25,000 detached tesserae, which were assigned the number of the quadrant in which they were found (Llobet and Molinas 2015).

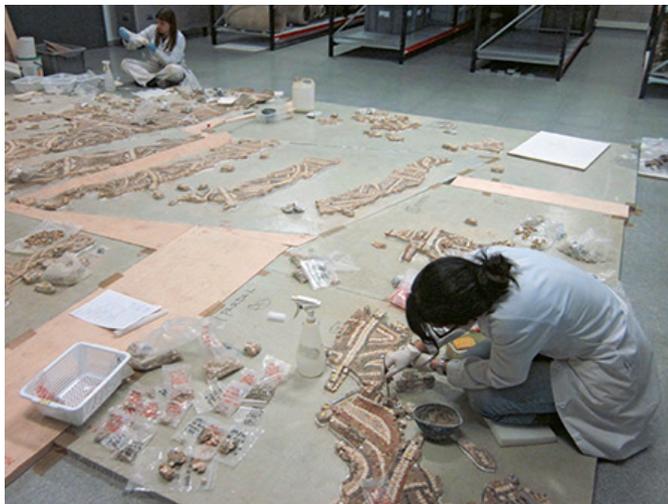
Figure 8 Re-laying the fragments and tesserae recovered from the opus tessellatum onto the new honeycomb support. Photo: Silvia Llobet

Once the panels were finished, the mosaic fragments were transferred to the new support and adhered by applying small dots of epoxy resin between the intervention layer and panels. Re-laying some fragments proved quite difficult, having been discovered out of context. Three factors played a key role in correctly arranging the fragments on the new support: information concerning the area in which they were discovered, the fragment's decoration, and the design template based on the orthophotograph.

we decided to fill small lacunae in between fragments and finish certain decorative lines with the tesserae, making the parts of the mosaic that had sustained substantial loss and the overall piece easier to understand. The entire re-laying process has been exhaustively documented (fig. 8).

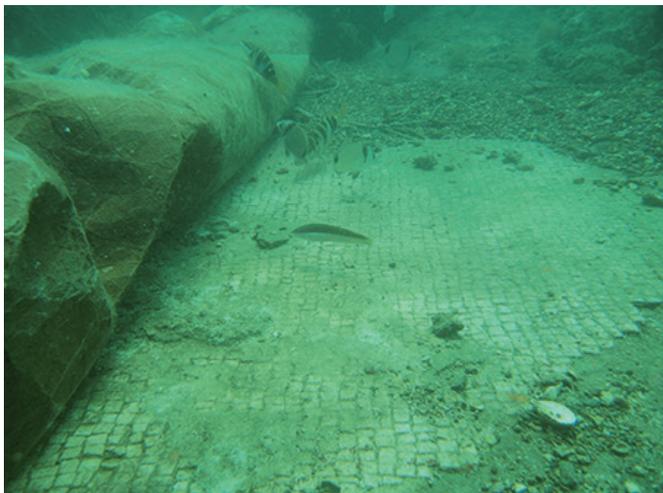
Figure 4 Covering with geotextile after restoration work in 2004. Photo: ISCR

In 2005 routine maintenance was carried out on the 2004 restoration work. Further work took place in 2008, when the protective covering was replaced with a new one. It had to be replaced again in 2009 after high seas had torn it away. A different kind of specially designed padded geofabric was laid in sections, like a military tortoiseshell formation. The stability, adhesion, and overall state of the perimeter grouting work of 2009 were checked the following year. The perimeter

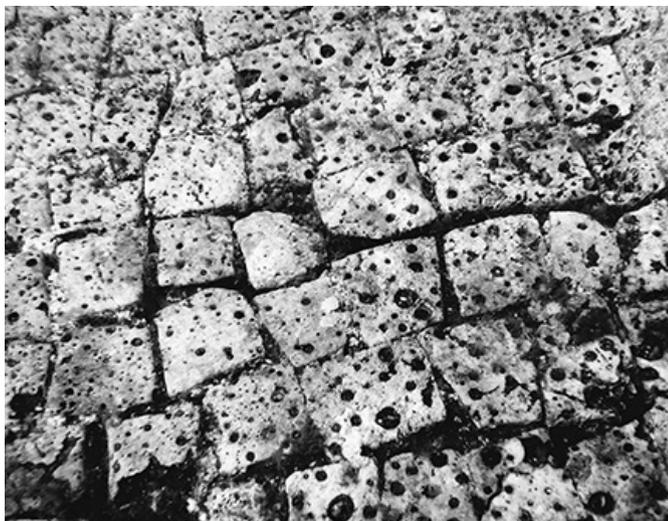
Figure 5 The evident revitalization of boring Porifera. Photo: ISCR

At the beginning of the project, in 2004, the mosaic pavement showed bioerosion phenomena related to the epilithic colonization due to zoobenthos and phytobenthos and to the endolithic colonization caused by boring Porifera (fig. 5). As described in the previous paragraph, the more extensive damage was caused by the loss of the screed layer below the mosaic, due to marine erosion that removed this portion of the structure and also to marine bioerosion (Ricci et al. 2009; Davidde et al. 2010). The mosaic surface was almost completely covered by a thick layer, in some cases up to 5 cm, of phytobenthos and zoobenthos.

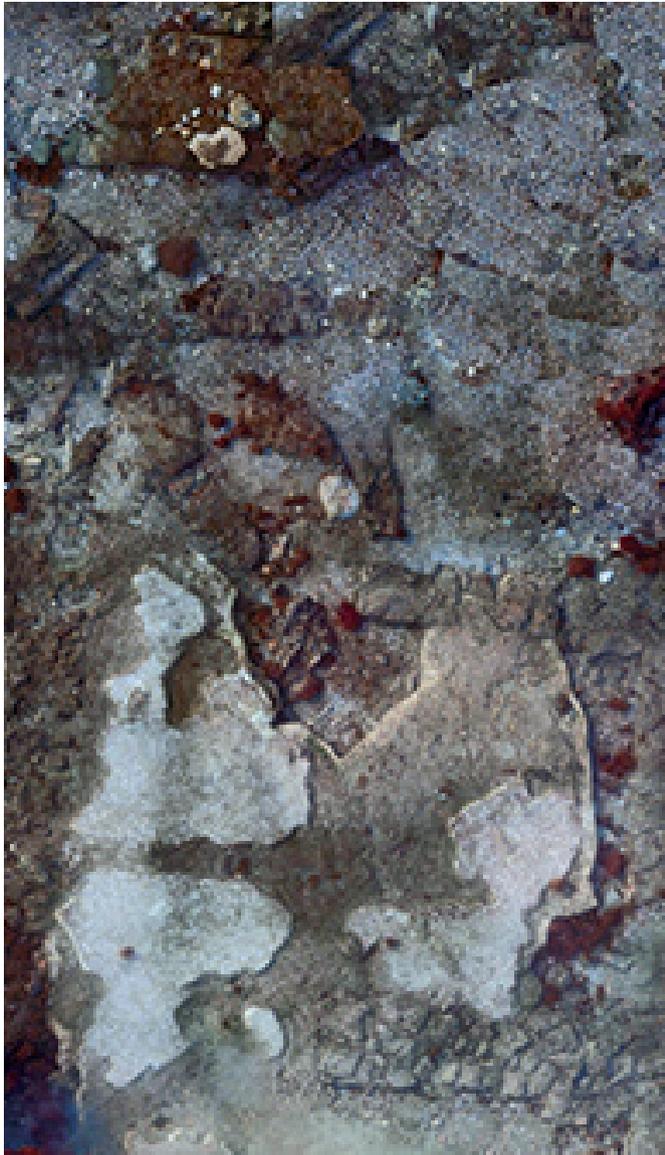
Figure 7 Photomosaic of the studied area. Photo: ISCR

In light of the situation observed, it was determined that total cleaning was needed. In 2014 cleaning of the mosaic surface was carried out using brushes and scalpels to clean the mosaic surface, followed by new placement of geotextile in order to devitalize new endoliths growth and to retard the new colonization. A photographic survey also permitted the elaboration of a photomosaic of the studied area (fig. 7).

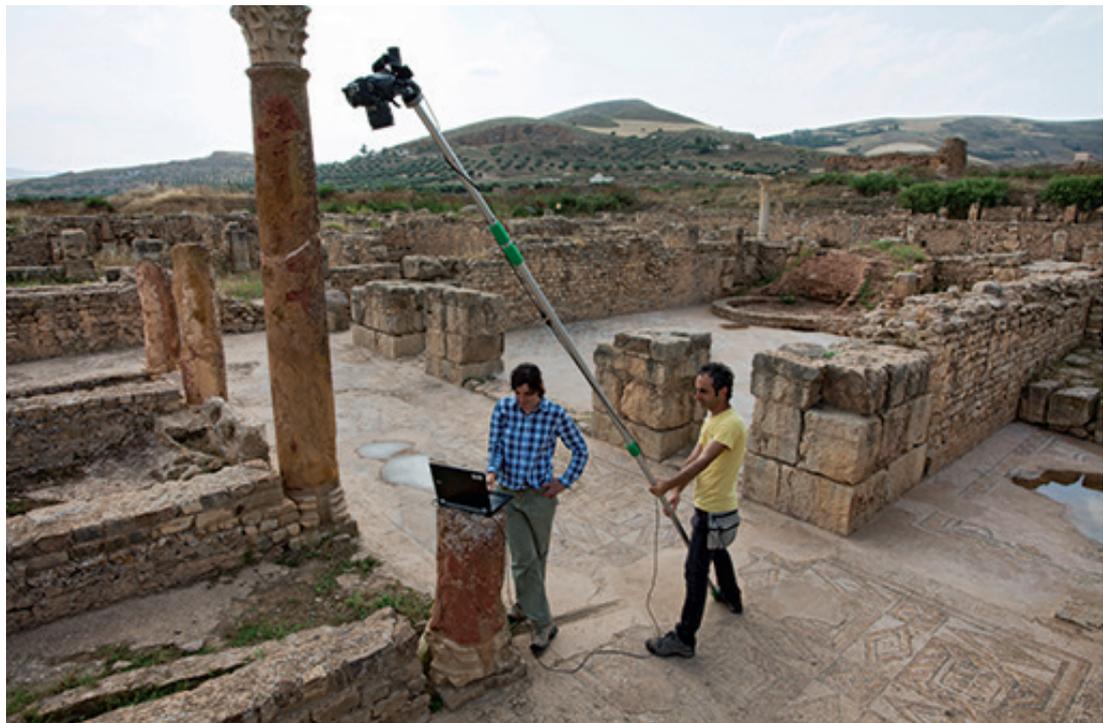
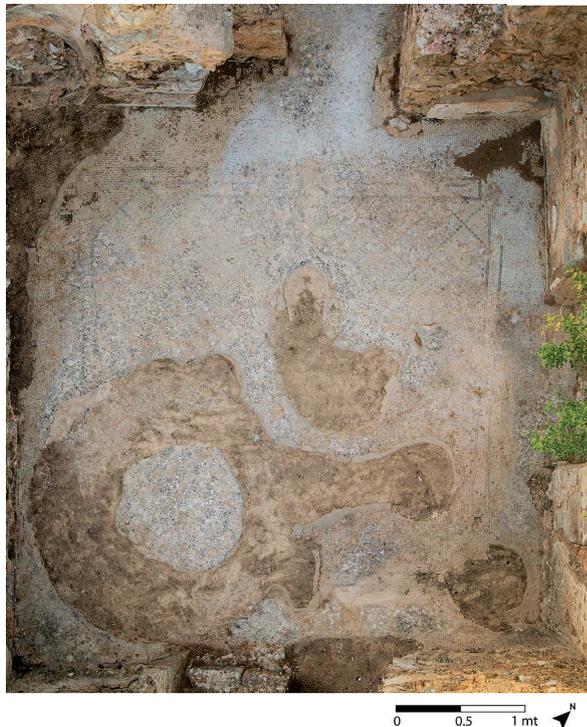
Figure 2 Survey photograph modified for use by the conservation technicians as a base photo for manual documentation

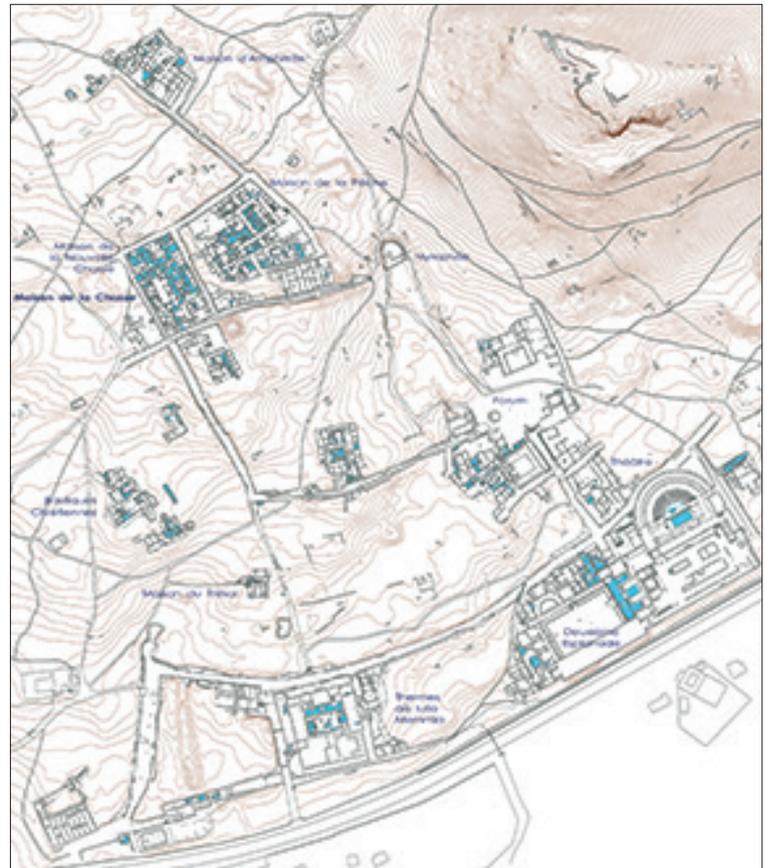
Figure 3 GIS plan of Bulla Regia showing locations of mosaics

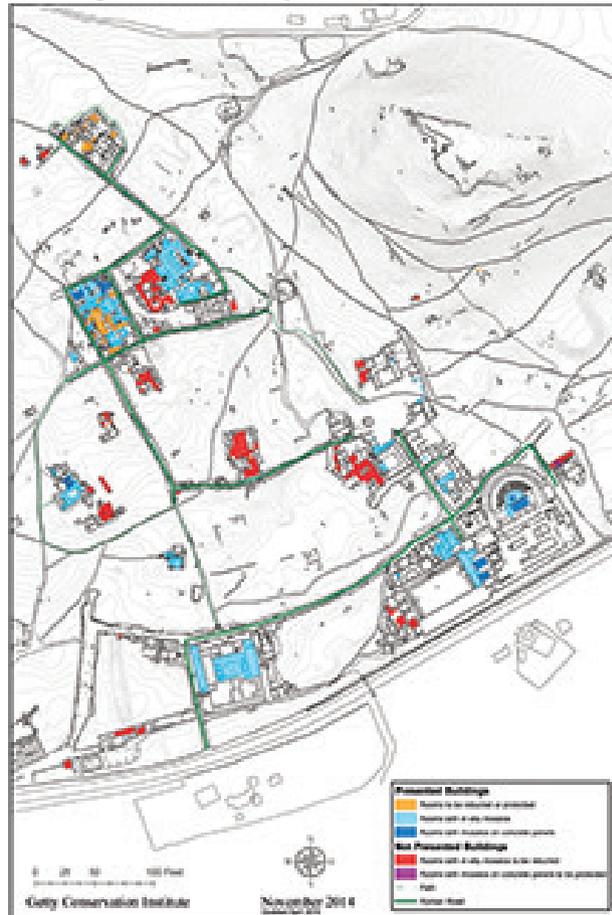
Bulla Regia Model Field Project: Proposed Presentation Plan

Figure 5 Site plan with buildings to be presented to the public

At the same time, decisions are being made about which excavated buildings on-site will be presented to the public and which ones will be preserved by reburial, based on a variety of sitewide assessment criteria, including significance, threats, and location (fig. 5). Within this presentation framework a longer-term program of interventions is being formulated, including monitoring and maintenance cycles every six months and treatment work in buildings to be reburied or presented, while continuing work on priority mosaics

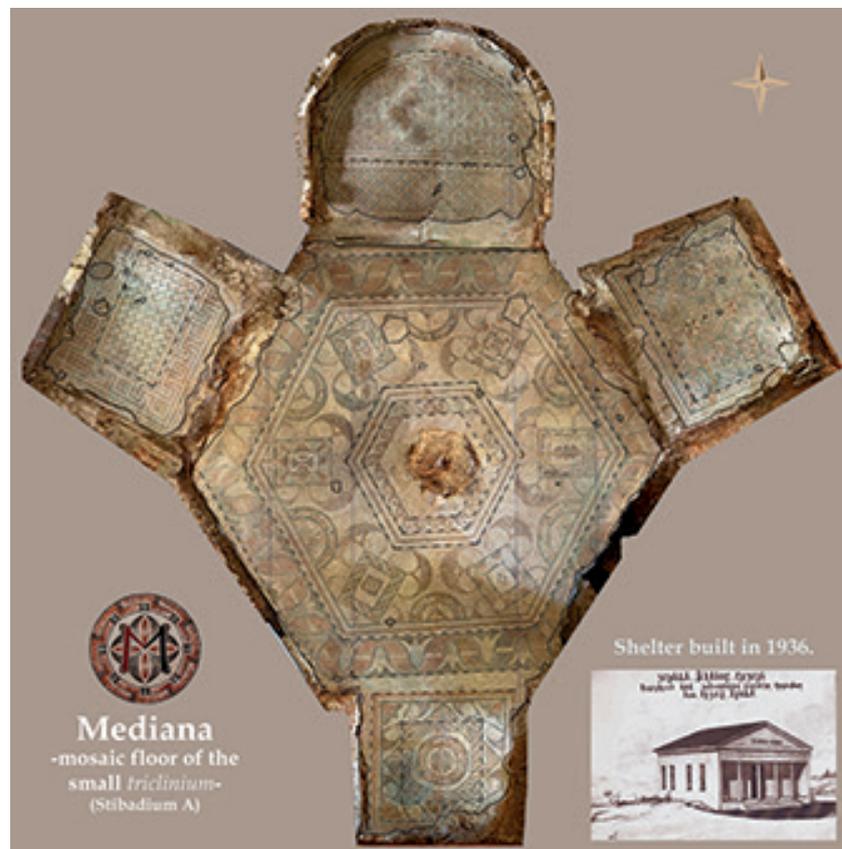
Figure 3 Photogrammetry of the mosaic from the small triclinium A and its shelter from 1936.
 Courtesy of Institute for Cultural Heritage Preservation Nis (ICHPN)

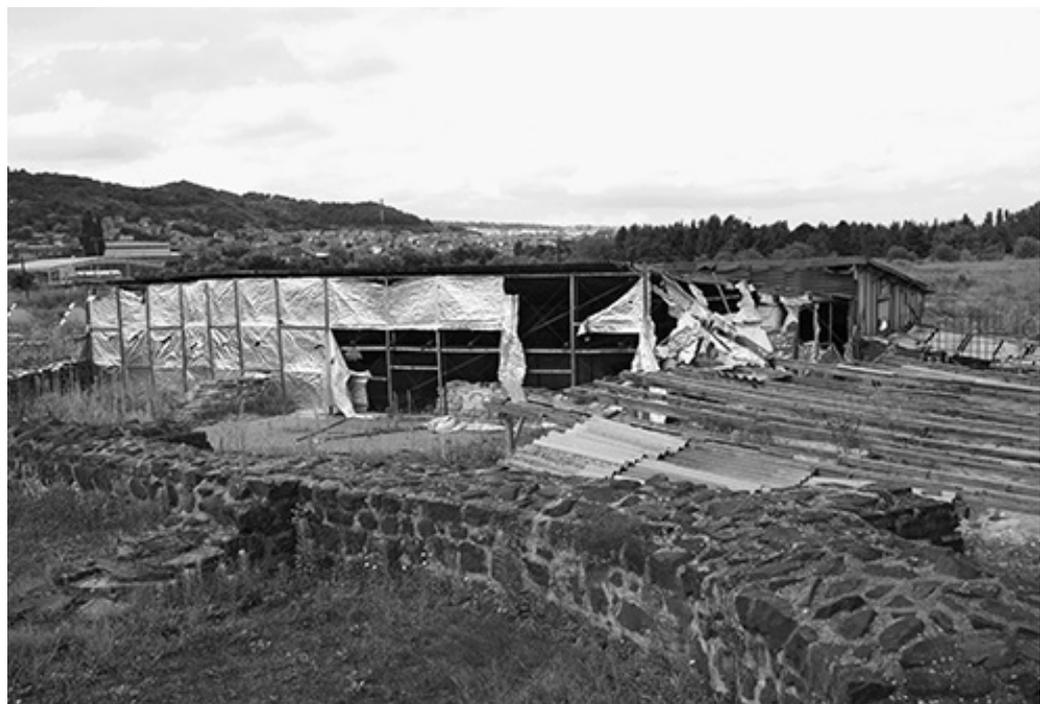
Figure 5 Short-term provisional shelter from the beginning of the twenty-first century. Photo: Zoran Radosavljević

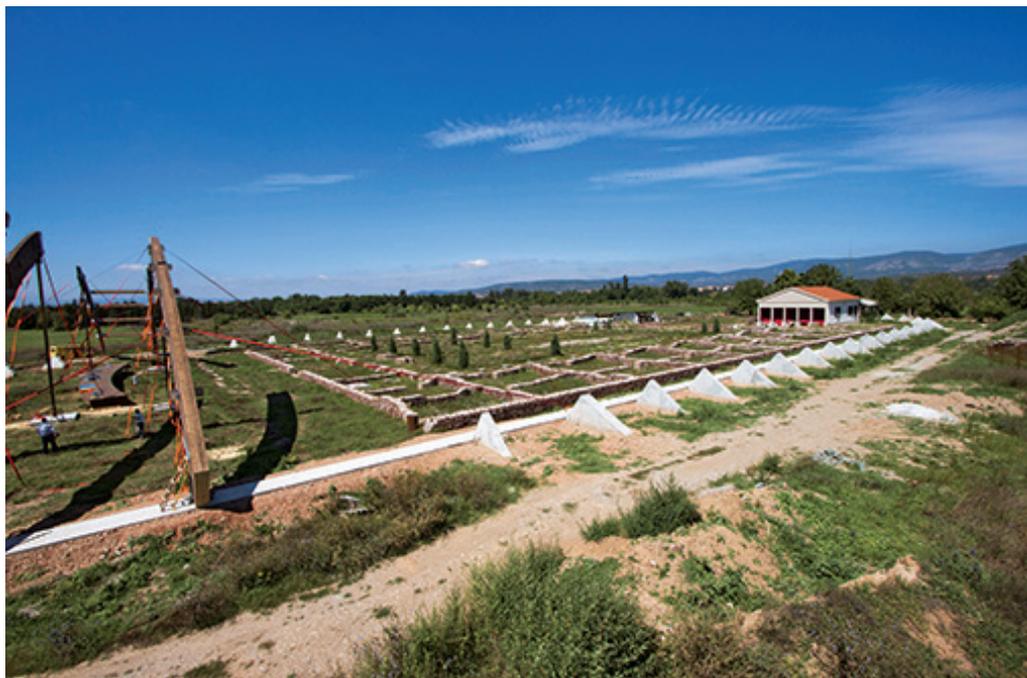
Figure 7 The assembling of the structure for the shelter. Photo: Zoran Radosavljević

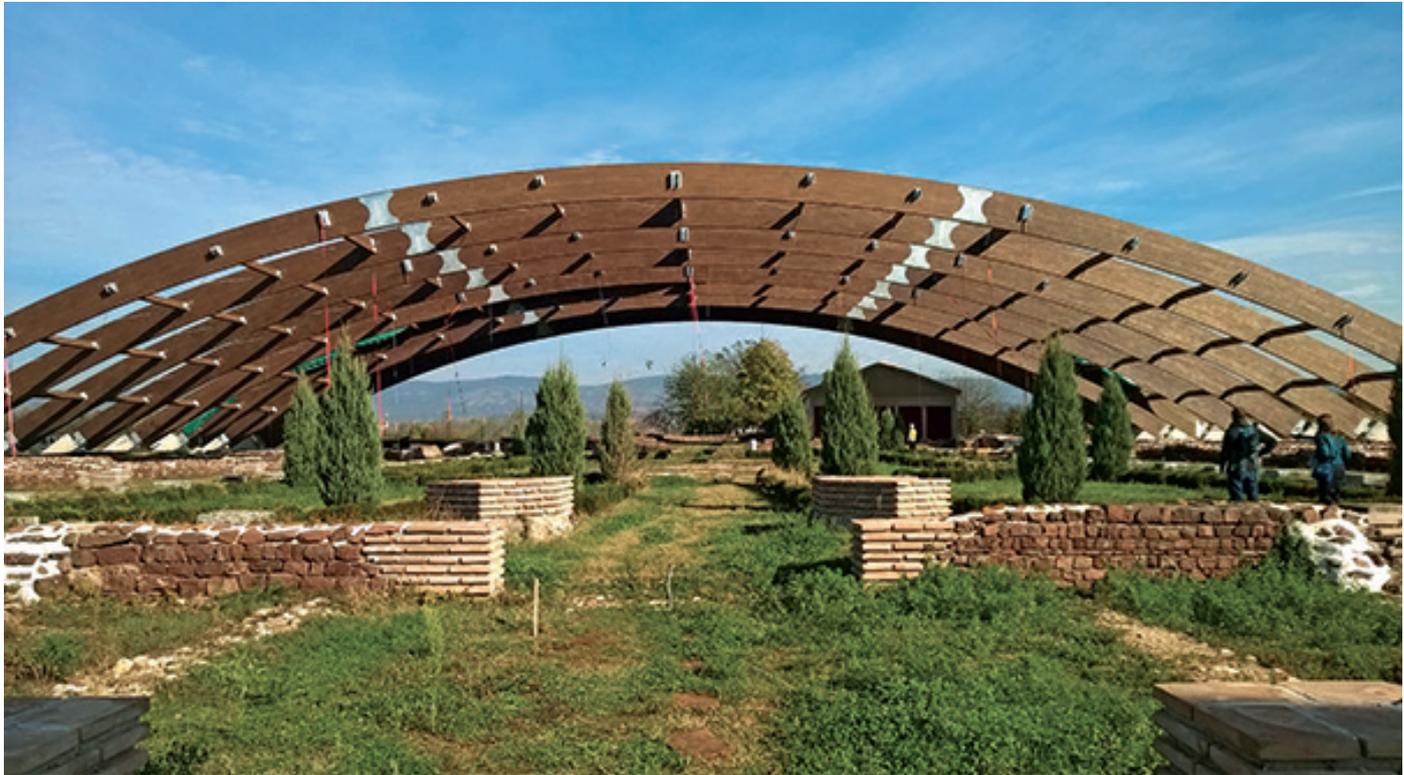
Figure 8 The shelter at the end of 2014; work in progress.

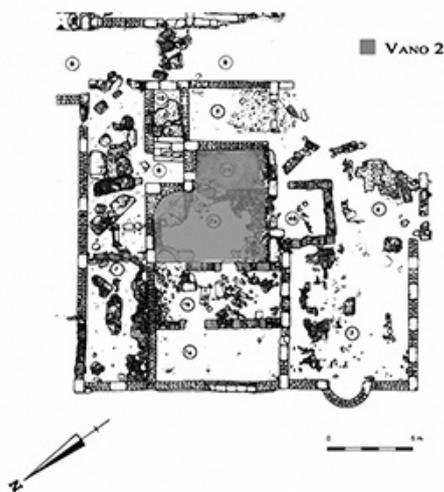
Figura 2 Planimetria della parte settentrionale della villa con il vano 2 in evidenza. Disegno: R. Accorrà, rilievi R. Accorrà, F. Satta, L. Serio, Soprintendenza per i Beni Archeologici per le province di Sassari e Nuoro

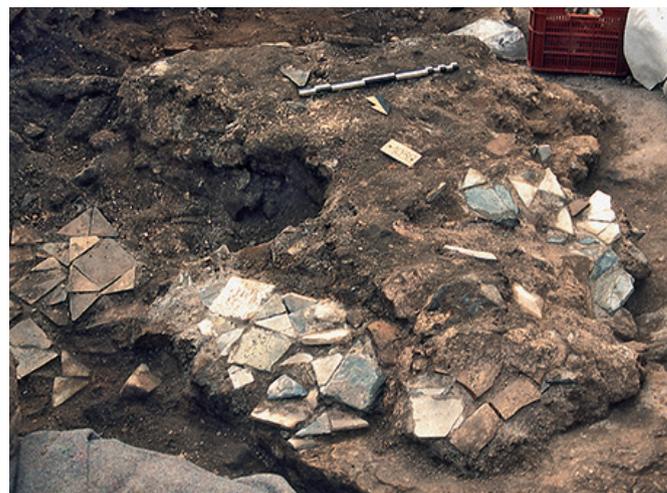
Figura 4 Veduta del crollo dell'*opus sectile* in situ. Foto: Soprintendenza per i Beni Archeologici per le province di Sassari e Nuoro

Durante il recupero del materiale lapideo di Sant'Imbenia, limitate porzioni dell'*opus sectile* sono state ritrovate ancora in connessione tra loro, in una sorta di istantanea del crollo (fig. 4). Gli elementi recuperati nella loro posizione di crollo sono stati documentati con fotografie e rilievi al momento dello scavo, fornendo la chiave di lettura dell'originaria decorazione, nella sua unità disegnativa di base ripetitiva, fondamentale per formulare un'ipotesi attendibile per la

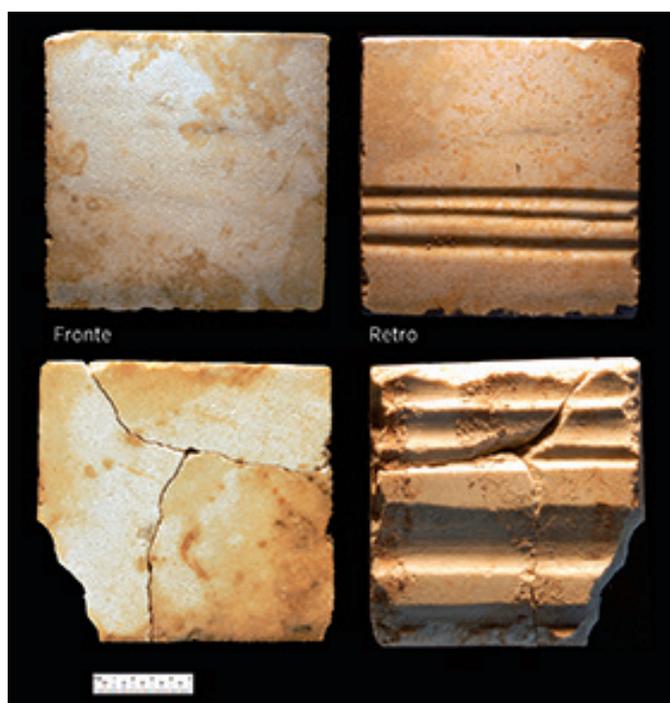
Figura 5 Lastre quadrate dell'*opus sectile* prima del montaggio, fronte e retro. Sul retro sono presenti segni di lavorazioni precedenti. Foto: CCA, Centro di Conservazione Archeologica – Roma

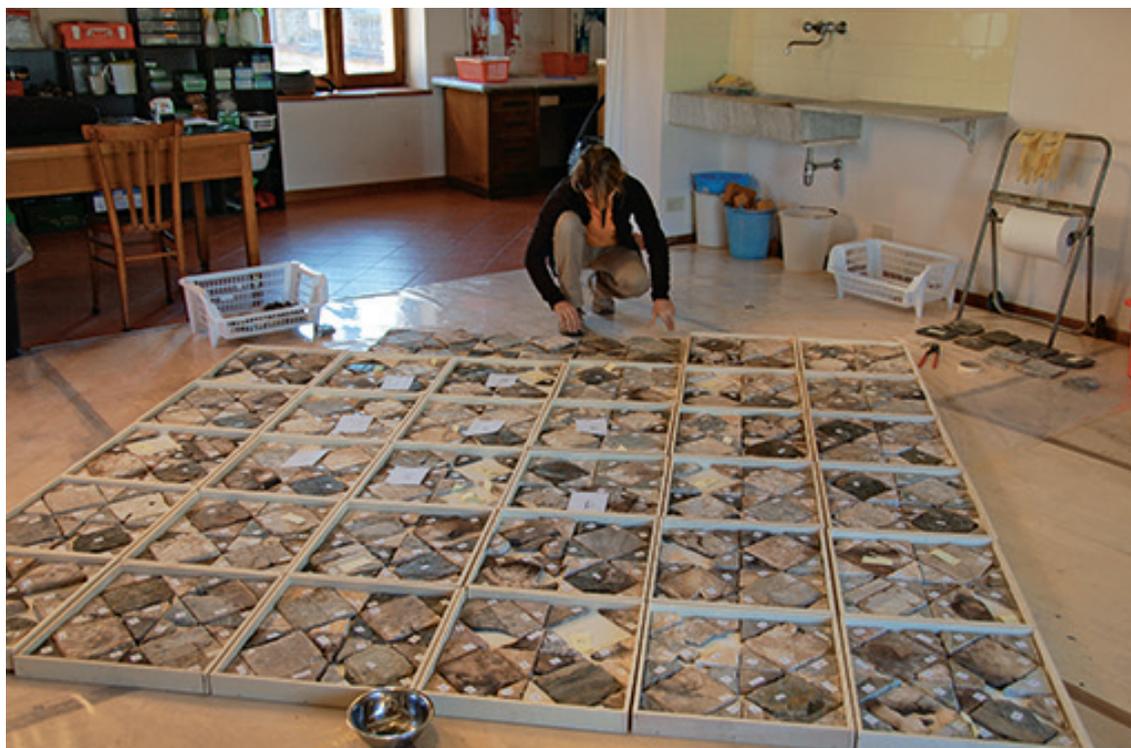
Figura 7 L'*opus sectile* durante la fase di accoppiamento delle lastre dentro le casseforme. Foto: CCA, Centro di Conservazione Archeologica — Roma

Sono state utilizzate due miscele: la prima, con granulometria fine, è stata applicata allo scopo di sigillare gli spazi di connessione tra una lastra e l'altra; la seconda, con un impasto più resistente, a granulometria maggiore, destinato ad accogliere il supporto finale. La malta è stata livellata creando

un sottolivello di 5 millimetri rispetto alla cornice perimetrale e lungamente lavorata per renderla perfettamente aderente agli elementi lapidei sottostanti. Su questo strato, trascorso il tempo dell'asciugatura e della presa, sono stati incollati, con resina epossidica, i corrispettivi pannelli di Aerolam, tagliati a misura, incastrandoli all'interno della cornice della cassaforma.

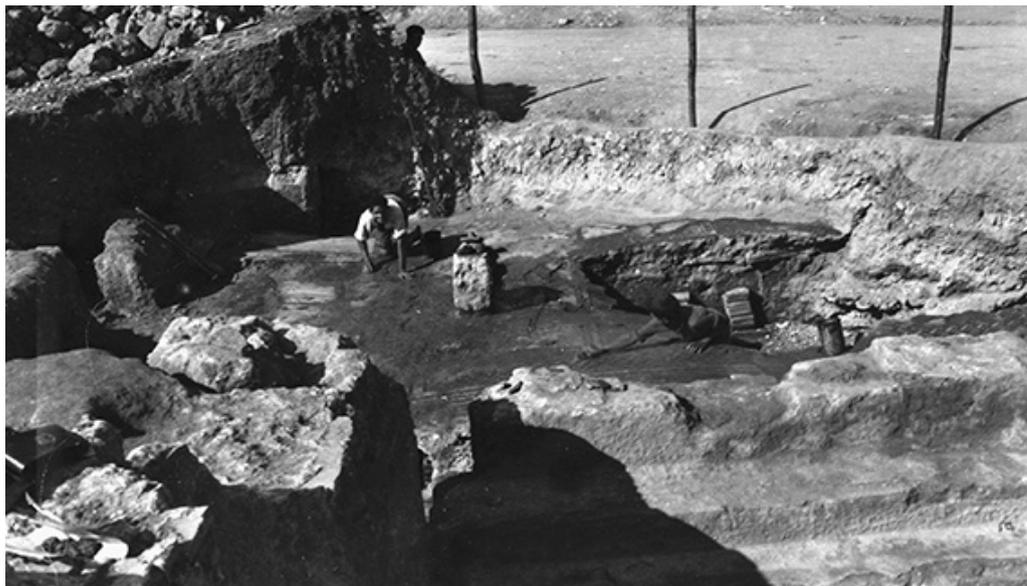
Figura 1 L'ambiente con pavimento a mosaico, oggi perduto: "Il pavimento della grande sala a *suspensurae*, distrutto nel centro e sull'intero lato occidentale, consisteva in un grandioso mosaico policromo, verosimilmente quadrato, misurante più di cinque metri su ciascun lato. Il bordo è formato da una fascia continua con motivi di quadrati inseriti in svastiche. Nel centro, sopra un fondo a treccia, si aprono emblemata quadrati regolarmente disposti . . . soltanto di uno di essi è riconoscibile con evidenza il soggetto (un delfino)" (Pallottino 1947: 232).

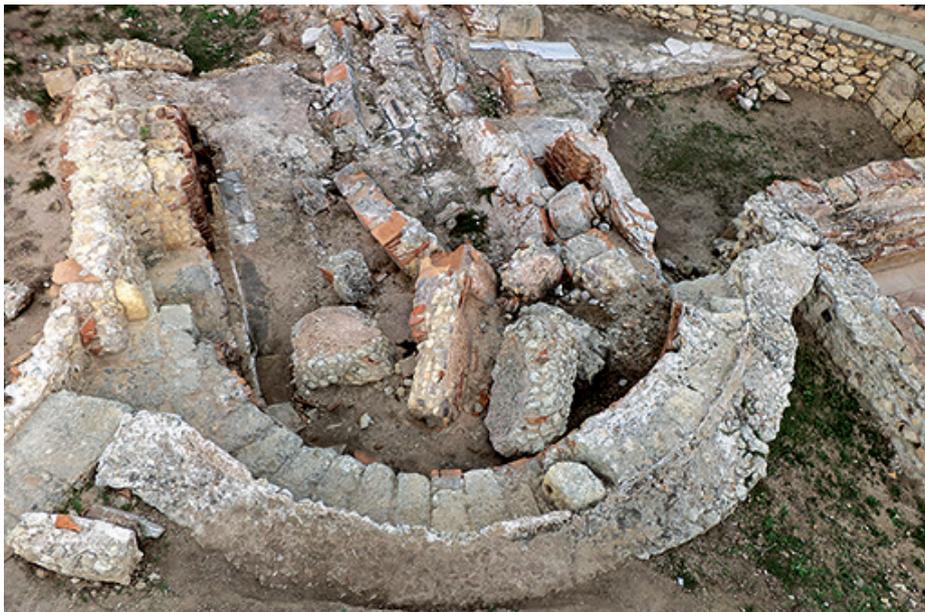
Figura 2 Il *tepidarium* prima degli interventi di restauro; è visibile lo stato di deformazione del solaio e del pavimento musivo che ha portato, assieme ai crolli e all'effetto degli agenti meteorici, alla perdita di parte del rivestimento.

Nel *tepidarium* il pavimento era in più punti sfondato dai crolli, con deformazione del rivestimento musivo e ampie zone di distacco, aggravate dalla vegetazione (figg. 2, 6). Per poter restaurare e mettere in sicurezza il rivestimento musivo era necessario rimuovere parte del crollo, soprattutto nella porzione nord dell'ambiente, conservando comunque le porzioni di maggiori dimensioni, testimonianza del collasso della struttura.

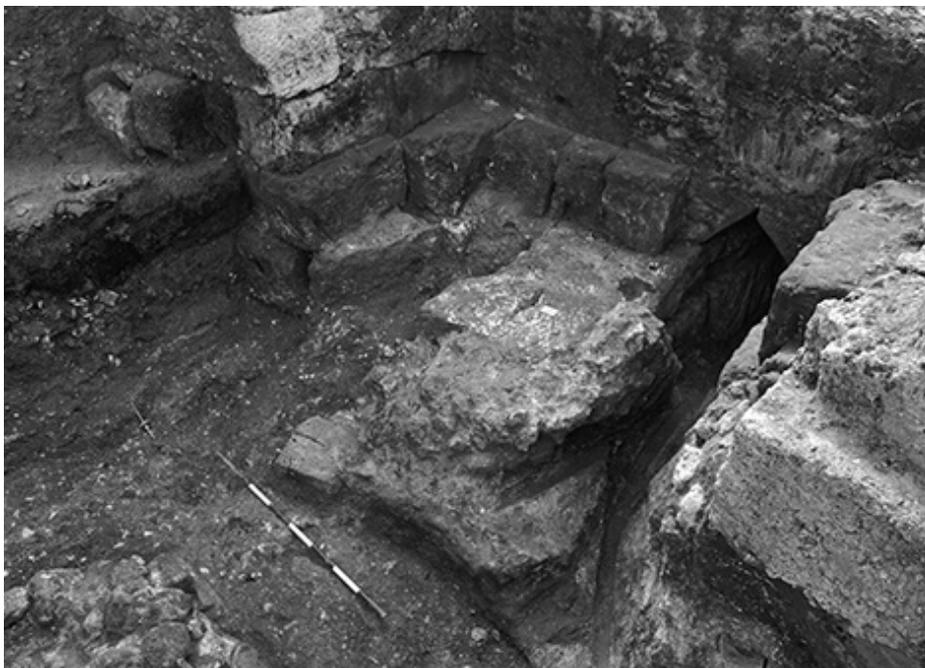
Figura 3 Il saggio di scavo alle spalle delle Terme. È visibile il condotto coperto, che si lega a destra all'abside del grande ambiente in laterizio e si appoggia a sinistra al corpo di fabbrica in opera quadrata. Sul fondo l'impronta delle *fistulae*.

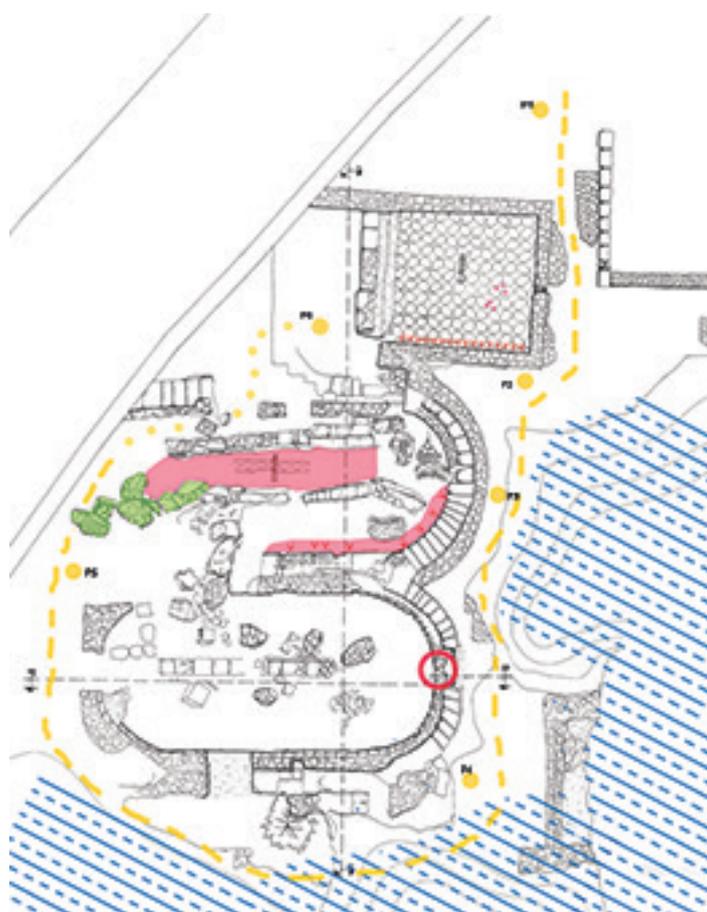
Figura 4 Planimetria orientata a est, su rilievo della Soprintendenza n. 519 del 1981, con l'indicazione dei fenomeni di degrado e degli interventi previsti. Le fasce blu individuano le aree di terreno instabile e accidentato per l'accumulo di terreno di riporto e per la presenza di saggi scoperti; le aree evidenziate in rosa individuano mosaici e rivestimenti in lastre marmoree bisognosi di consolidamento. Il cerchio rosso indica il lacerto murario da consolidare. I percorsi tratteggiati in giallo sono stati modificati in corso d'opera per evitare il passaggio all'interno degli ambienti.

Nel marzo 2012 la situazione era compromessa sia per lo stato delle strutture, sia per la sicurezza e comprensibilità per il pubblico. Nel novembre 2012 si sono avviati i lavori di restauro e sistemazione dei percorsi (fig. 4). Gli ambienti presentavano un diffuso degrado delle murature, causato dalle infiltrazioni di acqua meteorica alla sommità dei muri, per ristagno alla base e a causa dell'aggressione di agenti chimici e biologici.

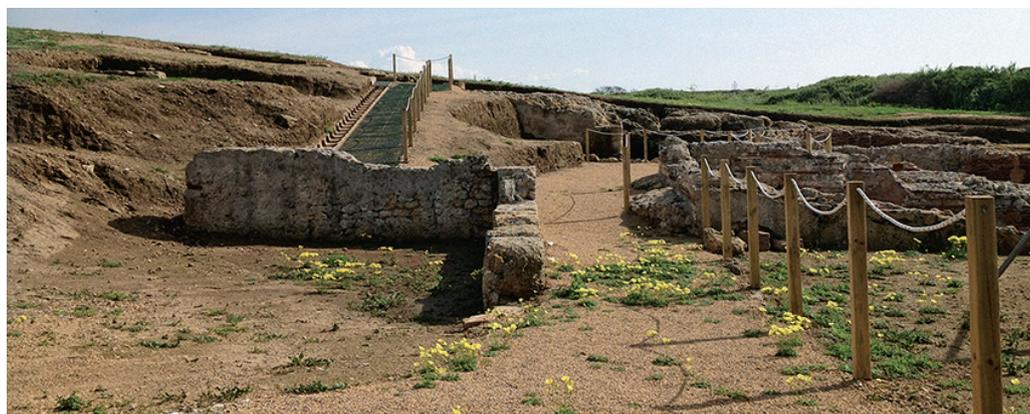
Figura 5 L'aspetto dell'area dopo gli interventi. Si è scelto di utilizzare materiali a basso impatto visuale (paletti di legno, corda, grigliati permeabili per le rampe) che non distolgono l'attenzione del visitatore dal monumento e che è possibile con facilità rimuovere o spostare secondo le esigenze dello scavo, nell'ottica di un futuro approfondimento delle ricerche nelle parti ancora non scavate.

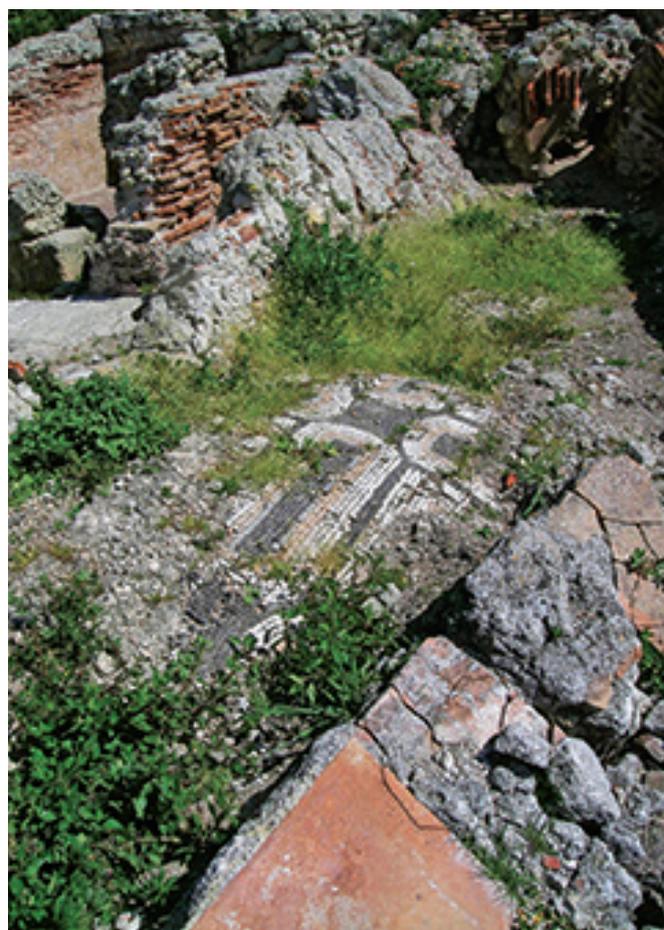
Figura 6 Particolare del mosaico del *tepidarium* prima dell'intervento.

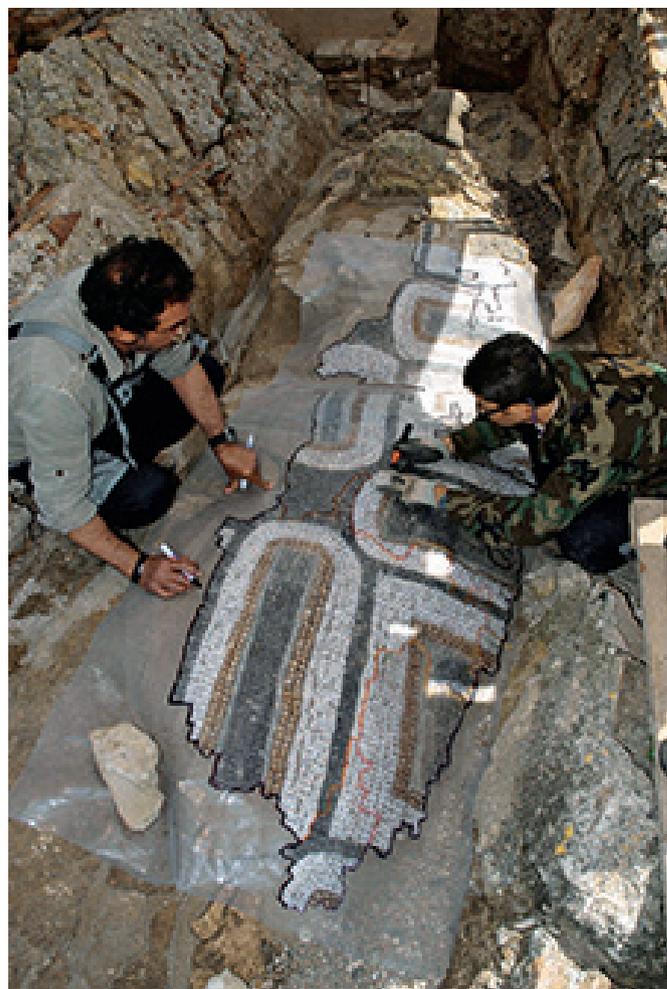
Figura 7 Il mosaico del *tepidarium* durante il restauro.

Pertanto alcune zone di estensione limitata, in cui il mosaico appariva particolarmente sconnesso e dove era difficile individuare la posizione originaria di ogni tessera, sono state perimetrare con una piattina sottile di piombo, limitando i risarcimenti alla necessità di garantire la coesione delle tessere (fig. 7).

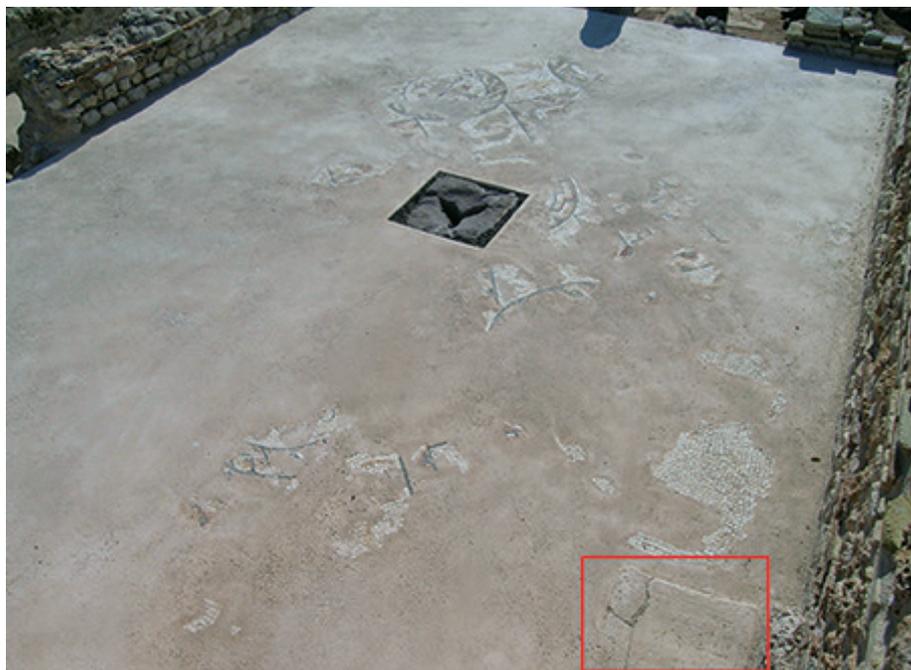
Figura 3 Piccole Terme: Mosaico del *frigidarium* (I fase), restaurato e posto in quota con il tardo pavimento in sesquipedali (indicato in rosso).

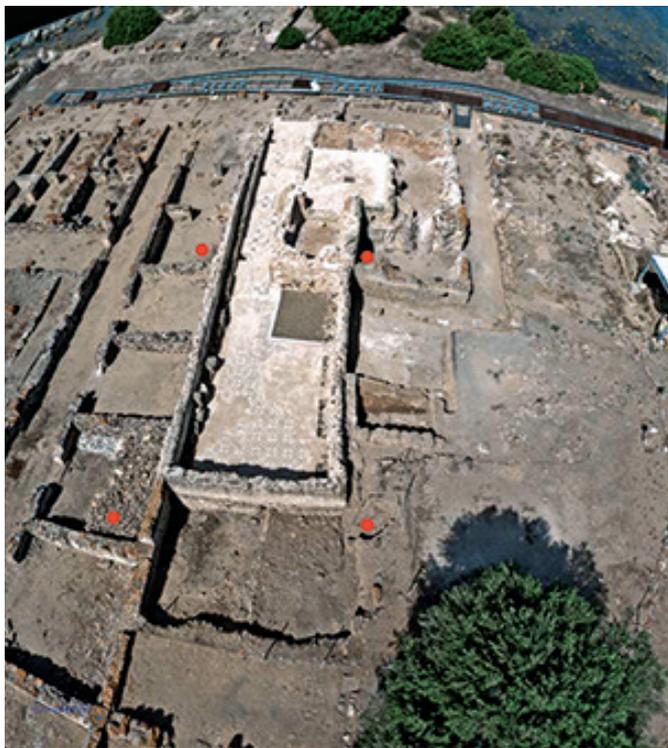
Figura 4 Piccole Terme: Mosaici del corridoio e dell'*apodyterium*; indicati in rosso i saggi per la posa dei piloni di copertura. Copyright e rielaborazione di B. M. Giannattasio
