Proceedings of the 12th Conference of the
International Committee for the Conservation
of Mosaics, Sardinia, October 27–31, 2014

The Conservation and Presentation of Mosaics: At What Cost?

*Proceedings of the 12th ICCM Conference
Sardinia, October 27-31, 2014*

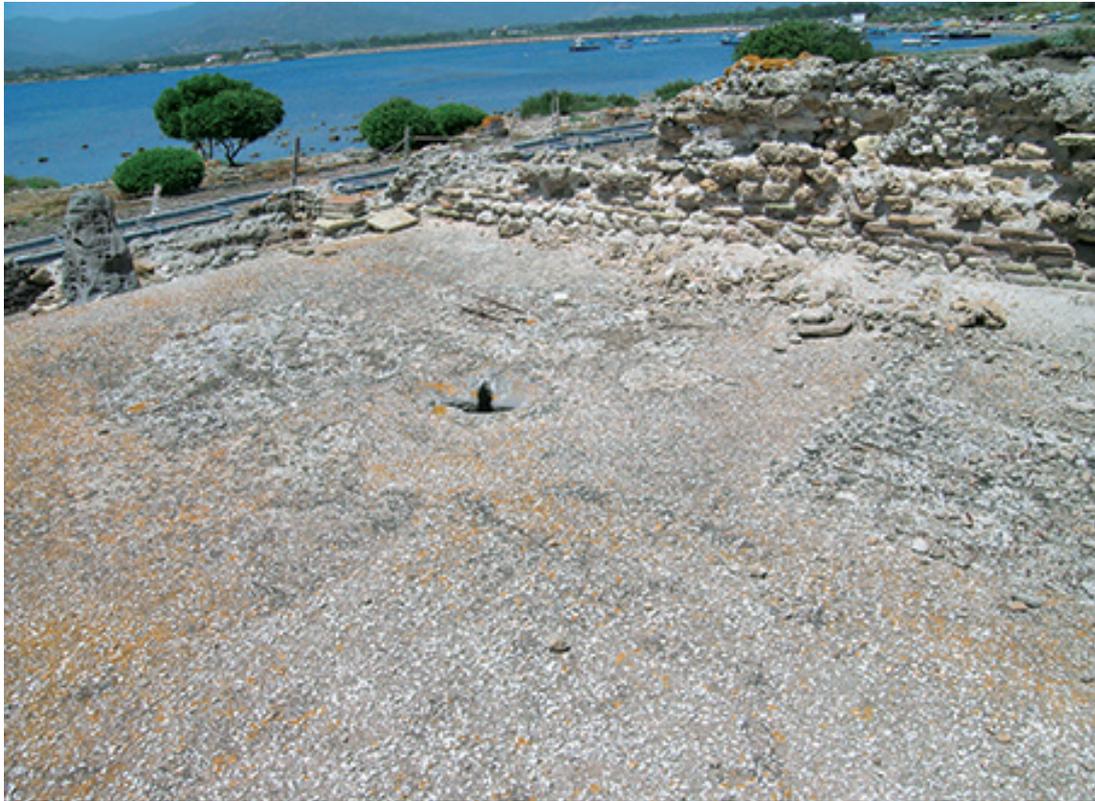
Figura 5 Piccole Terme:
Stato di degrado del
mosaico del *frigidarium*
ante restauro 2011. Foto:
E. Romoli

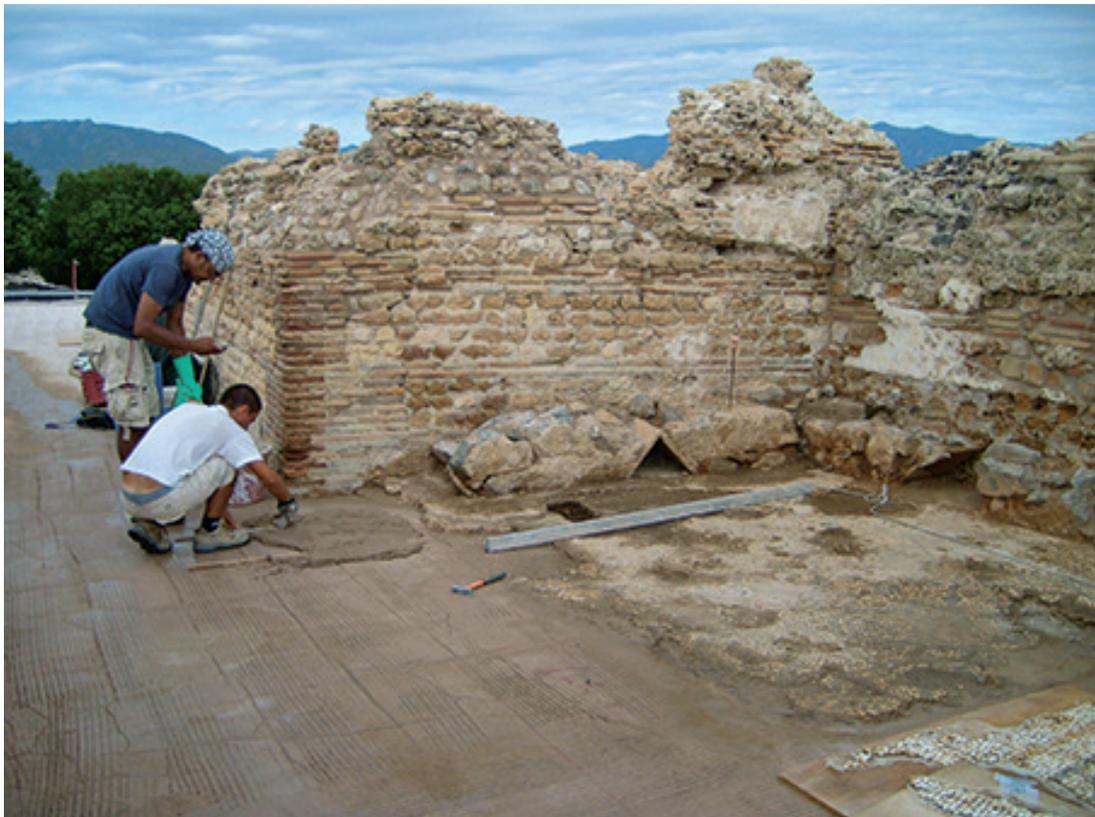
Figura 6 Piccole Terme:
Nuova soletta di malta
in calce idraulica e
frammento di mosaico ori-
ginario (testimone Pesce)
dell'*apodyterium*. Foto: E.
Romoli

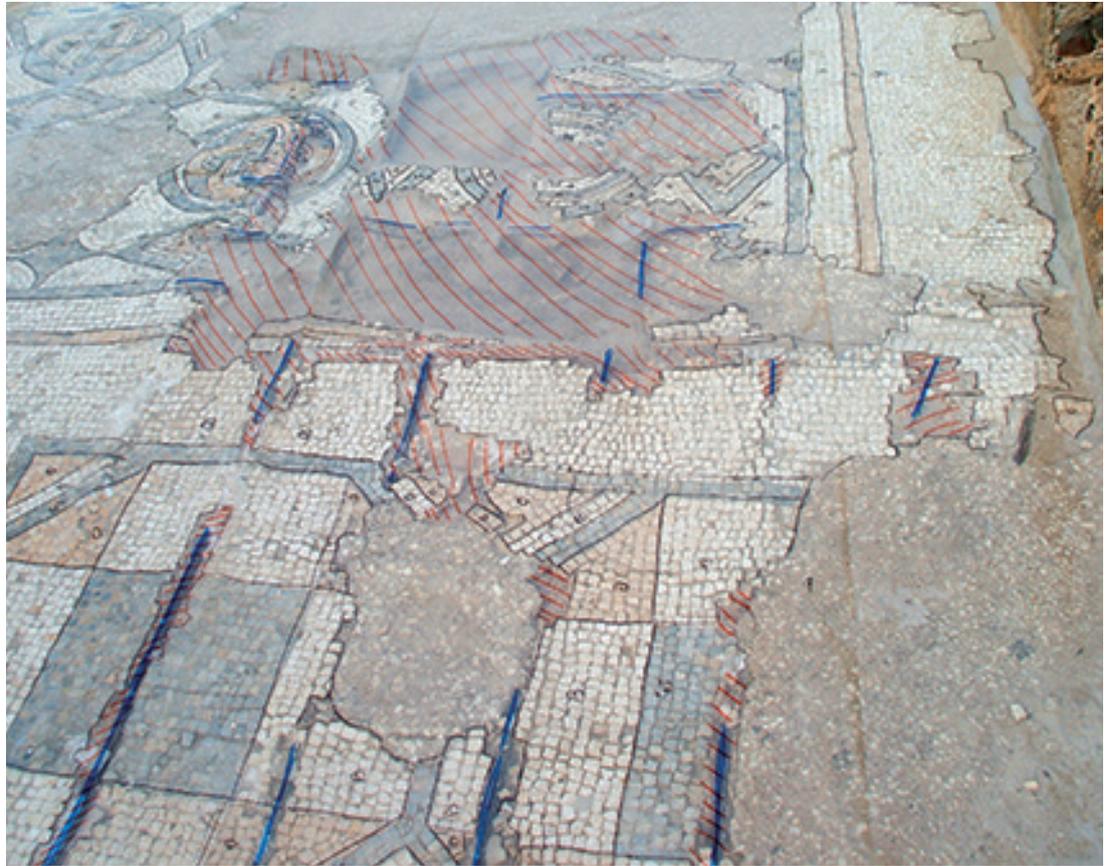
Figura 8 Piccole Terme:
Velatura del mosaico del
frigidarium per la rimo-
zione. Foto: E. Romoli

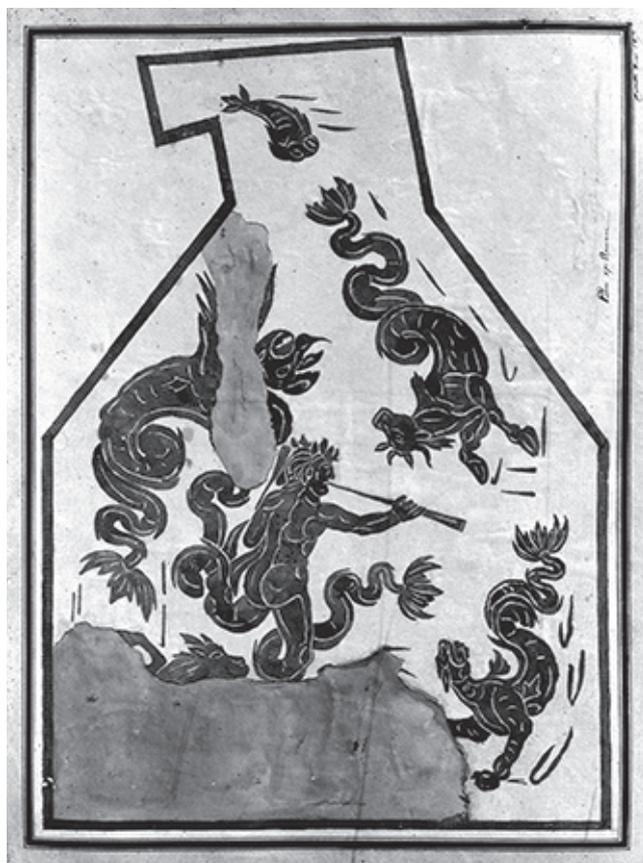
Figura 2 Disegno del mosaico prima del distacco. Copyright © Musei Vaticani.
Tutti i diritti riservati

Sulla base del disegno realizzato dal Camilli prima del distacco nel 1817, in cui si vede il mosaico allo stato del ritrovamento (fig. 2), è ipotizzabile che l'area presa in esame come esempio sia stata suddivisa in piccole porzioni, intorno alle quali venivano rimosse alcune file di tessere (fig. 3) allo scopo di creare delle aperture fin sotto il massetto, necessarie per inserire gli attrezzi occorrenti al loro sollevamento. Prima di effettuare il distacco, la superficie del mosaico veniva ricoperta da uno spesso strato di gesso che lo racchiudeva insieme al massetto in una specie di sandwich (fig. 4).

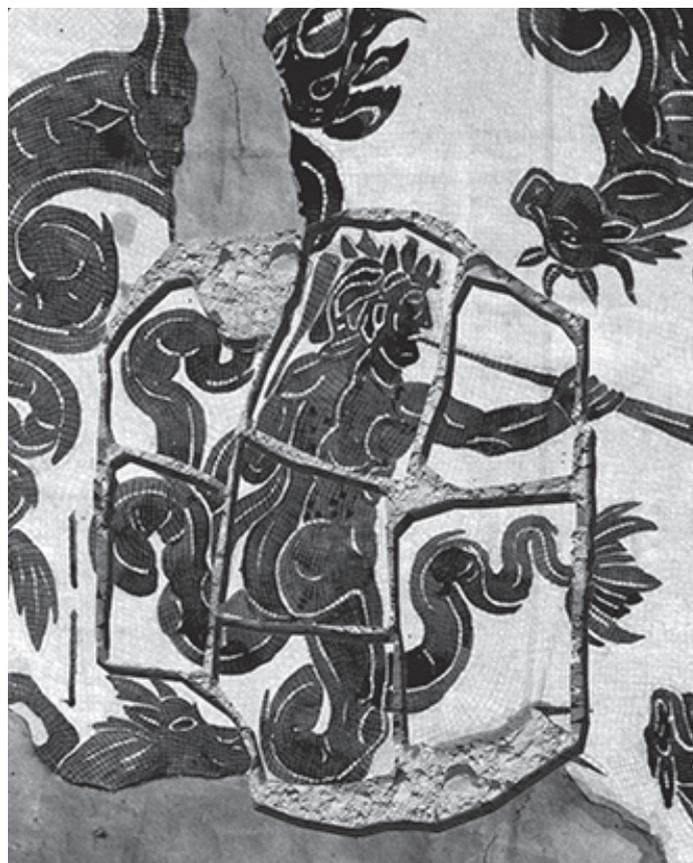
Figura 3 Ipotesi di distacco a blocchi. Credit: Roberto Cassio

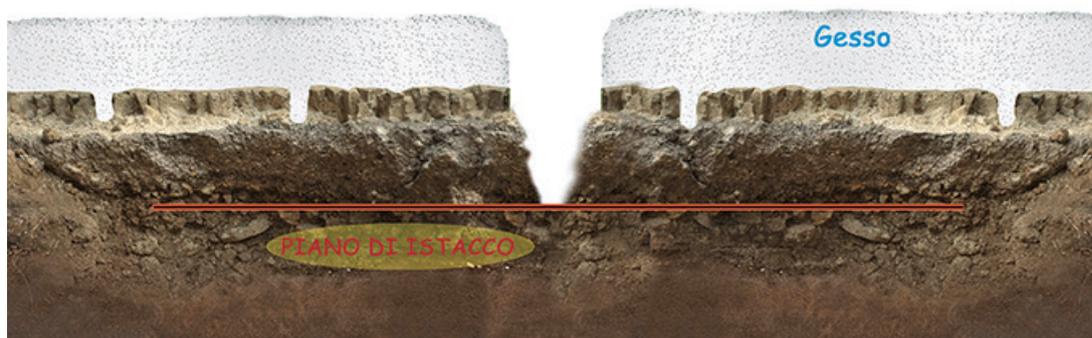
Figura 4 Vista in sezione del distacco a blocchi.
Credit: Roberto Cassio

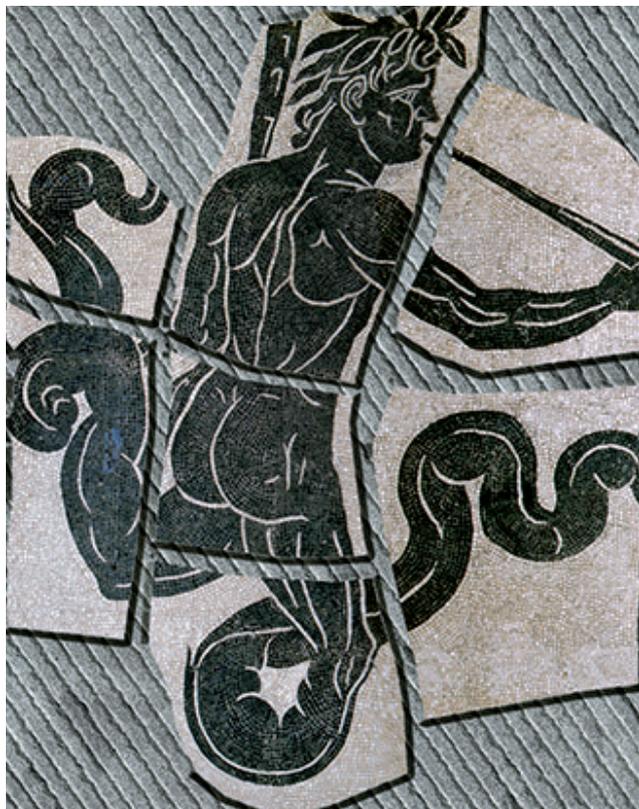
Figura 5 Montaggio su pannelli in pietra peperino dei blocchi distaccati.
Credit: Roberto Cassio

Dopo il trasferimento al Museo, i blocchi distaccati venivano ripuliti dagli strati di malta originaria e preparati per la riapplicazione nella nuova sede. Le sezioni di mosaico erano quindi applicate su un nuovo supporto in lastre di peperino spesse circa 8–9 cm, di forma regolare e con dimensioni adatte

a contenere anche più sezioni (fig. 5). A conclusione della riapplicazione si integravano le zone mancanti di tessere sia per ricucire tra di loro le sezioni di mosaico sia per realizzare nuove campiture.

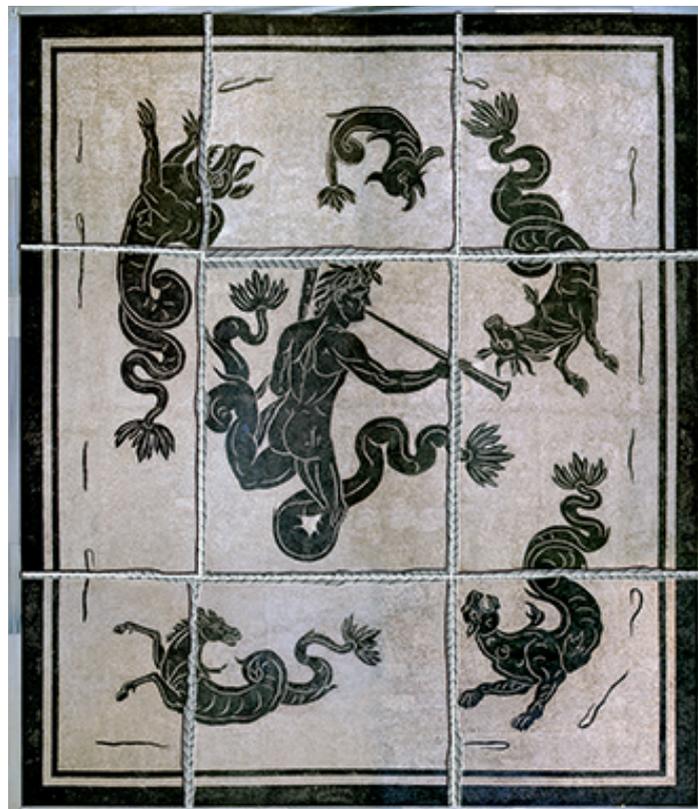
Figura 6 Composizione dei pannelli per il mosaico attualmente esposto presso la galleria del Braccio NUOVO. Credit: Roberto Cassio

Ogni nuovo pannello veniva così inserito nella zona di pertinenza per la composizione del nuovo pavimento (fig. 6), a cui seguiva l'integrazione sul posto delle cuciture fra i singoli pannelli, integrazioni che tendevano ad essere di tipo

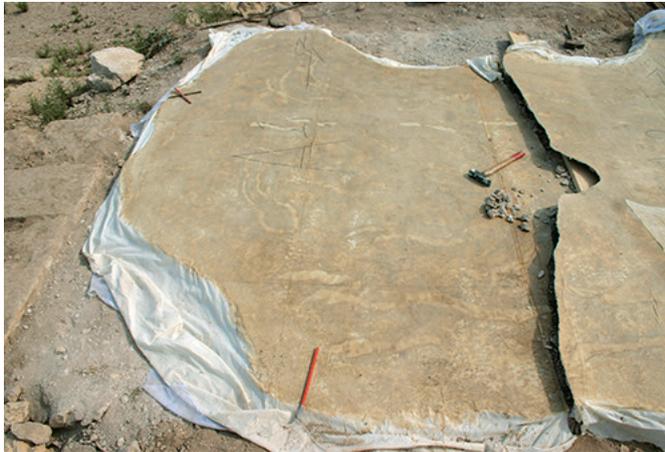
Figure 4 Mosaic of Ain El-Helwe being lifted from the site. Photo: Maher Jbaee, by permission of DGAM in Syria, 2008

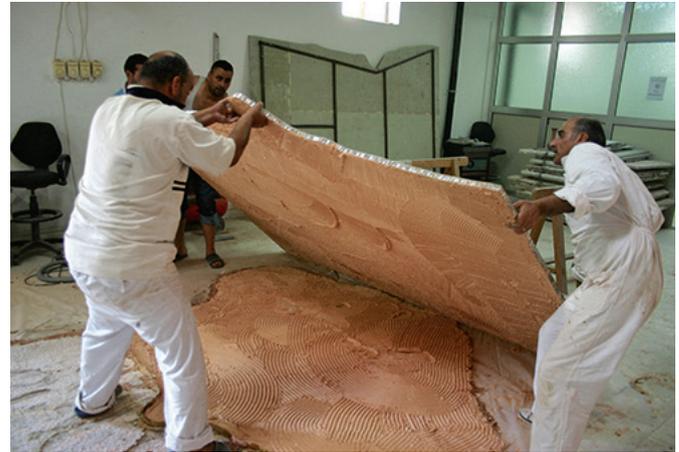
Figure 5 The mosaic on the new support. Photo: Ousama Nofal, by permission of DGAM in Syria, 2012

After fixing the mosaic to the new support we were able to determine its condition, as follows:

- Lacunae in places where the artist used glass tesserae, especially in the shaded areas of the marine animals;
- Detachment of some tesserae previous to and during the process of removing the mosaic;
- Deterioration and erosion of some glass tesserae;
- Depressions in some places;
- Salt encrustation on the surface of the mosaic.

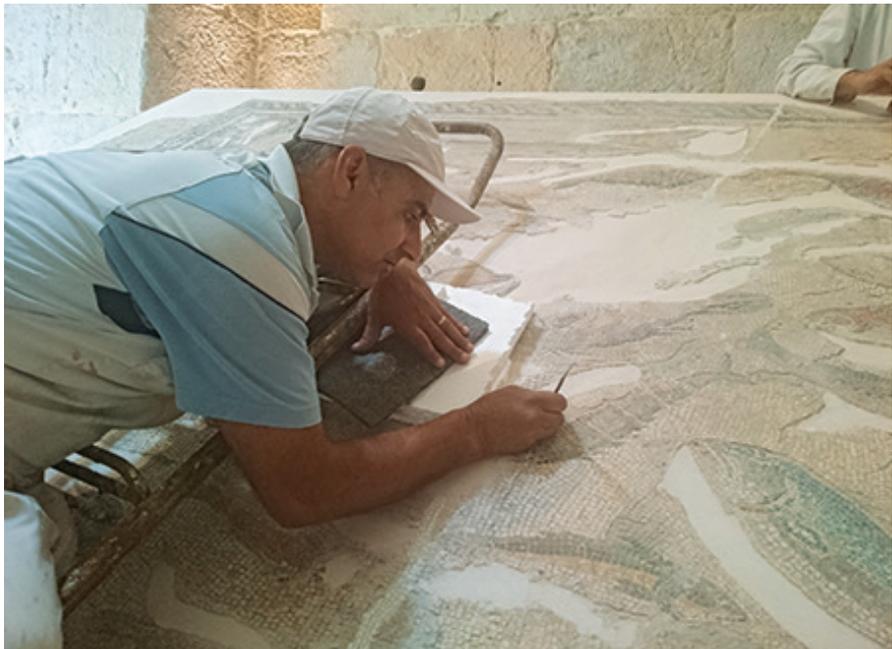
Figure 7 Final restoration work. Photo: Eman Bouaini, by permission of DGAM in Syria, 2013

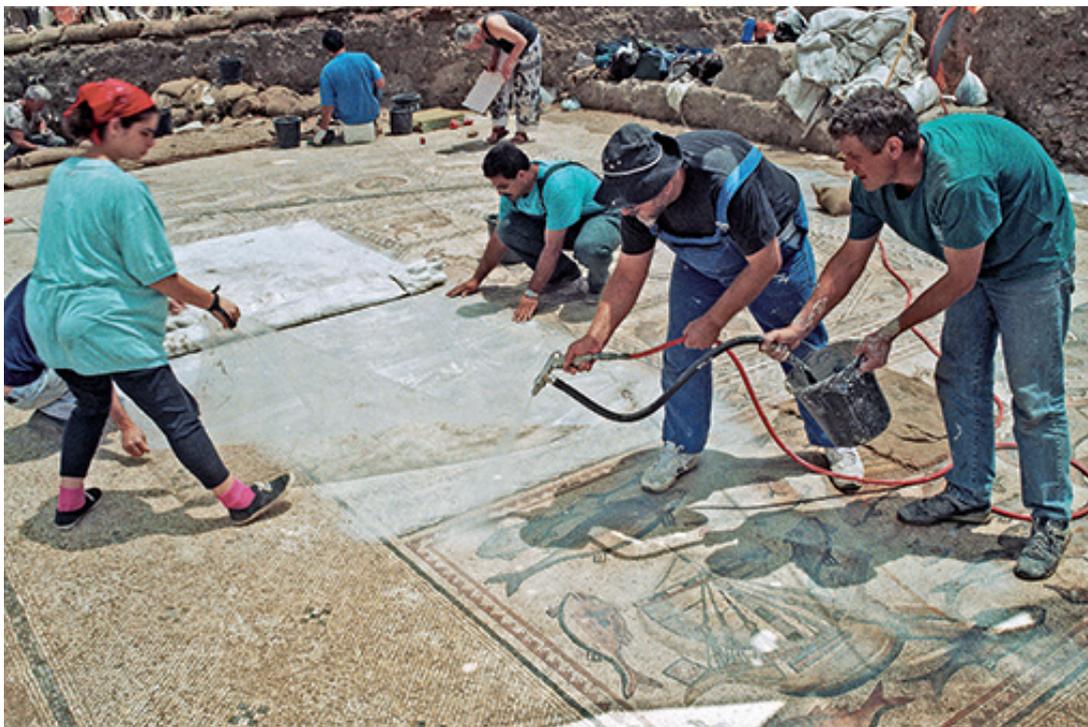
Figure 4 Cleaning of the mosaic, 1996. Photo: Nicky Davidov, IAA

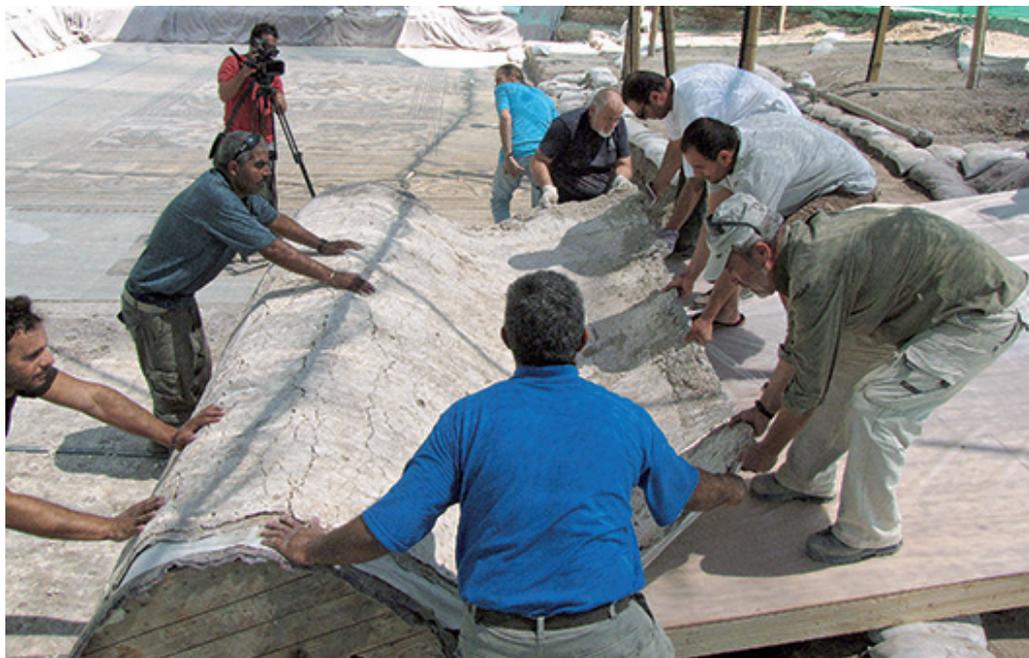
Figure 5 Lifting of the mosaic.

damage exists and should be taken seriously into consideration. The risk increases enormously in the case of a unique, 150-square-meter mosaic. A roller was used for the detachment and immediate transfer to wooden platforms (fig.5). Only in one case (the long panel with vine leaves) was the “sandwich” method used to flip the panel. Wooden planks were inserted under the mosaic, connected with clamps to a wooden support lying on the mosaic surface. The mosaic was turned by a team of twelve persons. The operation was extremely difficult to accomplish because of the quality of the Roman mortar, which was hard to cut through, and the dimensions and weight of the sections (maximum surface 16 square meters; weight approximately 1,000 kg). The tesserae that became detached during the lifting (a very limited number) were glued back in their original places with PVA glue on the canvas before the end of each day’s work. The panels were transported to the IAA laboratory and given new supports based on Aerolam (honeycomb aluminum) panels and aluminum bars for reinforcement. The central part of the mosaic, about 35 square meters was prepared in the laboratories for traveling abroad. Up to the present, it has been exhibited with great success at the Metropolitan Museum, New York; the Legion of Honor Museum, San Francisco; the Field Museum, Chicago; the Museum of Art, Columbus, Ohio; the Penn Archaeological Museum, Philadelphia; the Louvre Museum, Paris; the Altes Museum, Berlin; Waddesdon Manor, United Kingdom; and the Hermitage Museum, St. Petersburg, Russia. The mosaic has been seen by more than a million visitors and

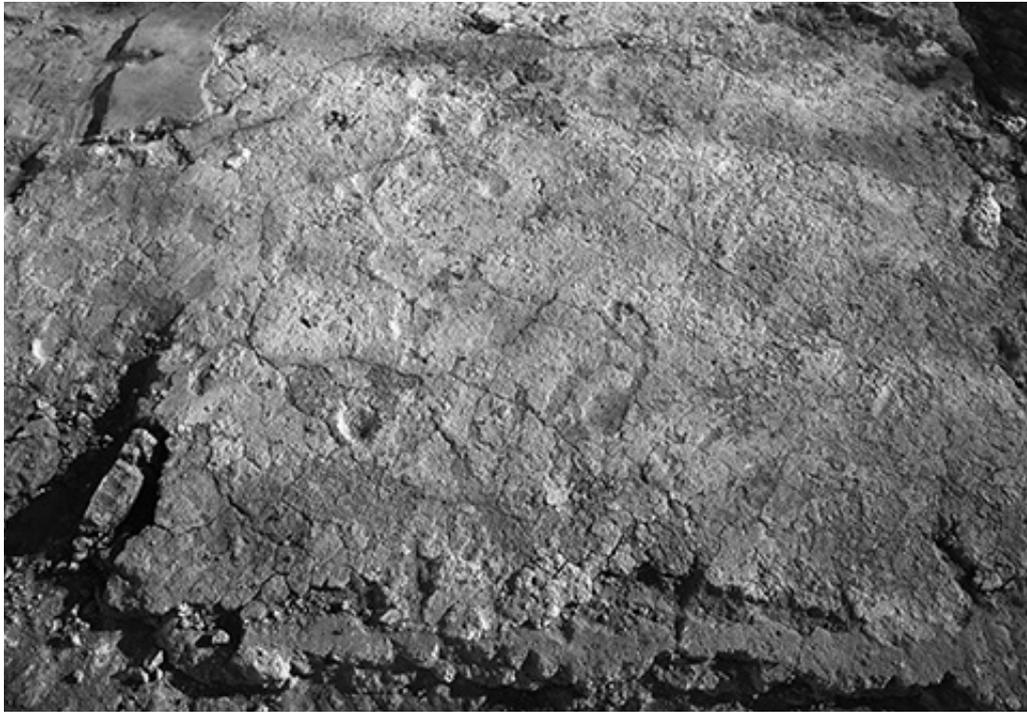
Figure 6 Footprints on the rudus layer. Photo: Nicky Davidov, IAA

layout of the mosaic, provided us with important information about the working methods of the ancient craftsmen. The foundation of the mosaic was laid on a well-leveled platform composed of two layers of stones (round riverbed stones and cut limestone) covered with a strong and high-quality lime mortar, forming in this way the classical *statumen* and *rudus* layers. The joints between the mortar surface of the *rudus* laid down each day were very carefully worked (irregular edge with an angle of 45 degrees) in order to provide the best possible adhesion of the mortars applied the following day. The outlines of the mosaic composition were marked on the *rudus* using a sharp tool or string with red pigment.

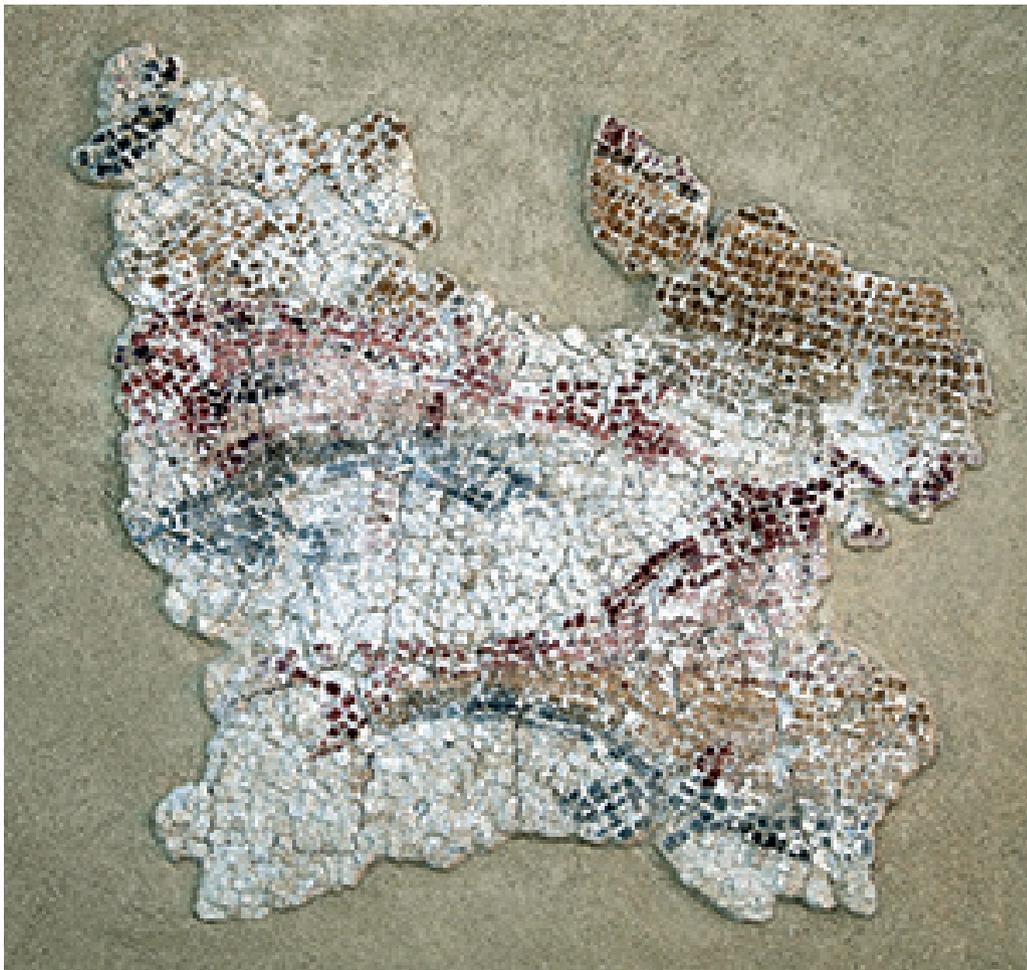
Figure 7 The sinopia under the “marine scene” panel. Photo: Nicky Davidov, IAA

The layer of the nucleus was applied according to the composition of the mosaic, and on it was designed the outline of the mosaic composition and the layout of the tessellatum. Two methods were used in different locations: on the long panel with krater and wine leaves, the composition was traced using a sharp tool in the fresh mortar—a method called *graphia* or *paradeigma* in Greek (fig. 8). The second method employed preparatory fresco painting under the “Fish Panel” using five different pigments. This method was unknown until the discovery and scientific study of the paint. We suppose the same method was used under the whole northern section of the composition, but we were not able to conserve enough representative fragments to be certain. The painting was covered with a very thin layer of lime mortar (lime bed) and the tesserae were embedded in it.

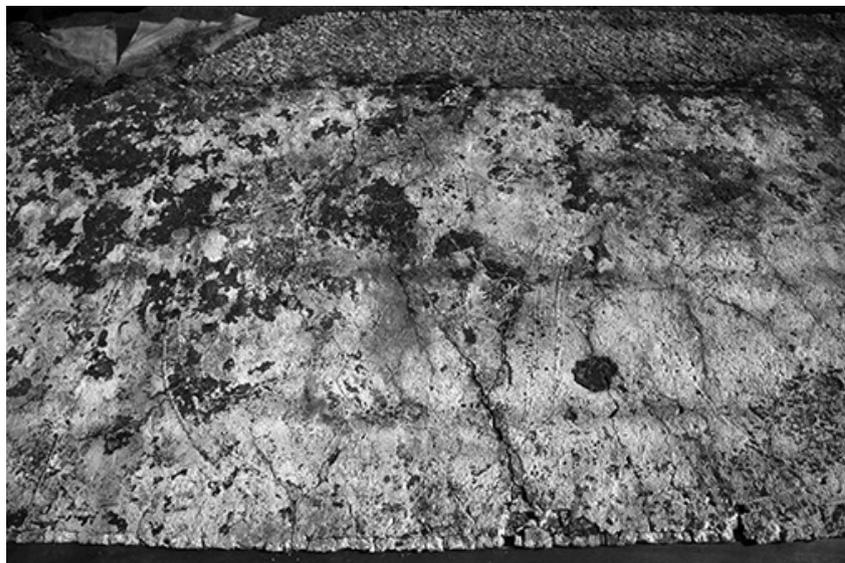
Figure 8 Preparation design (*paradeigma*) under the panel with krater and vine leaves. Photo: Nicky Davidov, IAA

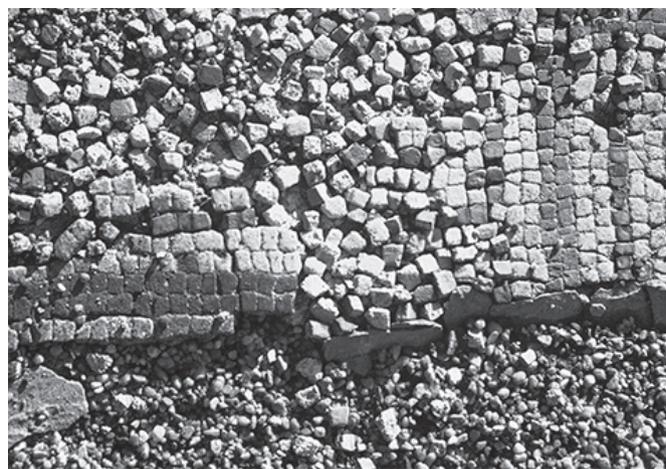
Figure 2 Bordure disloquée de la mosaïque n^o 8 en 1991. © ARM (Atelier de restauration de mosaïques de Saint-Romain-en-Gal)

disloquée sur toute la largeur de la pièce, constitue le cas le plus alarmant (fig. 2). Les mosaïques du second groupe paraissent moins altérées ; leur cohésion est mieux préservée malgré quelques lacunes, des fissures et le développement de mousses le long du mur de l'église.

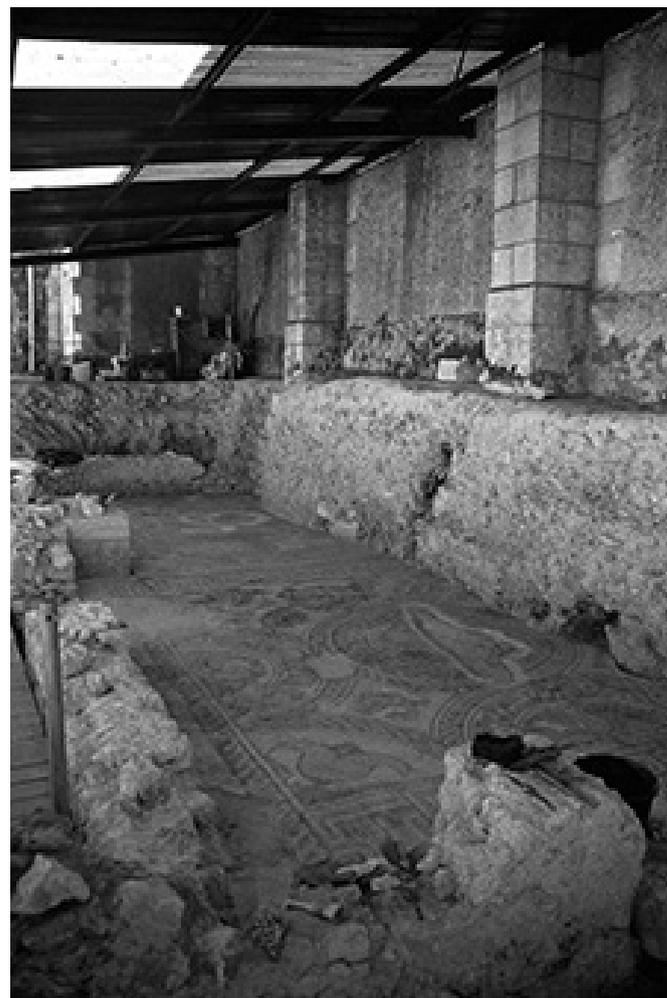
Figure 3 Mosaïques n°s 11 et 11b après les consolidations effectuées en 1991. © ARM (Atelier de restauration de mosaïques de Saint-Romain-en-Gal)

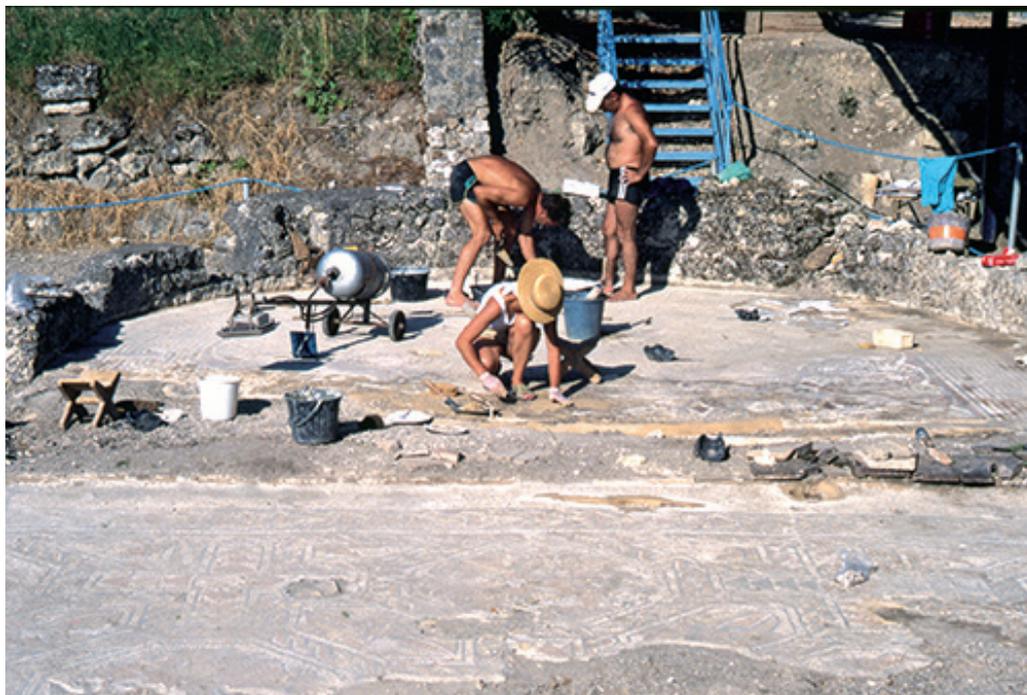
Figure 4 Mosaïques n^{os} 7 et 8 en cours de consolidation en 1991. © ARM (Atelier de restauration de mosaïques de Saint-Romain-en-Gal)

- stabiliser les parties vulnérables par des solins de bordure en mortier de chaux chargé de sable et par des pansements de gaze collés sur les zones boursoufflées ou en voie de dislocation (figs. 3 et 4);
- recouvrir les mosaïques n°s 9, 11 et 11b, maintenues *in situ*, par des géotextiles et une couche de sable;
- protéger à titre temporaire, avant leur dépose, les mosaïques des salles n°s 4, 7 et 8. L'état de dégradation extrême de ces trois pavements ne permettant pas de les recouvrir de sable, des abris temporaires sont installés par le Service archéologique de Gironde; il s'agit de serres-tonneaux à structure tubulaire métallique, bâchées avec des matériaux présentant une isolation thermique, en l'occurrence un film multicouche anti-condensation utilisé dans le secteur agricole. Des protections complémentaires pour protéger les pavements

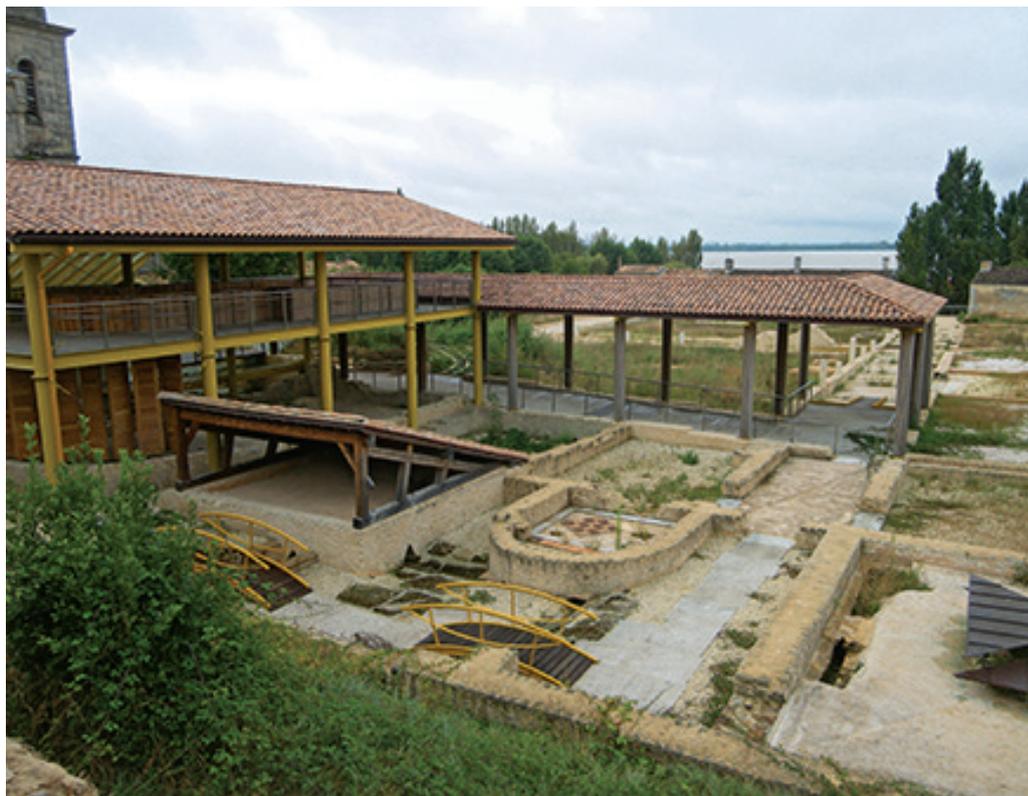
Figure 5 Vue depuis l'entrée du site de l'abri édifié en 2013. © ARM (Atelier de restauration de mosaïques de Saint-Romain-en-Gal)

Sur ce site aquitain au climat tempéré par la proximité de l'océan, la solution retenue par l'architecte est une structure semi-ouverte. L'abri édifié, en ossature métallique avec couverture de tuiles et habillages en bois et verre, couvre les mosaïques n^{os} 7 et 8 et protège également les mosaïques n^{os} 9, 10 et 11, restées en place le long de l'église. Il présente en toiture une bonne isolation thermique, qui réduit l'échauffement dû au rayonnement solaire et évite les problèmes de condensation ; une ventilation modulable, pouvant être augmentée par fort ensoleillement grâce à des panneaux orientables disposés suivant le contour des salles à absides ; et un système de passerelles permettant de voir les mosaïques au niveau du sol et en surplomb. La lisibilité de la *villa* antique est favorisée par l'aménagement de l'accès et des circulations, et par l'orientation de l'abri, ouvert comme dans l'organisation originelle, vers le péristyle et l'estuaire (fig. 5).

Ces points positifs, à considérer avant tout, ont cependant été tempérés lors de la repose ultérieure des mosaïques par les problèmes liés aux pénétrations d'eau et aux nombreux oiseaux se partageant l'abri. Le débordement insuffisant de la toiture du côté des pluies dominantes venant de l'ouest a occasionné des flaques assez importantes qui, bien que s'écoulant le long de la pente jusqu'aux exutoires

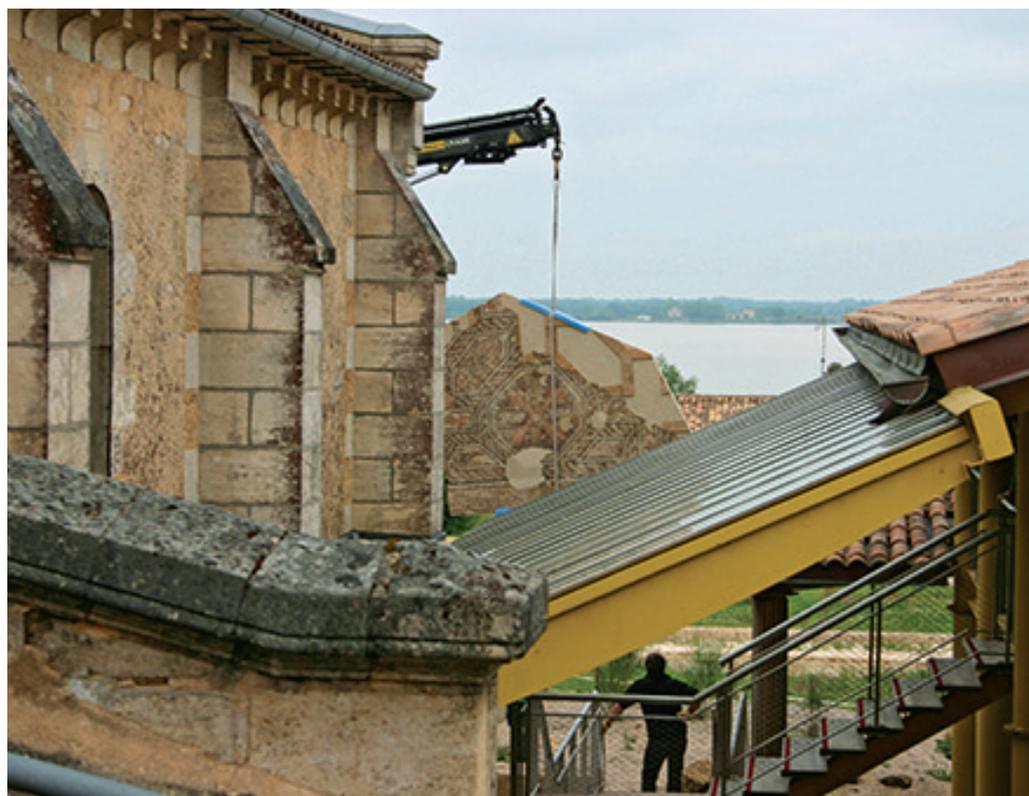
Figure 6 Transport des panneaux des mosaïques n^{os} 7 et 8 pour leur repose *in situ*. © ARM (Atelier de restauration de mosaïques de Saint-Romain-en-Gal)

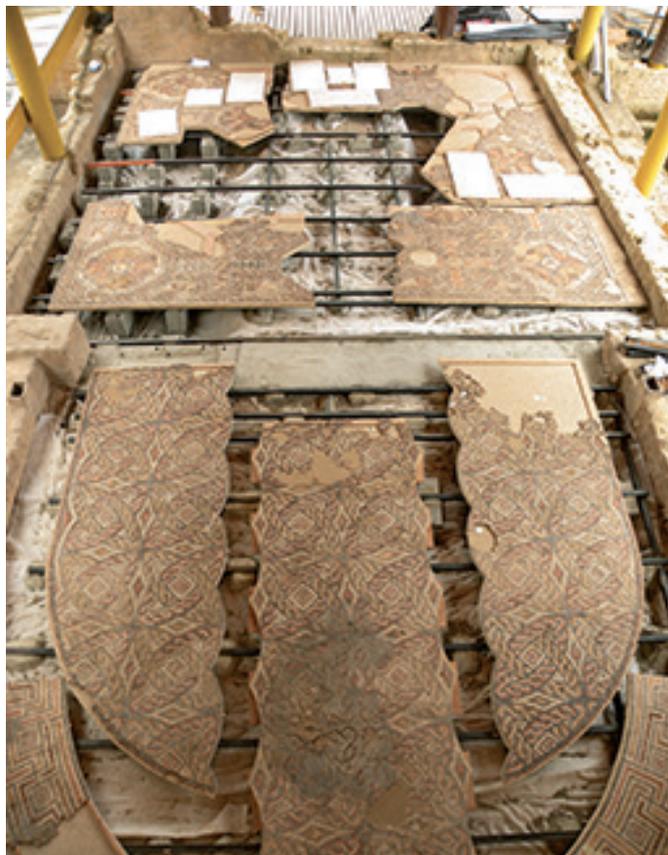
Figure 7 Assemblage des panneaux constitutifs des mosaïques n°s 7 et 8 lors de leur repose *in situ* en 2014. © ARM (Atelier de restauration de mosaïques de Saint-Romain-en-Gal)

cas de nécessité de démontage : des agrafes en acier inoxydable insérées, par l'endroit, transversalement aux raccords des plaques ; et des platines de contreplaqué collées au revers des panneaux le long de ces raccords. En périphérie de chaque pavement, un joint en polyuréthane expansé assure la liaison des mosaïques avec les murs. La base de ces derniers est protégée par un film polyéthylène pour éviter l'adhérence de l'enduit lors de sa mise en place dans les lacunes.

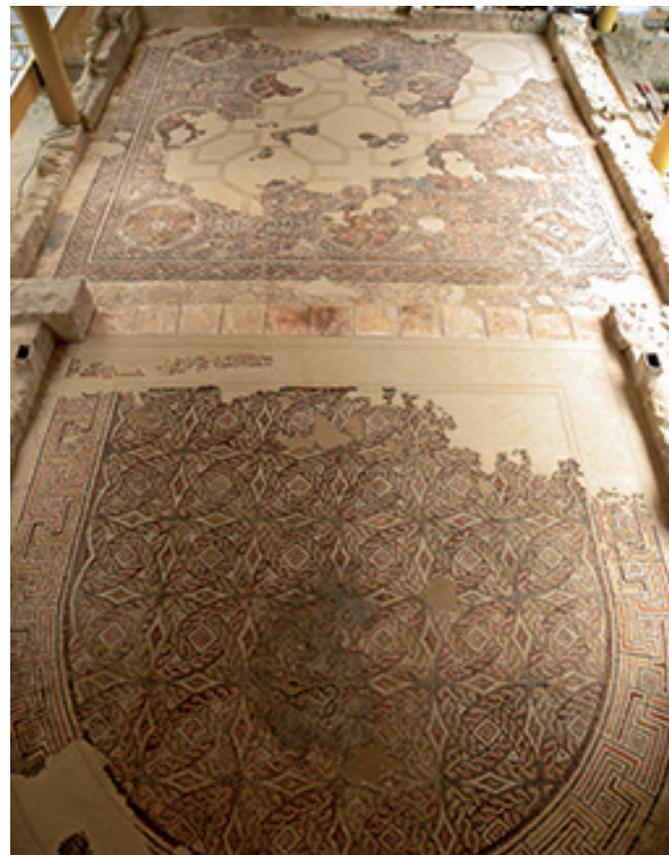
Figure 8 Vue des mosaïques n°s 7 et 8 après le traitement des lacunes. © ARM (Atelier de restauration de mosaïques de Saint-Romain-en-Gal)

Les lacunes des mosaïques sont ensuite comblées avec un mortier de chaux dont la couleur et le grain ont été choisis après une série d'essais réalisés en atelier. Il a été décidé de réaliser un traitement bicolore afin d'évoquer, en plus sombre sur une base claire, la trame géométrique des décors dans les parties disparues, tant pour faciliter la lecture des motifs que pour animer les grandes plages inertes qu'auraient constituées les lacunes sans ce traitement complémentaire. Composé du mélange de chaux hydraulique de Saint-Astier et de sables colorés, ce mortier vient combler les lacunes à environ 1 mm en retrait de la surface de la mosaïque afin que celle-ci se détache du fond.

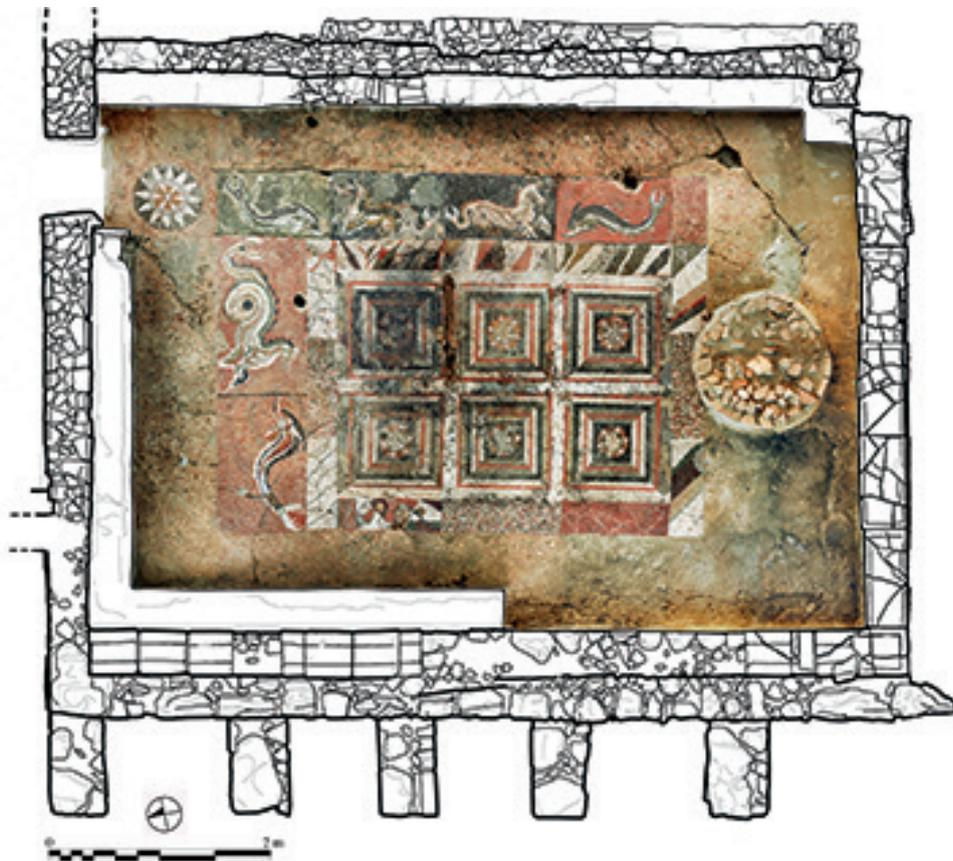
Figura 2 Ortofotopiano del pavimento musivo della "Sala dei draghi e dei delfini". Foto: A. De Natale, 2014

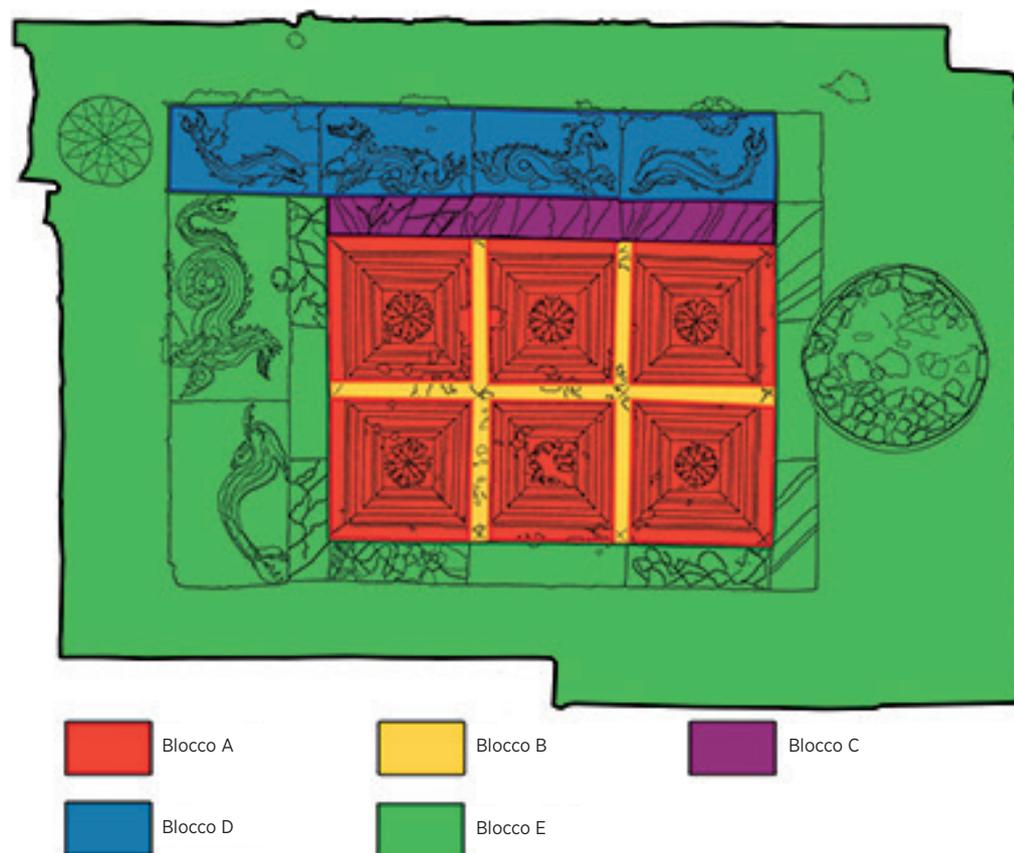
Figura 4 Mappatura grafica dell'organizzazione in "blocchi funzionali" del pavimento musivo. Foto: A. De Natale, 2015

tori o "blocchi" funzionalmente distinti, la cui configurazione sembra mostrare un forte legame con l'impianto compositivo e iconografico del mosaico (fig. 4). Tale scansione emerge, in particolare, a livello del massetto, e si associa spesso a una differente composizione degli strati preparatori che di seguito analizzeremo. La frequente individuazione dei giunti tra i diversi blocchi, osservabile attraverso le lacune o spesso rivelata da alcune importanti fessurazioni, ha consentito, dove possibile, di ricostruirne i profili e, in via alternativa, di ipotizzarne la configurazione. Lo stesso schema sembra essere rispettato anche nel sottostante strato di vespaio che mostra, a seconda delle zone, una differente orditura o tipologia degli elementi che lo compongono. La dinamica dei rapporti fisici tra le diverse parti, purtroppo, non è sempre individuabile o comprensibile, ed è importante ribadire la parzialità dei dati in ragione della limitatezza dei punti di accesso agli strati più profondi.

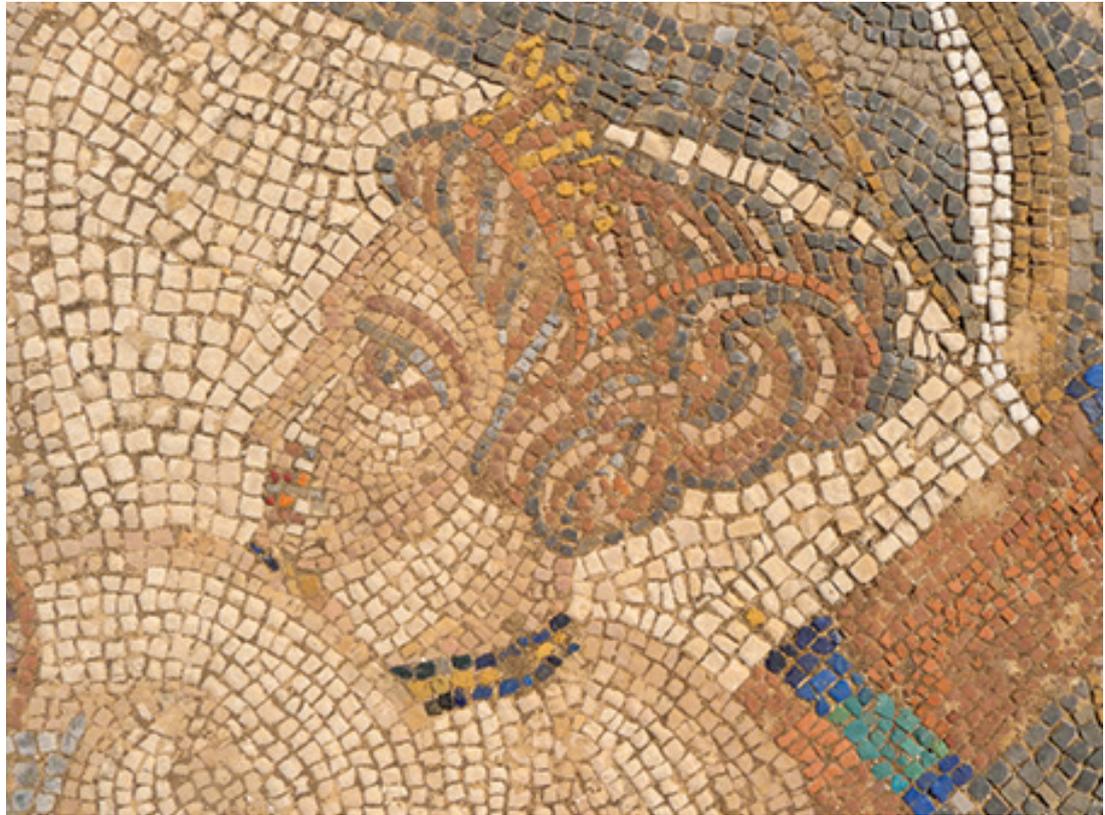
Figure 2 Heavily deteriorated mosaic, near-risk of total loss. Photo: Ermanno Carbonara. © J. Paul Getty Trust

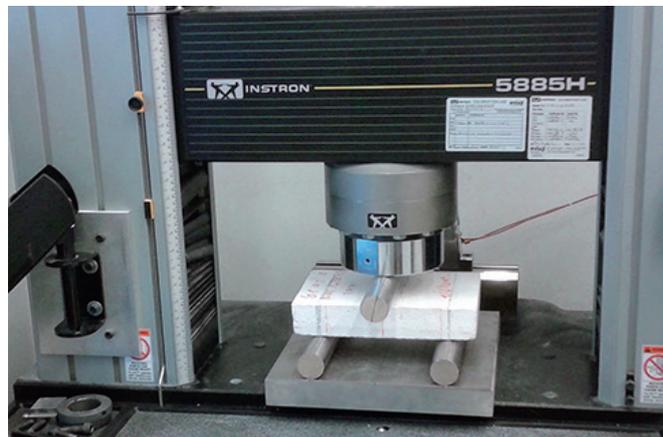
Figure 3 Flexural-tensile strength testing on a mid-scale mockup placed into an in-house built testing fixture loaded by the Instron Universal Testing Machine.

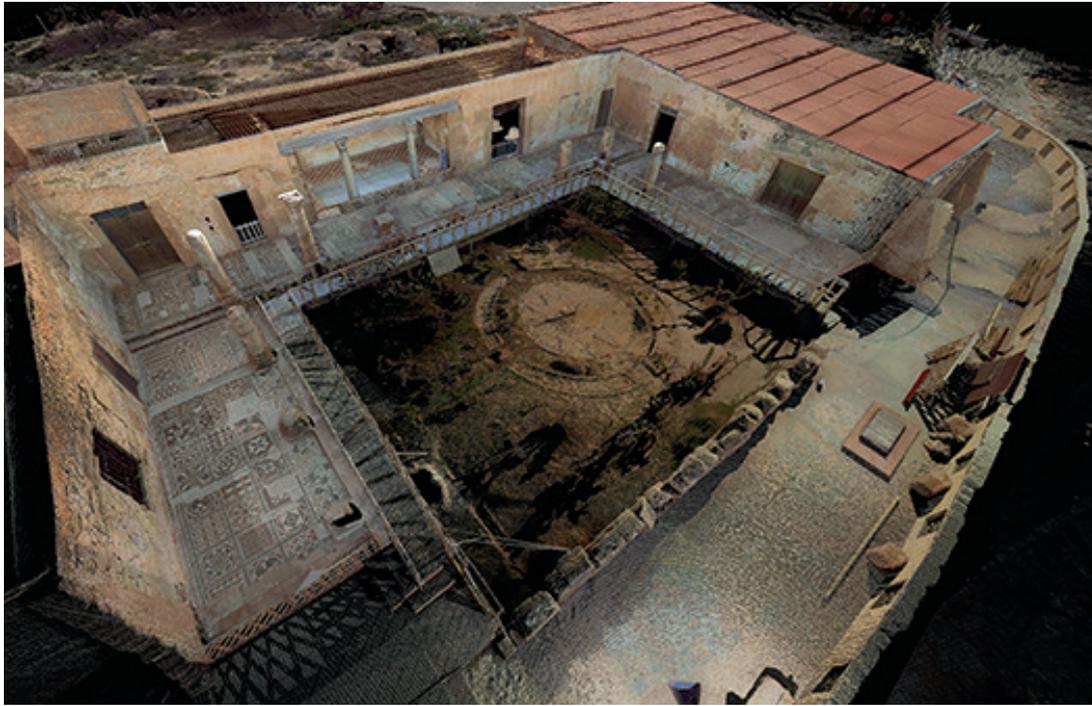
Figure 1 Villa of Silin: laser scan showing the view from the north; on the right, mosaic A1 of the peristyle. Image: ISCR Archive

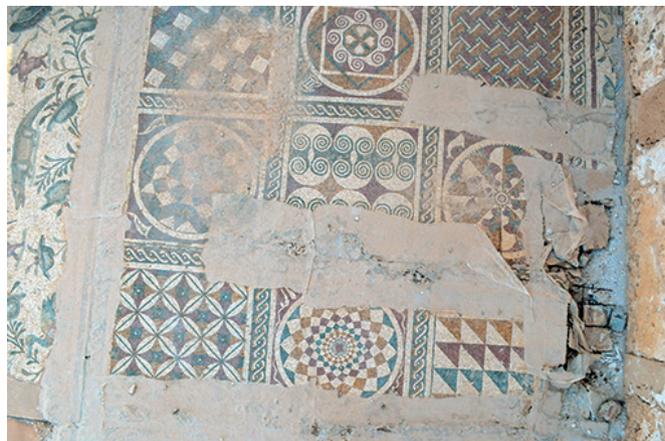
Figure 2 The original state of preservation of the mosaic. Photo: ISCR Archive

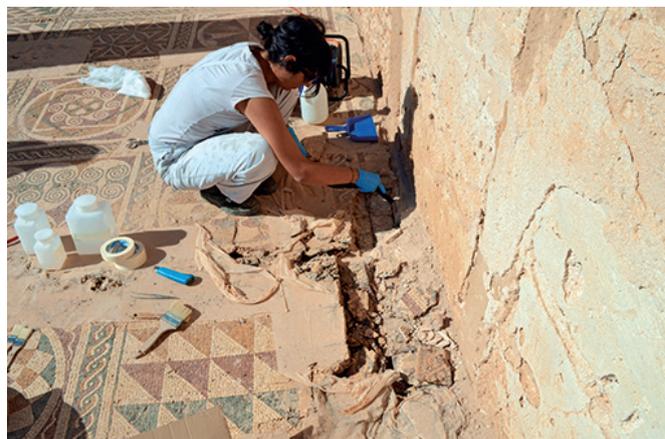
Figure 3 Removal of materials used during earlier work; iron rods in the concrete that have caused severe deformation and cracks are visible.

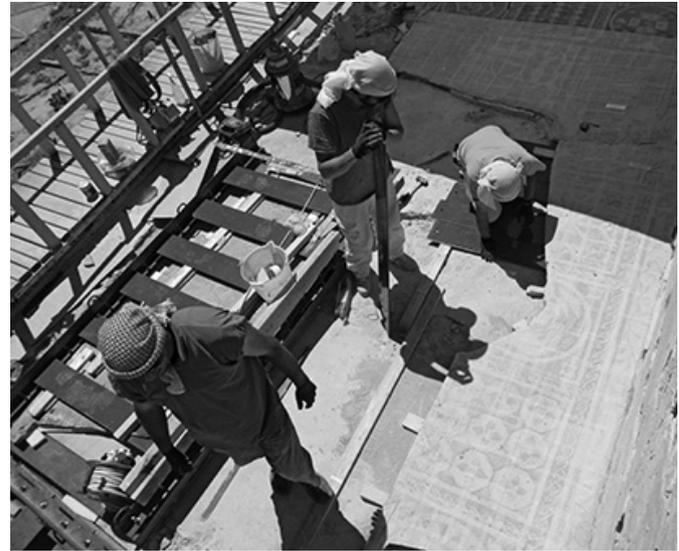
Figure 4 Dismantling phase of the panels: insertion of galvanized iron strips to facilitate the dismantling, lifting, and transport of the mosaic. Photo: ISCR Archive
