Proceedings of the 12th Conference of the
International Committee for the Conservation
of Mosaics, Sardinia, October 27–31, 2014

The Conservation and Presentation of Mosaics: At What Cost?

*Proceedings of the 12th ICCM Conference
Sardinia, October 27-31, 2014*

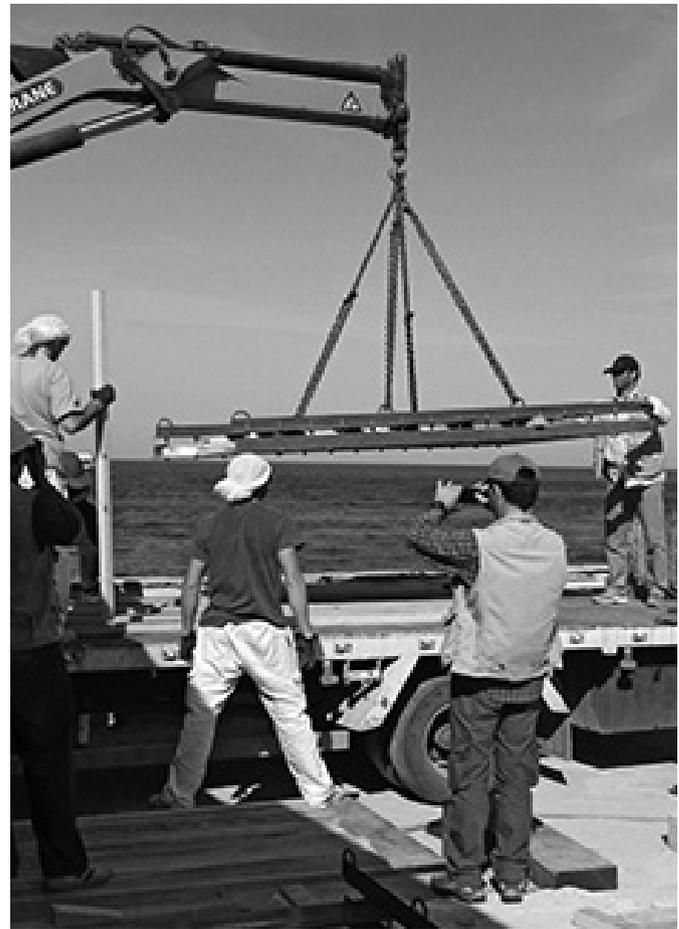
Figure 5 Lifting phase of one of the mosaic panels, showing the crane lifting the made-to-measure metal box. Photo: ISCR Archive

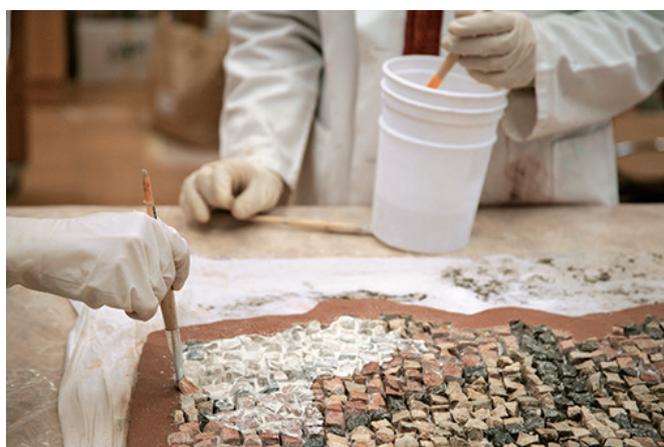
Figure 4 Application of the bedding mortar to the Emona mosaic. Photo: Documentation RC ZVKDS

The mosaic back, which was wetted, was then covered with the first layer of bedding mortar, composed of calcite sand, natural hydraulic lime 3.5, and Microsil microspheres (hollow glass particles) in a 1:1:1 ratio. The four sides of each mosaic tessera were enclosed by mortar reaching up to three quarters of their height (fig. 4). Then the mosaic was shaken so that the mortar could settle and reach its temporary support.

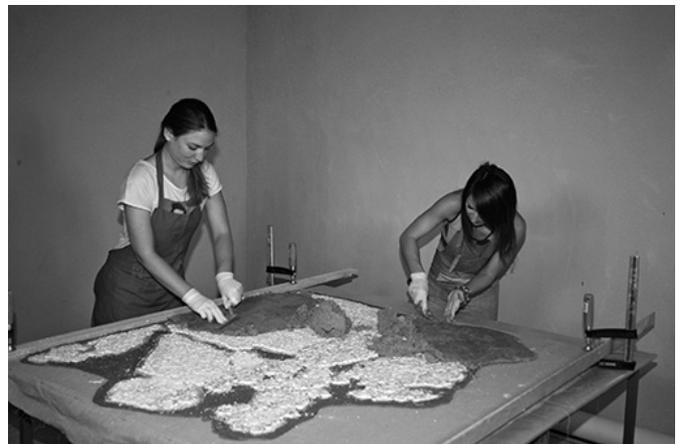
Figure 6 Application of the first layer of lightweight mortar with mineral additives. Photo: Documentation RC ZVDKS

After ten minutes, when the mortar had partially dried, a first layer of the lightweight mortar composed of natural hydraulic lime 3.5, Microsil, three different size fractions of Rondofil (recycled glass beads), and polypropylene fibers was applied in a thickness of about 1 cm to achieve a flat and smooth

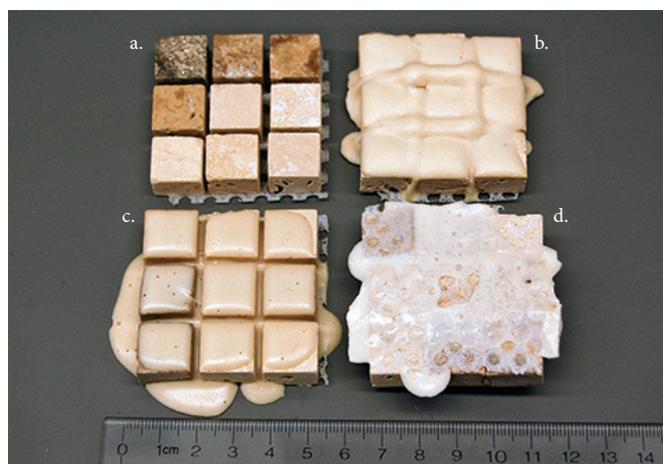
Figure 3 Properties of the Rencast 1774 (Rencast) epoxy system mixed and poured according to the manufacturer's guidelines. (a) Uncoated 3 × 3 tiles, adhered on the bottom with a mesh, used as a mock-up. (b) 10g Rencast resin (R):2.5 g Rencast hardener (H):0.125g Rencast foaming agent (A). (c) 10g R:2.5g H:no foaming agent. (d) Back side of the 3 × 3 tiles showing how the 10g R:2.5g H:0.125g A mixture flowed through the gaps between tiles and covered the back. Credit: Institute for the Preservation of Cultural Heritage, Yale University

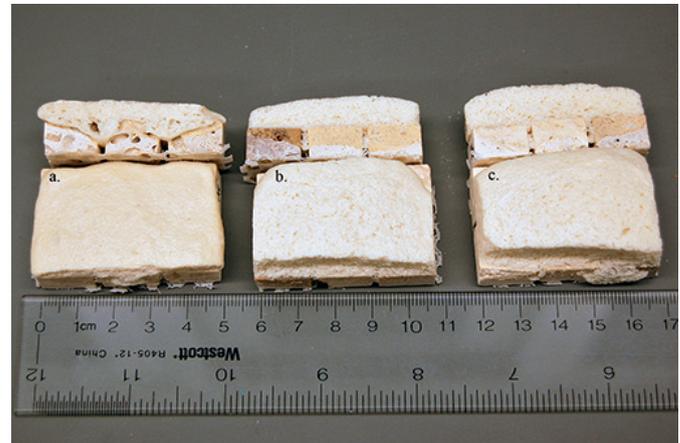
Figure 4 The effect of increasing the amount of Rencast 1774 foaming agent on the foaming of the Rencast 1774 epoxy system (all formulations include 10 g Rencast 1774 resin, 2.5 g Rencast 1774 hardener, and 0.3 g Cabosil TS720 as well). (a) 0.12 g foaming agent; (b) 0.38 g foaming agent; (c) 0.50 g foaming agent. Credit: Institute for the Preservation of Cultural Heritage, Yale University

It was decided that the ideal foamed epoxy should not flake as that should lead to weakening of the adhesion between the backing system and mosaic over the long term. In addition, the uncured formulation should not flow. It should foam homogeneously and not shrink during cure. With this in mind, twenty-seven unique mixtures using the Rencast resin were made, with the hope that the traits of the ideal foamed epoxy would be found. A summary of the samples made is shown in table 1. Unfortunately, the series of formulations made to see if the Rencast epoxy system could be modified to meet desired treatment criteria were largely unsuccessful. Despite this, several interesting outcomes were observed. First, a more space-filling epoxy was made by changing the amount of foaming agent. Adding more foaming agent, regardless of type, resulted in an increase in the final volume of the cured epoxy (fig. 4), with the Rencast foaming agent foaming slightly more than the PMHS.

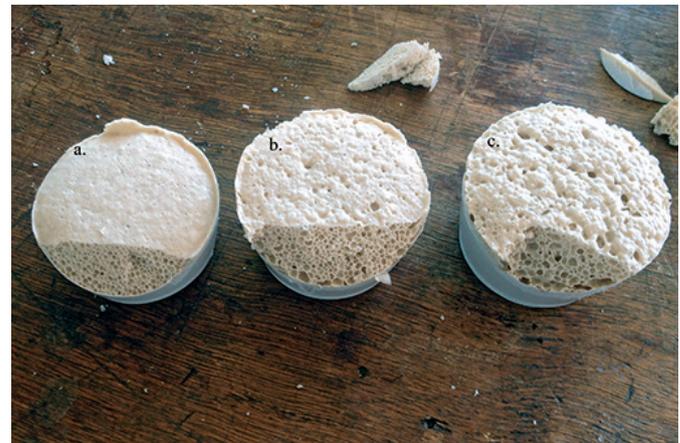
Figure 6 Effect of foaming agent on the Hodgson foams made with 10% Epon 828, 20% diluent, and 70% English whiting. (a) 1 vol. % foaming agent (FA); (b) 2 vol. % FA; (c) 3 vol. % FA. Credit: RH Conservation Engineering

Figure 6 shows the samples made with 10% Epon 828, with increasing poly(methylhydrosiloxane) content. The sample with 2% foaming agent seemed ideal for application with the

mosaic treatment; however, the foaming this sample exhibited would need to be monitored as it bubbled quite a bit. It was worried the foam would push on, and possibly disrupt, the mosaic surface. Testing of this hypothesis was not possible, so this epoxy was not chosen for treatment of the mosaic.

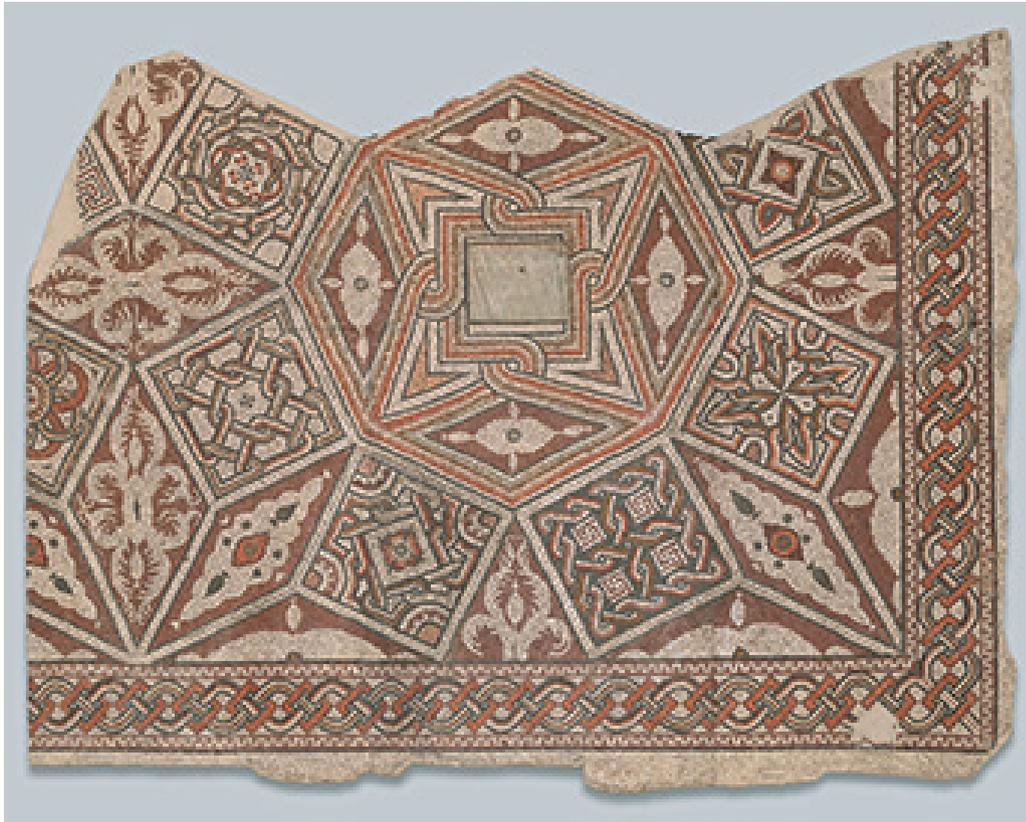
Figure 8 The geometric floor mosaic from the south aisle of the Church of Bishop Paul, i.e., Procopius Church (1929.418), after conservation treatment. Dimensions of treated fragments: 364.5 × 284.5 cm (143.5 × 112 in).

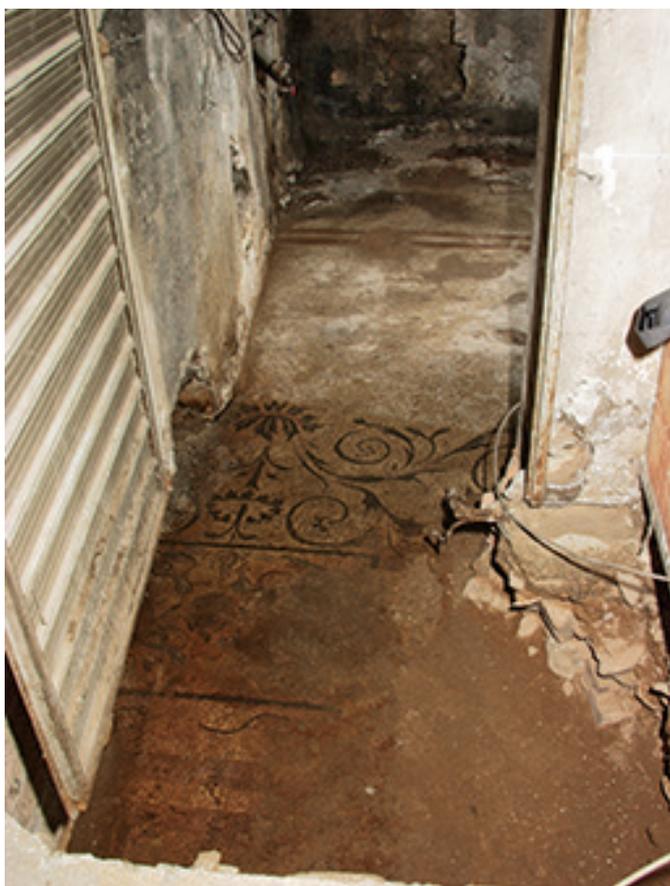
Figura 2 Spello, Ex Ospedale, locale adibito a caldaia e rimessa in luce del mosaico. Foto: Valentino Pescari. Riprodotta con il permesso della Soprintendenza per i Beni Archeologici dell'Umbria

Rimosso il laterizio che copriva il pavimento antico, il mosaico appariva in discreto stato di conservazione e si sviluppava anche oltre la parete settentrionale del piccolo ambiente, proseguendo fuori dal complesso architettonico (fig. 2).

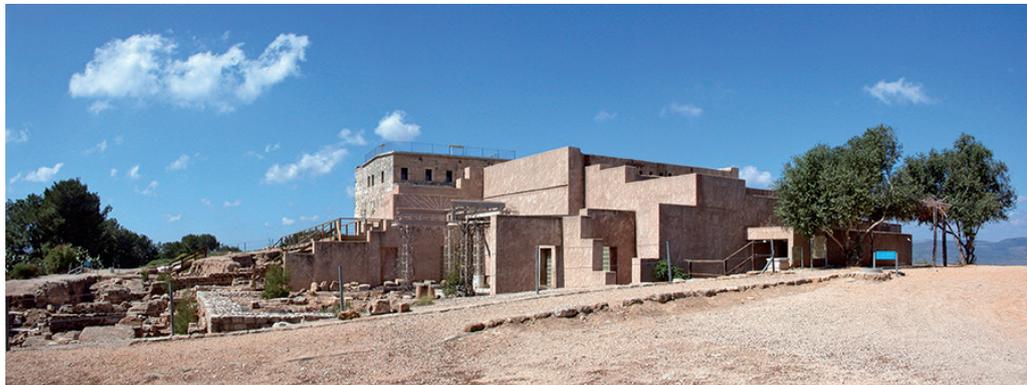
Figure 3 View of the massive concrete enclosure over the northern part of the Dionysos mosaic building, Zippori. While respecting the views from the watchtower, the enclosure does not evoke the image of the Roman villa, and lack of development of the surroundings impairs the legibility of the urban layout.

The enclosure, designed by L. Belkin,² is a reinforced concrete structure built in parts directly on the original walls covering an area of about 400 square meters. Illumination in the building is provided by spotlights concentrated over the Dionysos mosaic. The total shelter planning and construction costs (not including mosaics treatment) was \$400,000.

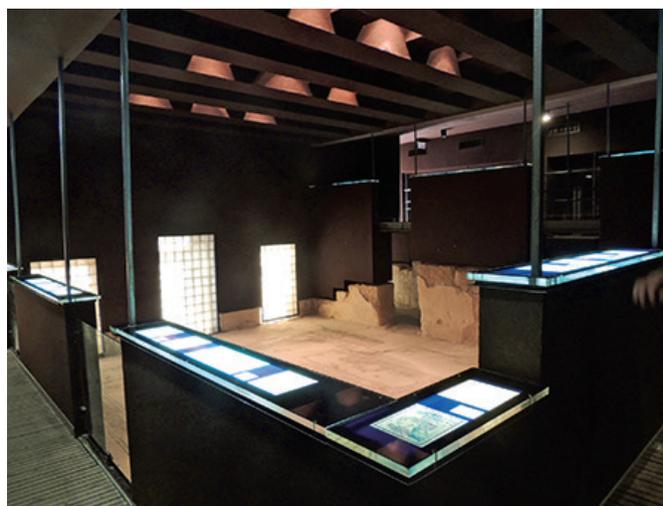
Figure 4 Interior view of the Dionysos mosaic building. The closed interior highlights the mosaic’s artistic qualities at the cost of understanding the unique setting of the building and the connection of the triclinium to the peristyle courtyard. Photo: Y. Alef (2014) © IAA

clinium, detracts from the legibility of the remains as a whole and prevents the experience of the spatial qualities of the reconstructed building (fig. 4). Relying on artificial lighting also came at the cost of intensive maintenance. The original lighting system consisted of about fifty-five short-life light-bulbs; they were later replaced by nine light fixtures of 2,000 lifetime hours (Sela 2002). The alternative illumination system requires only annual changing, but the amount of lighting is not sufficient and affects the presentation.

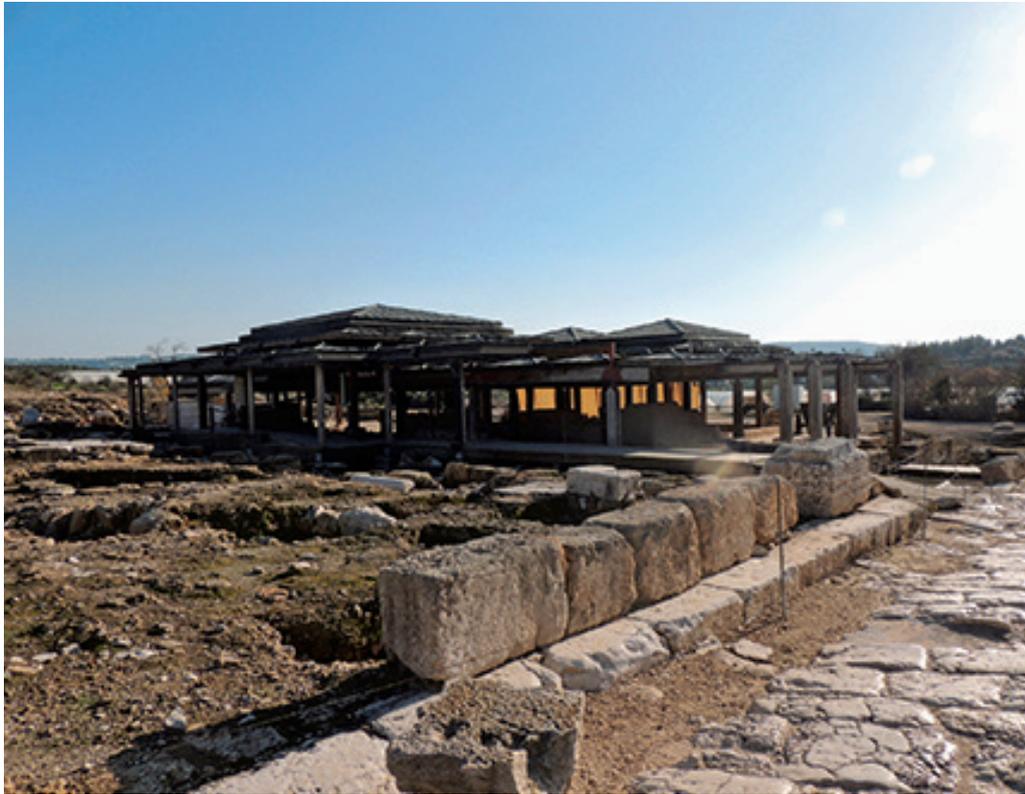
Figure 5 View of the open shelter over the Nile Festival building next to the cardo. The modular roof is composed of a complex system of pyramids made of fiberboard covered with copper sheets.

The decision to use copper and fiberboard on the roof for their aesthetic appearance had its costs too. The high thermal conductivity of the copper causes condensation on the fiberboard in summer. In winter, leaks from the roof were noticed after rain. It is not surprising, then, to find mosaics that show signs of microbiology and fiberboard that shows signs of rot.

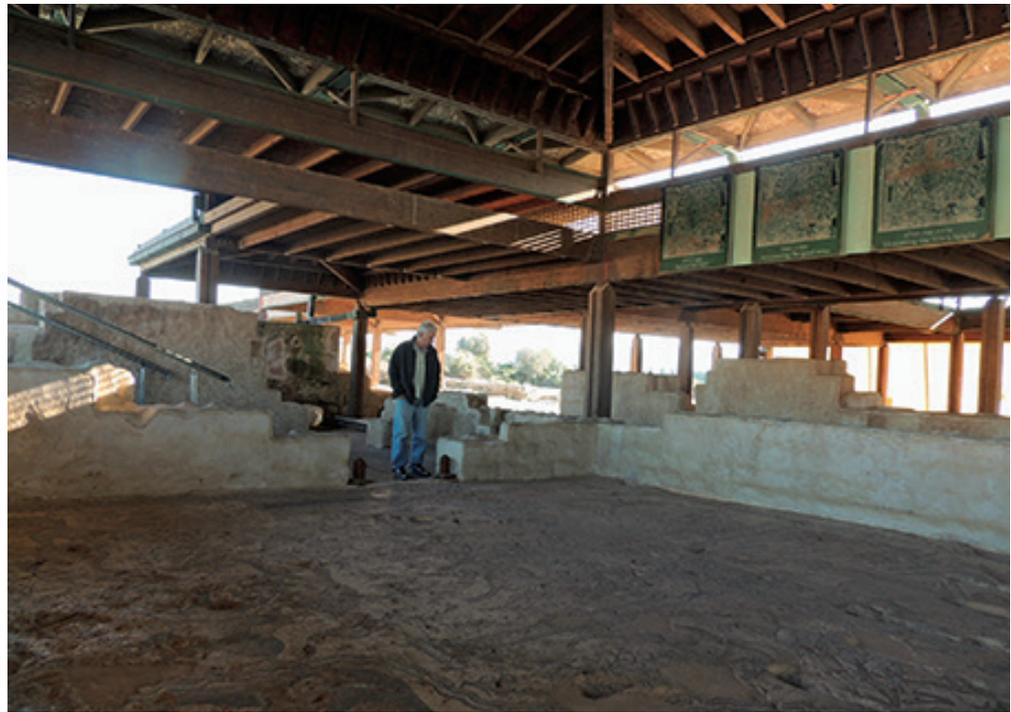
Figure 6 Interior view of the open shelter over the Nile Festival building. The elaborate design “competes” with the remains. Photo: Y. Alef (2014) © IAA

The presentation of the site focused on the display of the mosaics as architectural elements. This entailed re-creating the sense of volume by partially reconstructing the walls and defining the perimeters of the room in roof partitions and by integrating new floors in missing places. The path too had a role in enhancing the archaeological context by leading from the *cardo* to the original entrance and inviting visitors to view the mosaics from the ground level (Sivan 2002).

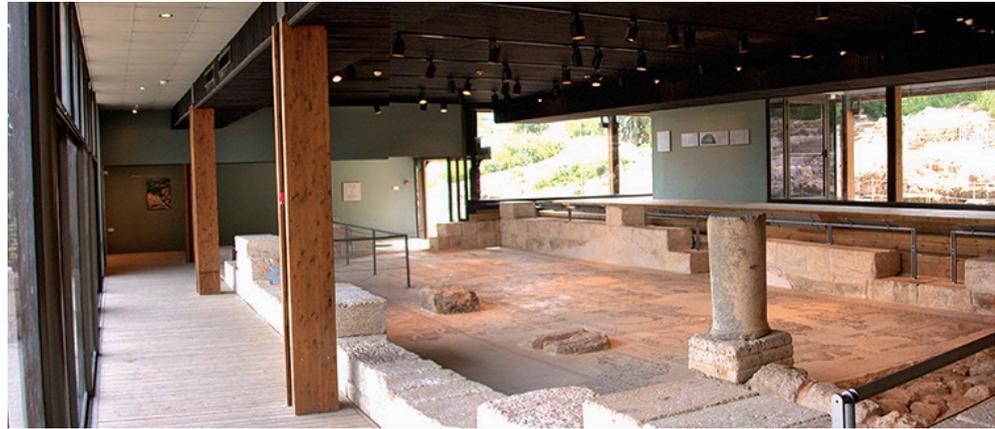
Figure 8 Interior view of the synagogue with glass curtain walls. Plans for the new presentation will cover the windows in order to better control the lighting of the mosaic. Photo: Y. Alef (2006) © IAA

The synagogue is displayed as an object in a modern “showcase” that stands apart from the remains and does not create a unique sense of place.

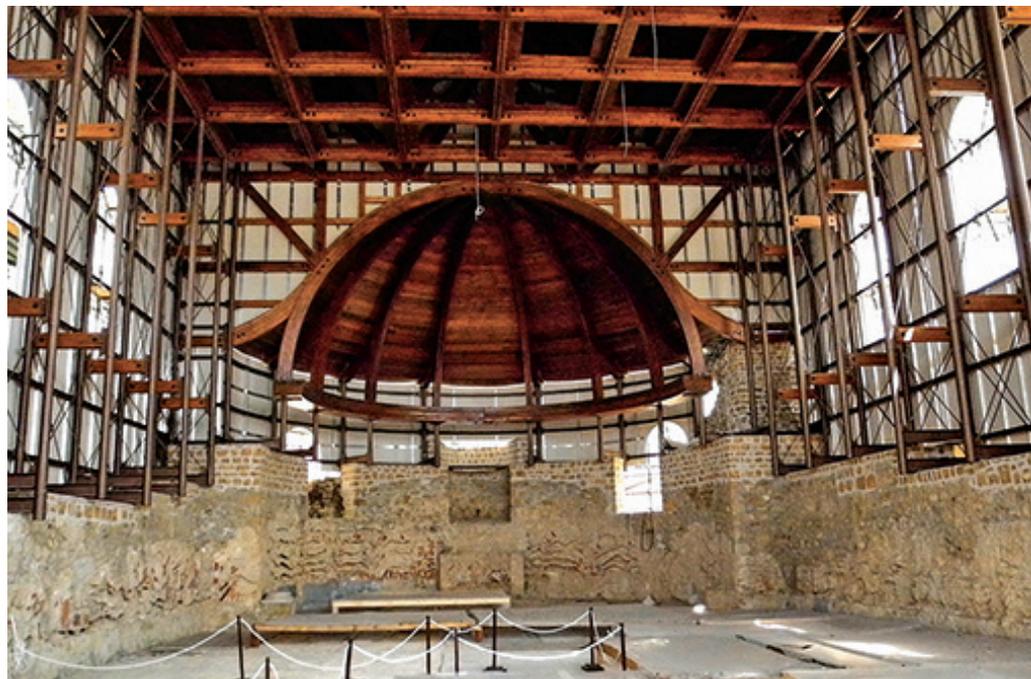
Figure 3 Basilica of the Villa del Casale at Piazza Armerina after the recent intervention. Photo: Gionata Rizzi

The second example is a project that has been implemented, although it is still to be completed: the large shelter mentioned above for the Roman Villa at Piazza Armerina and its famous mosaics. In this project we had to deal with two failures of the previous interventions: one due to the unbearable temperature that this transparent shell created inside, and the

second due to the shadows that the structure projected on the floor, making it very difficult to appreciate the mosaics (fig. 3).

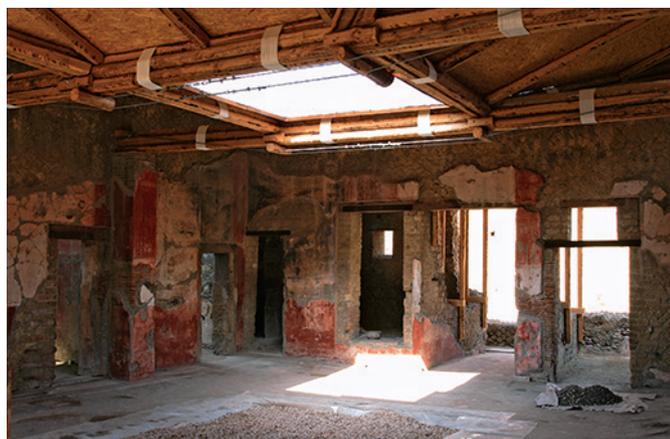
Figure 4 Temporary shelter over the atrium of the House of the Gemma at Herculaneum. Photo: Gionata Rizzi

The third case is at Herculaneum, a fascinating site where it is becoming more and more obvious that finishes conceived for indoor conditions (mural paintings, stuccoes, mosaics, and opus sectile) cannot be preserved without restoring the conditions of an indoor place. In the atrium of the House of the Gemma we reproduced the same structure used by the Romans to support the roof; but instead of using large and heavy beams (which are expensive and difficult to bring to a site that is not reachable by vehicles), we used a series of simple poles tied together (fig. 4).

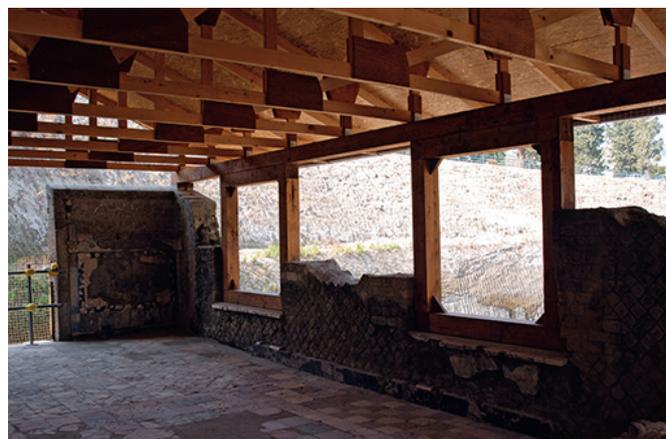
Figure 5 Temporary shelter over the triclinium of the House of Telephus at Herculaneum. Photo: Gionata Rizzi

Also at Herculaneum, in the triclinium of the House of Telefus, we set a series of trusses on a longitudinal beam supported by window frames set in their original position but over-dimensioned. With a little creativity we managed to produce reversible roofs for two rooms and without reconstructing the walls (fig. 5).

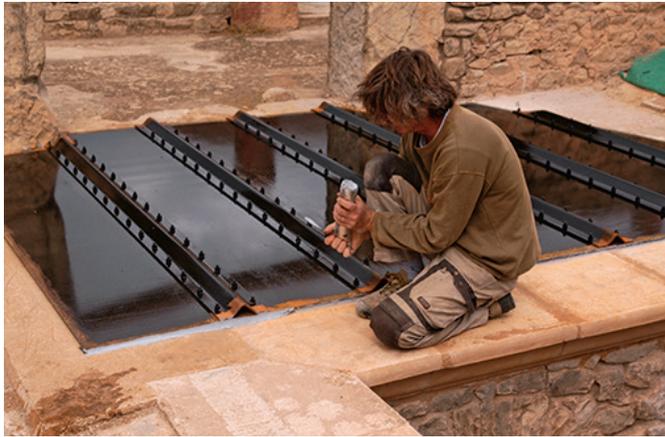
Figure 6 New cover over the missing vaults in the House of the Hunt (Maison de la Chasse) at the site of Bulla Regia, Tunisia. Photo: Gionata Rizzi

Finally, I want to discuss two examples from the extraordinary site of Bulla Regia, a cooperative project of the Institut National du Patrimoine (INP), the Getty Conservation Institute, and the World Monument Fund. Bulla Regia is famous for its subterranean houses, which, as long as their vaults are intact and no rain gets inside, provide the ideal conditions for the preservation of their mosaics. In the House of the Hunt, French archaeologists carried out extensive restoration work in the 1930s, but they left two gaps in the vaults of the peristyle that were both dangerous for visitors (who could fall into the lower level of the house) and bad for the preservation of the ancient fabric (because rain fell where it was not supposed to). In this case we solved the problem by finding a simple way to restore the continuity of the ground-floor peristyle: a “metal lid” made of metal slab (made of Corten, an alloy that is protected by its own rust), narrow enough to be handled by two people and joined together by ribs that increase the overall rigidity. The system proved effective: it leaves the section of the vault visible, and it is slowly taking up a patina that makes the metal slab recede visually into its surroundings. Among its good qualities, it is totally reversible (figs. 6, 7).

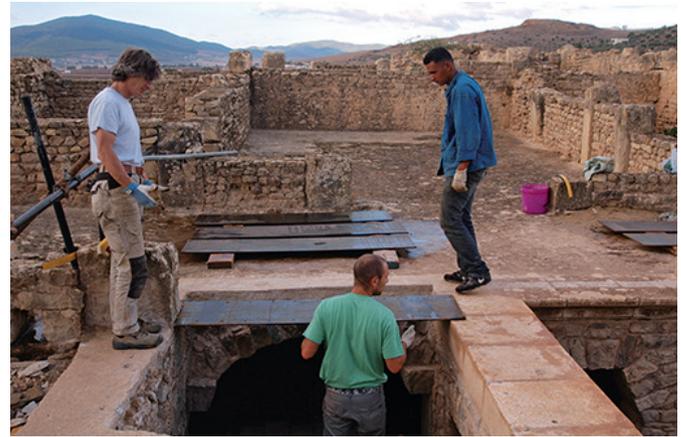
Figure 7 Installing the new cover over the missing vaults in the House of the Hunt (Maison de la Chasse) at the site of Bulla Regia, Tunisia. Photo: Gionata Rizzi

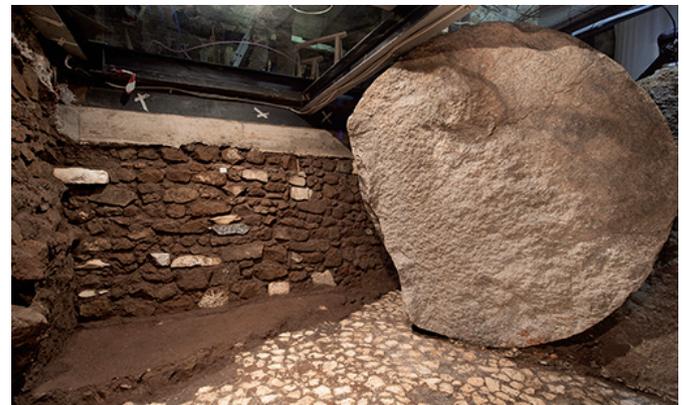
Figura 2 Palazzo Valentini, ex carceri: Fondazione in opera cementizia e spezzone di colonna in granito grigio dal *Templum divi Traiani et divae Plotinae*. Foto: ACC Photo Autuori Carletti Callipari

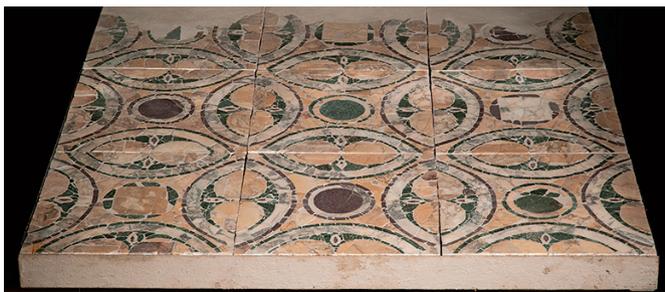
Figura 6 Palazzo Valentini, area delle Terme, *apodyterium*: Pannelli del pavimento in *opus sectile* del piano superiore riposizionati in stato di crollo.

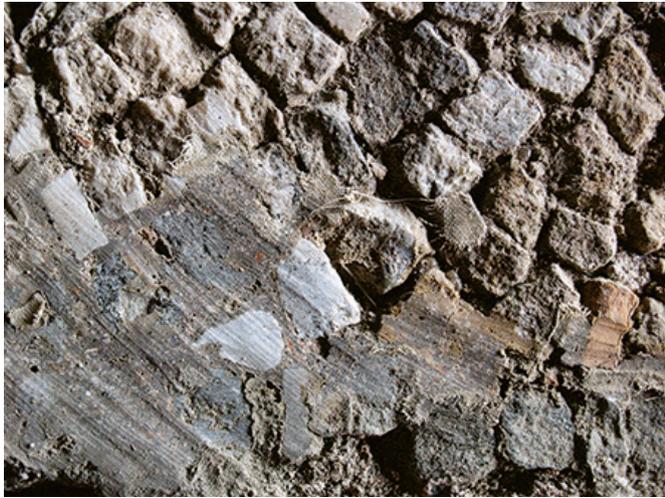
Figure 3 Previously restored mosaic fragment damaged by migration of epoxy to the mosaic surface and facings. Evidence of rough scratching of the epoxy and facing material, thus causing additional deterioration of the tessellatum. Photo: Elena Kantareva-Decheva, 2011

Previously restored mosaic fragments were in various states of preservation with poor-quality restoration work. All of them had been provided with new supports made of epoxy resin with filler sand and iron reinforcement. The epoxy had been applied directly onto the back of the fragments, with no reversible layer. The fragments had twisted supports, loss of single tesserae, rusty spots resulting from the corroded iron rebar reinforcement of the supports, migration of epoxy to the mosaic surface and facings, and evidence of rough scratches on the epoxy and facing material, thus causing additional deterioration of the tessellatum. Many fragments had been laid on larger supports than necessary, not taking into consideration that they had neighboring fragments that had to be matched and put together (Kantareva, Bospachieva, and Luk 2007) (fig. 3). All these factors made restoration work quite complicated, especially since epoxy is hardly soluble. Therefore, mechanical removal was required.

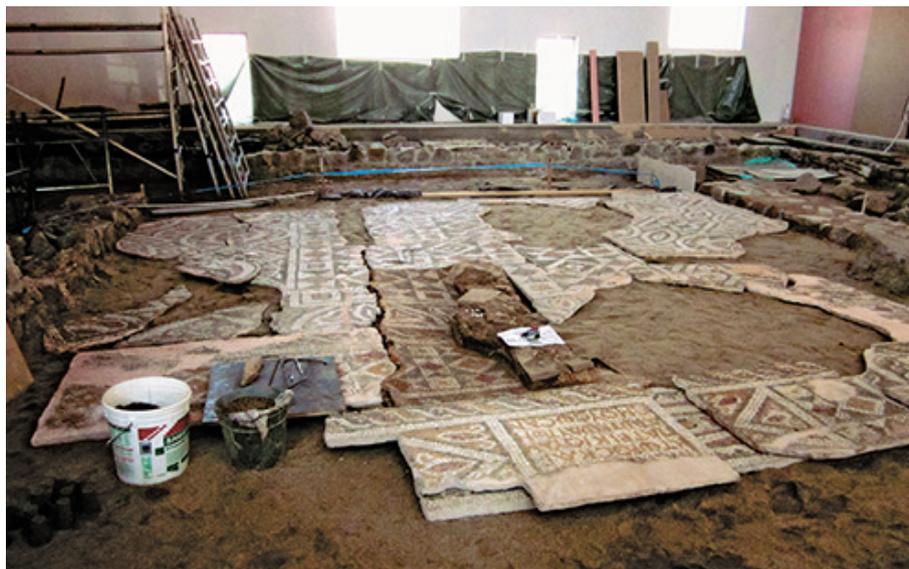
Figure 6 Re-laying the mosaic on-site.

The treated mosaics were relaid in the basilica following an evaluation of the condition of its original substructure. A decision was made to preserve it in situ as much as possible. The rudus was carefully scraped off and leveled. Geotextile and rammed sand served as a bedding layer for the fragments, which were placed on top. The preserved in situ fragment under the pulpit in the Naos helped determine the original level and location of the mosaic when putting the fragments together (fig. 6).

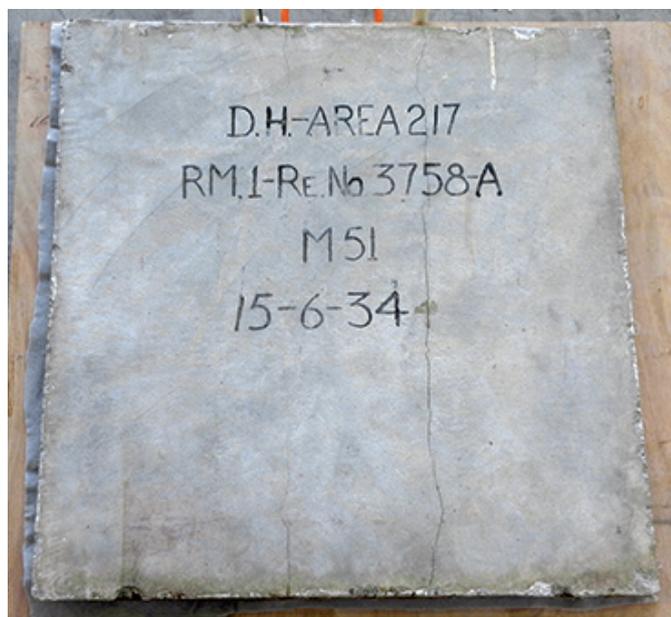
Figure 3 Dalle de ciment au revers de la mosaïque avec personnification provenant d'Antioche. © Paul Veyseyre, musée de Saint-Romain-en-Gal

L'enjeu de cette campagne était d'abord d'assurer la conservation de fragments de pavements de mosaïque déposés, dont le support moderne, en ciment armé, avait sensiblement vieilli, s'était altéré et provoquait des dommages sur le *tessellatum* antique, notamment des déformations, des fissures et des pertes d'adhérence des tesselles sur le support, voire la chute de tesselles dans les cas les plus critiques. Ainsi, la mosaïque avec personnification féminine⁵ était traversée par des fissures liées à la corrosion de l'armature métallique (fig. 3). La mosaïque de l'Amazonomachie⁶ présentait quant à elle une fissure du haut en bas qui suivait une barre métallique; l'armature moderne avait provoqué une déformation du *tessellatum*, particulièrement visible en lumière rasante (fig. 4). Dans le cas singulier de la mosaïque du Phénix⁷, la dépose obligeait le démontage d'une reconstitution dont on ne savait pas grand-chose. Des documents d'archives, notamment des factures, conservaient la mémoire de l'intervention de la maison Gaudin, qui avait réalisé, en 1936, ce remontage de 5,67 m de haut pour 4,25 m de large. On imaginait cinq ou six panneaux assemblés. Ce sont en réalité 18 panneaux qui ont été réunis, scellés au mur et liés les uns aux autres par des bandes de jonction refaites avec des tesselles antiques (fig. 5).

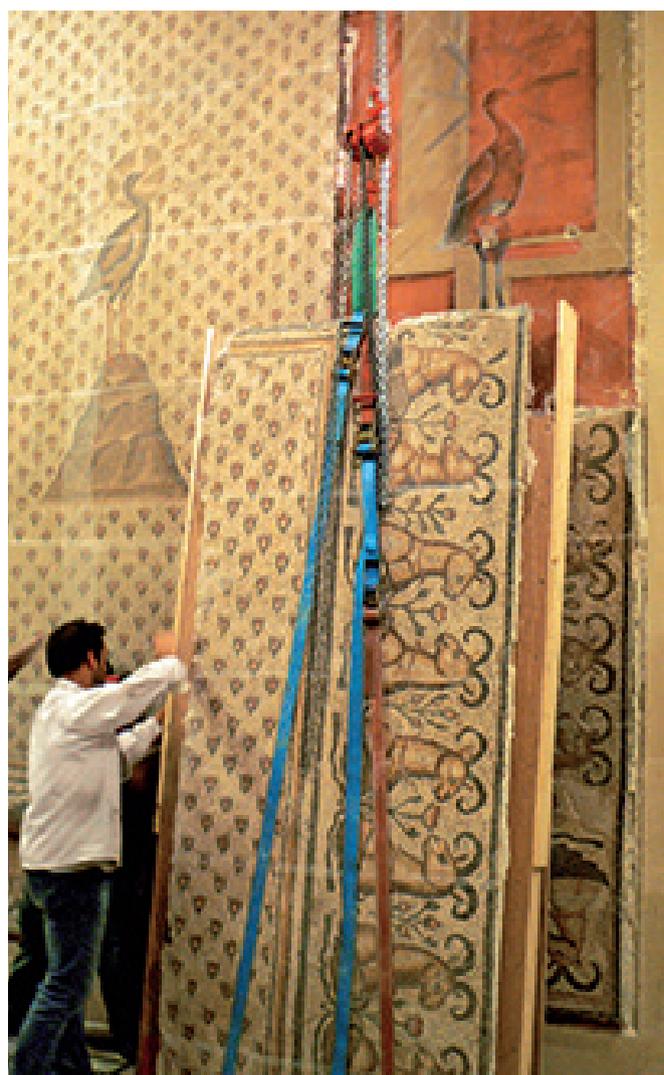
Figure 5 Dépose de la mosaïque du Phénix provenant d'Antioche. © Atelier de restauration de mosaïques, musée de Saint-Romain-en-Gal

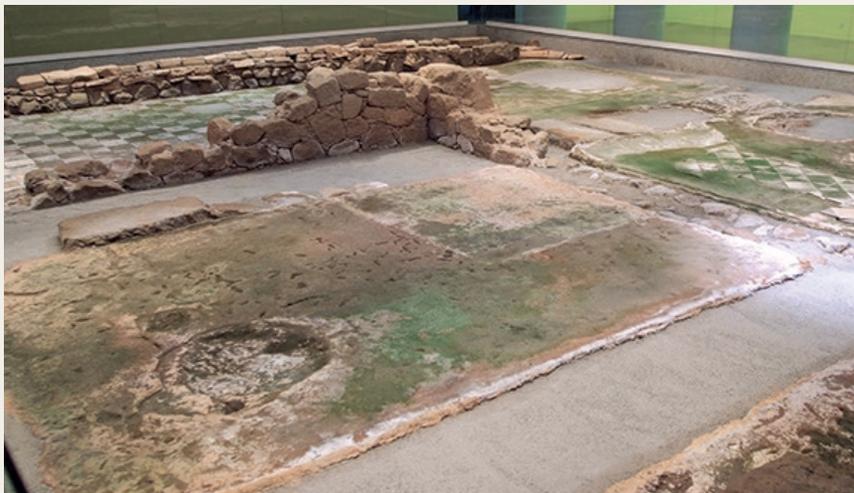
Figure 2 Mosaic with microorganisms and salts. Photo: © Archive of the D. Diogo de Sousa Museum (AMDDS)

In 2011, the entry of water was observed again along the ceiling. The humidity made it very difficult to combat the microorganisms and to resolve the problem of soluble salts. Once again, microorganisms were collected at different points on the mosaics and brought to be examined at the laboratory of the Catholic University of Porto (fig. 2).

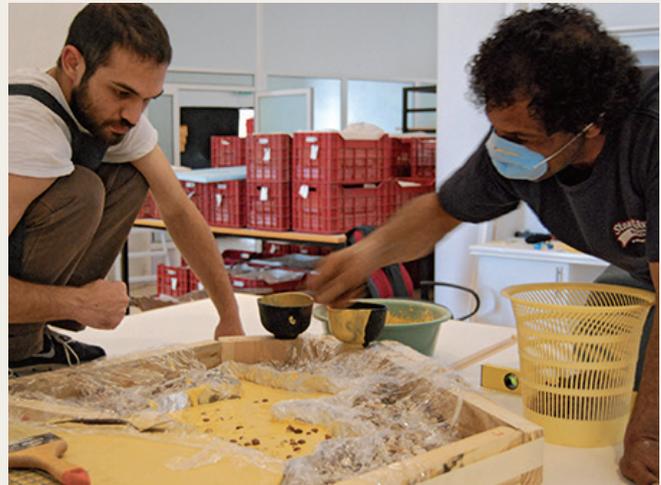
Figure 1 Casting dental plaster molds. Photo: S. Chlouveraki

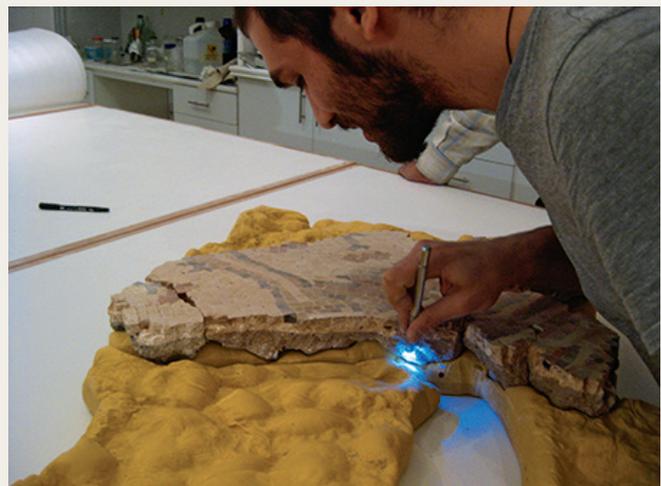
Figure 2 Fully detachable, retreatable, and easily transferable cast supports. Photo: S. Chlouveraki

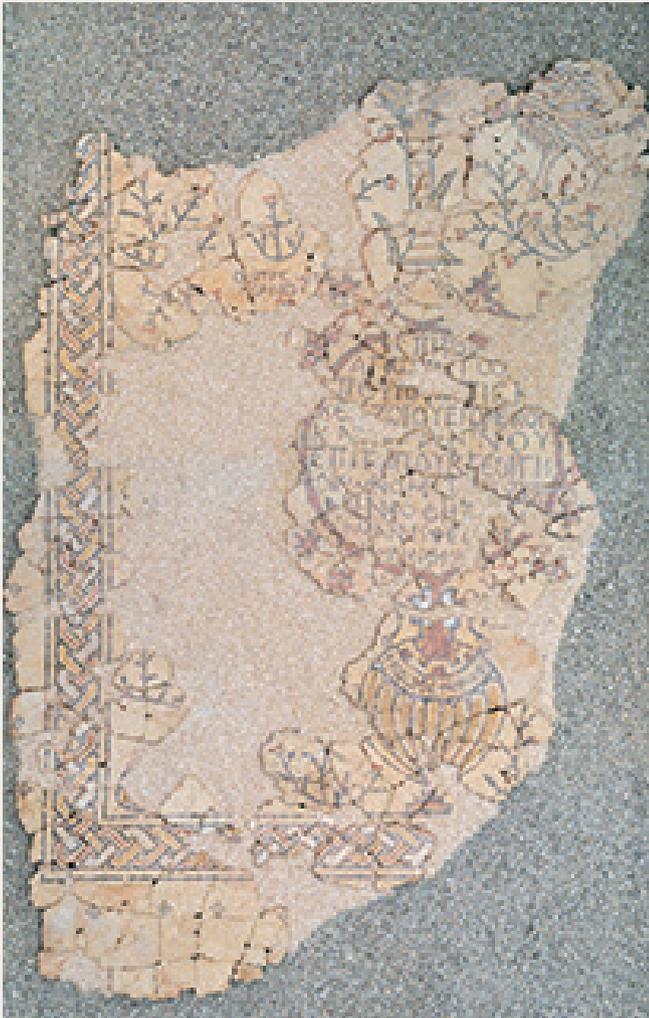
Figure 4 The resulting mosaic preservation, which allows for easy integration of new fragments. Photo: S. Chlouveraki

The presentation is adaptable. The mounting method used permits the addition and integration of new fragments as soon as their original location in the mosaic is found. The process of piecing together a mosaic puzzle by matching its fragments is slow but rewarding and quite promising (fig. 4).

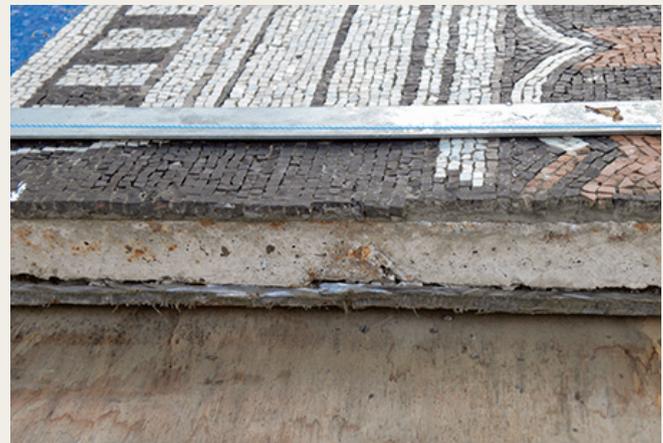
Figure 1 Cross section of the panel. Copyright © Lithou Sintirissis Inc.

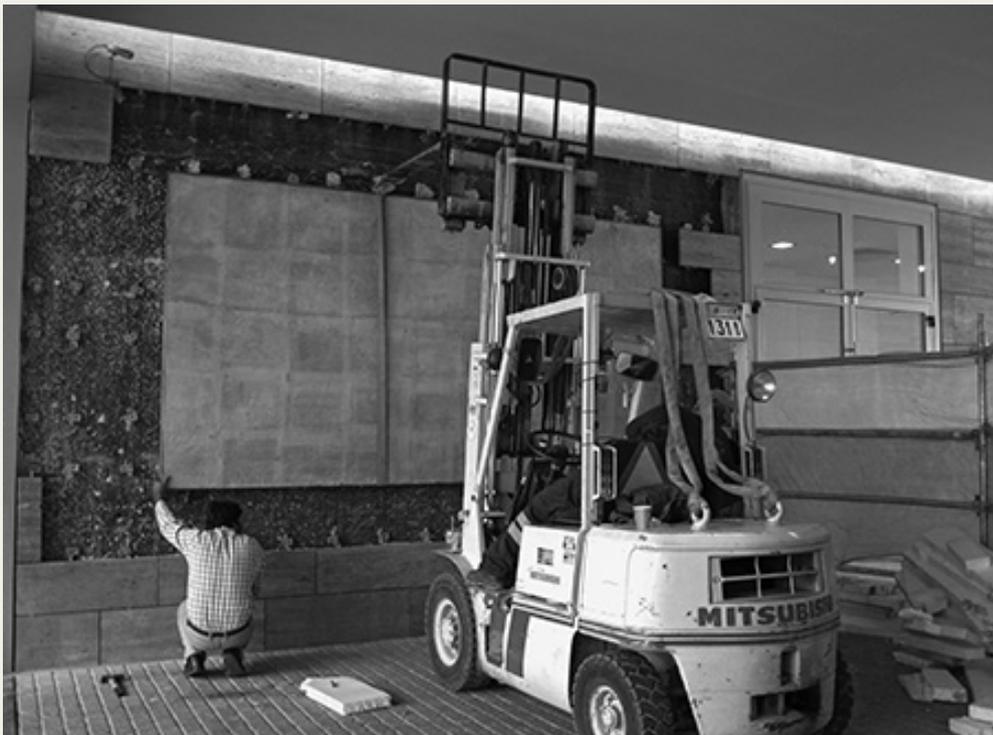
Figure 4 Mounting of the panel. Copyright © Lithou Sintirissis Inc.

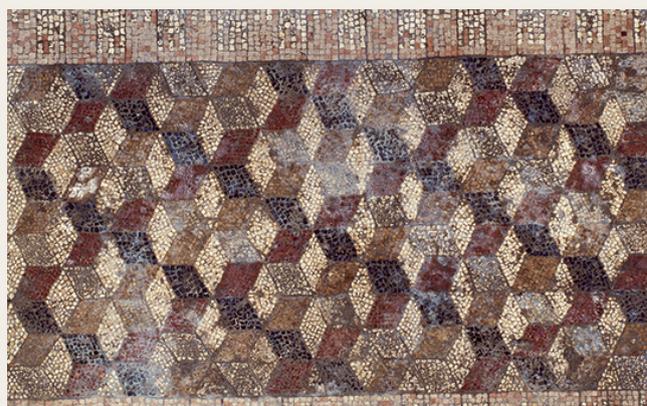
Figure 1 Thmouis, mosaïque aux cubes, avant restauration. Photo : A.-M. Guimier-Sorbets

Ce panneau d'*opus tessellatum*, bordé d'une file de tours crénelées, est orné d'une composition triaxiale de losanges (fig. 1) ; la disposition des cinq couleurs des losanges forme à la fois une composition de cubes en perspective et un quadrillage oblique ; la restitution du motif illusionniste avait fait l'objet d'études préalables (Daszewski 1985) avec une première restitution des couleurs (Guimier-Sorbets 2004, 2007). Les contours des losanges et des tours crénelées sont cernés de lames de plomb ; les losanges blancs, noirs, jaunes et rouges sont en tesselles de pierre. L'examen préalable aux travaux de restauration a permis de voir que de la peinture recouvrait tous les losanges et que cette peinture se trouvait aussi bien sur les joints du mortier interstitiel que sur la surface des tesselles. À la suite de restaurations anciennes non documentées, il est difficile de déterminer si les tesselles des losanges bleus sont en pierre blanchâtre et/ou en faïence, et si

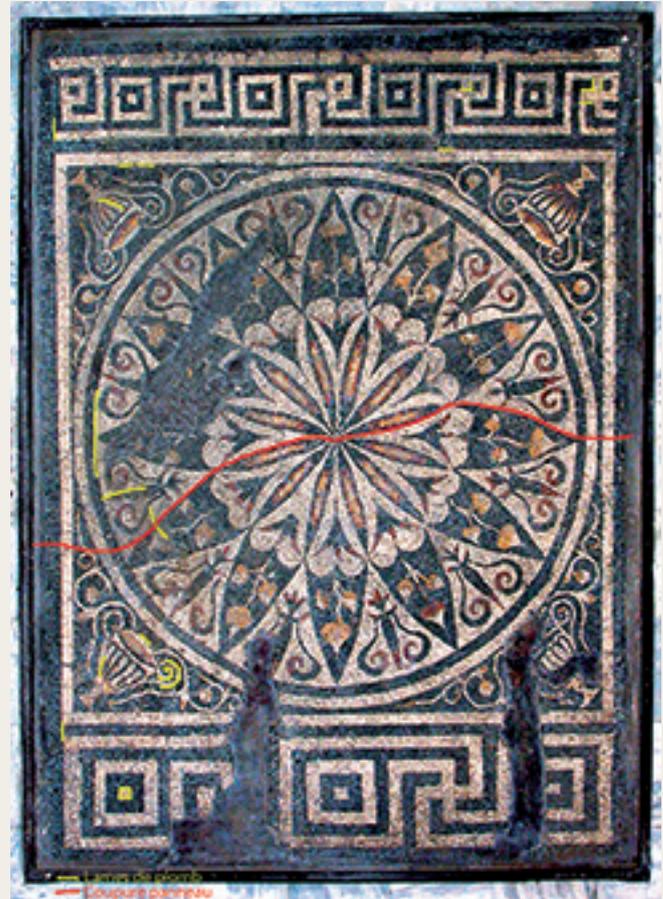
Figure 3 Alexandrie, mosaïque au fleuron avant restauration, avec limites de découpe en rouge et emplacement des lames de plomb en jaune. Photo : A. M. Guimier-Sorbets

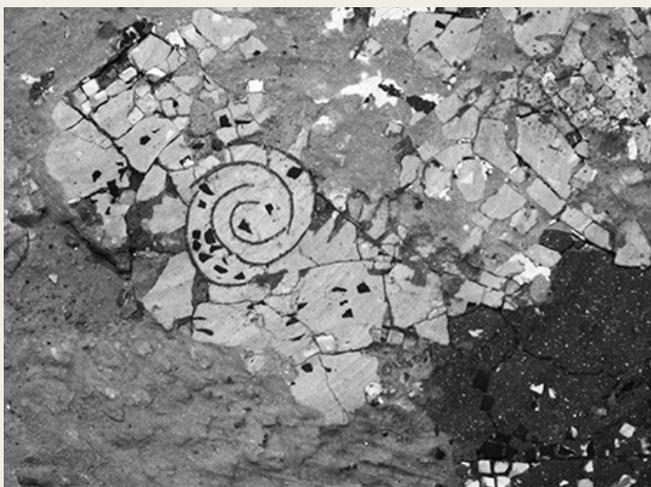
Figure 4 Alexandrie, mosaïque au fleuron, en cours de restauration, détail du revers avec lame de plomb. Photo: H. Tewfick

Le nettoyage du pavement a permis d'observer la présence de lames de plomb dans certains endroits du panneau (en jaune sur la photographie); la dépose de l'ancien support a mis en évidence les interventions successives des restaurateurs, utilisant divers types de ciment et de plâtre (fig. 4). L'examen des lames de plomb, uniquement placées dans des zones refaites, et sans aucune altération, montre qu'elles ne sont pas antiques mais dues à l'une des restaurations modernes, sans que nous

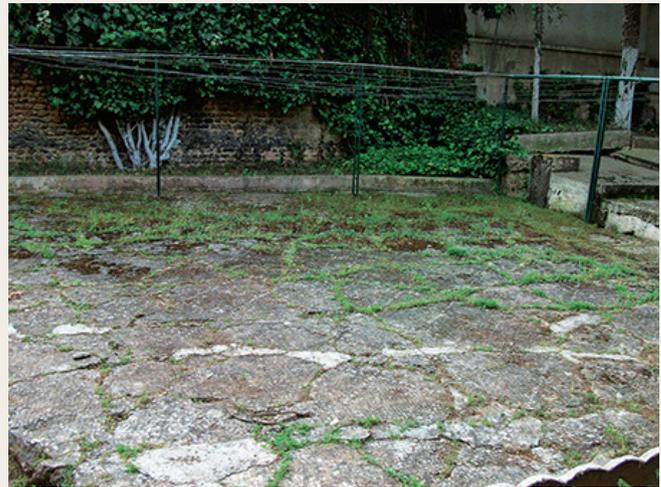
Figure 1 Le pavement avant restauration. Photo: M. C. Hamza

C'est le chercheur A. Ravoisié qui signala le premier ce monument, fouillé ensuite par V. Waile en 1893. Les dimensions de l'édifice sont de l'ordre de 60 m de longueur est-ouest et 40 m de largeur nord-sud pour une superficie d'environ 2 400 m². La mosaïque se trouve dans une salle au nord du bâtiment, et ses dimensions (irrégulières) sont de 6,2 m (côté nord) × 6,5 m (côté est) × 8,8 m (côté sud) × 7,37 m (côté ouest). Son décor tricolore est en tesselles blanches (calcaire), rouges (brique) et noires (schiste). Il s'agit d'un quadrillage oblique de filets triples dentelés bichromes ; les bordures sont des bandes rouges, blanches et noires (fig. 1).

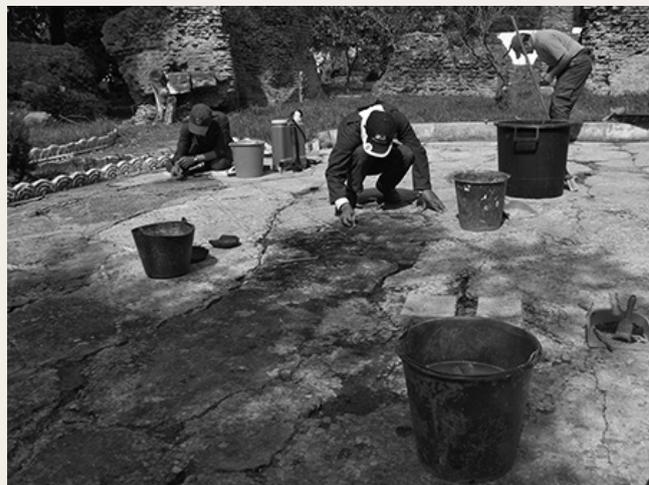
Figure 2 Nettoyage de surface. Photo: M. C. Hamza

Notre méthodologie s'adapte au constat fait sur le terrain et se résume en deux phases d'intervention. Première phase: le nettoyage mécanique de la surface (fissures et lacunes) (fig. 2); l'élimination des dépôts (terre et ciment); le démantèlement de la structure métallique. Seconde phase: le comblement des lacunes et des fissures avec un mortier hydraulique (chaux éteinte + sable de rivière + brique pilée) (fig. 3); la pose de solins; l'abattage des arbustes avoisinants et le renforcement des bords de la mosaïque.

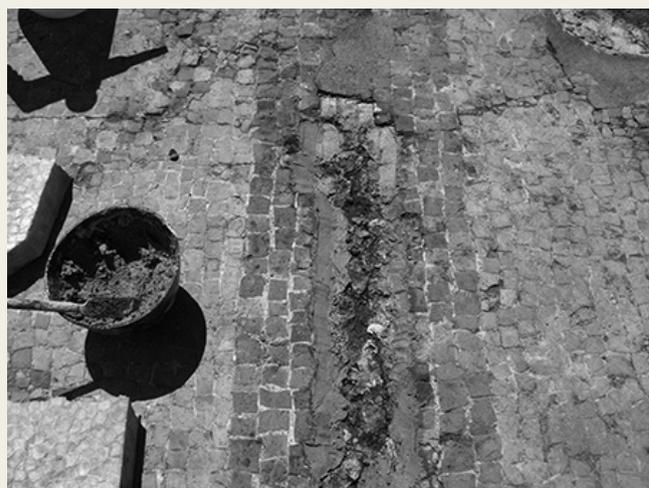
Figure 3 Comblement des lacunes dans une des bordures et pose de solin dans une lacune. Photo: M. C. Hamza

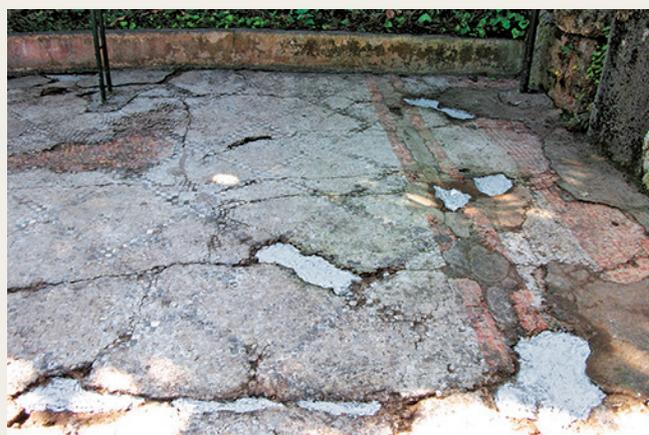
Figure 4 Le tapis de mosaïque après l'intervention de dérestauration et de restauration. Photo: M. C. Hamza

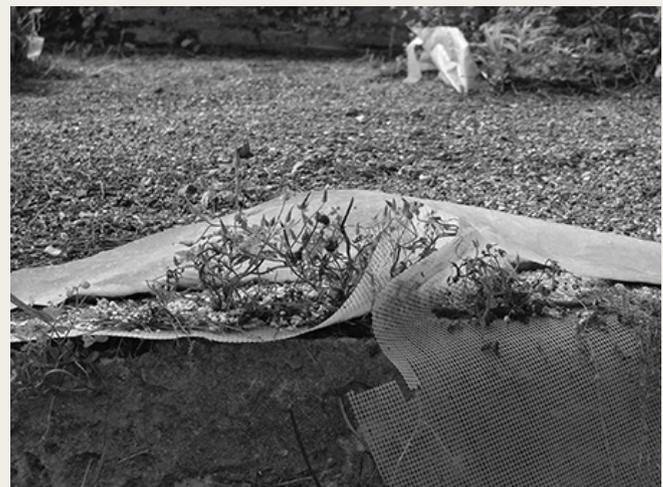
Figure 1 Vegetation growth on the edge of a covered mosaic in the Kladeos Bath complex. © Hellenic Ministry of Culture and Sports

When uncovering the Kladeos Bath mosaics, which lay in the most humid area of the site, a very thin weed root net was discovered on the central mosaics, spread over several parts of the surface, especially along the edges (fig. 1). It was not penetrating the mortar layers and was removed easily. Larger plants were scarce. The reburial stratigraphy here was different, maybe due to a shortage of materials at some point. The upper layer of net was replaced instead with a thick plastic sheet. After careful removal of soil and roots from the surface, the mosaic revealed minor problems, such as some loose tesserae, which were stabilized with mortar (fig. 2). The uncovering of the Kronios Bath mosaics revealed good overall condition, with the surface almost completely intact (fig. 3).

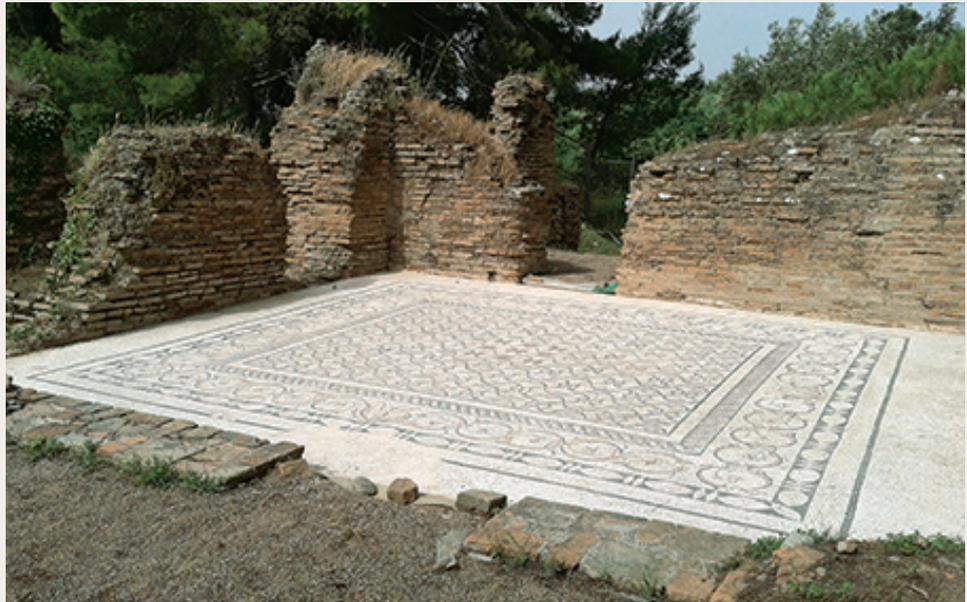
Figure 3 The uncovering of the mosaic of the Kronios Bath complex. © Hellenic Ministry of Culture and Sports

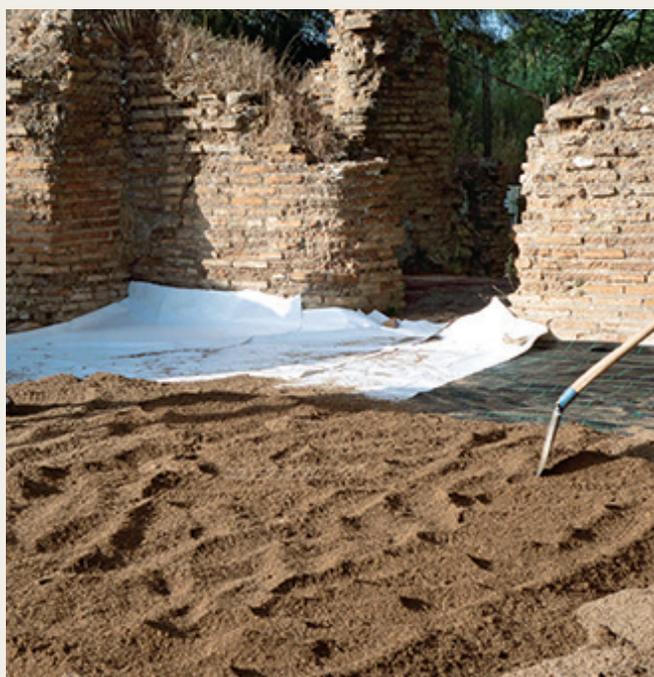
Figure 4 Application of the new reburial materials on the central mosaic of the Kladeos Bath complex. © Hellenic Ministry of Culture and Sports
