Proceedings of the 12th Conference of the
International Committee for the Conservation
of Mosaics, Sardinia, October 27–31, 2014

The Conservation and Presentation of Mosaics: At What Cost?

*Proceedings of the 12th ICCM Conference
Sardinia, October 27-31, 2014*

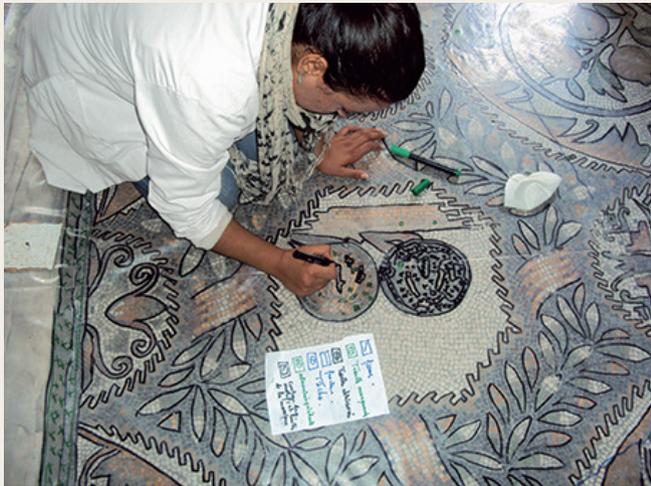
Figure 2 Documentation graphique. Mosaïque du *triclinium* de la maison de la Volière à la Municipalité de Tunis.

Après une mission d'expertise, de diagnostic, de documentation (fig. 2) et de recherche bibliographique menée par l'équipe technique de la conservation-restauration de la mosaïque du Musée national du Bardo, la décision a été prise pour sa récupération et non pas seulement sa restauration *in situ*. La direction générale de l'Institut national du patrimoine a obtenu l'accord de la Municipalité de Tunis pour l'accomplissement de ce projet. La

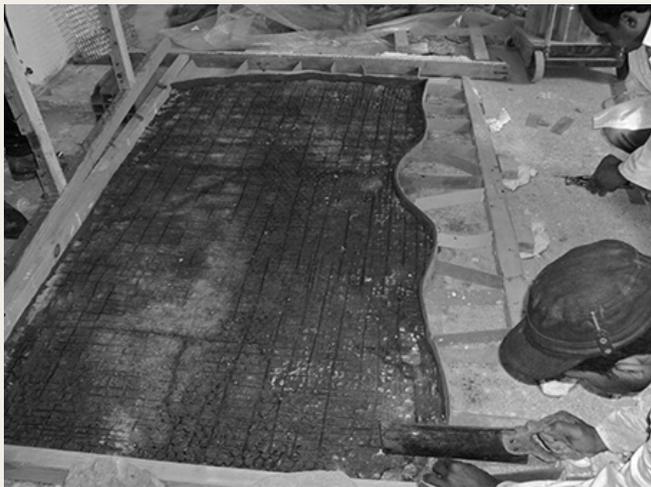
Figure 3 Changement du support.

nouvelle salle d'interprétation de la maison de la Volière (lieu de sa découverte) à Carthage fut choisie pour abriter la mosaïque (figs. 3, 4).

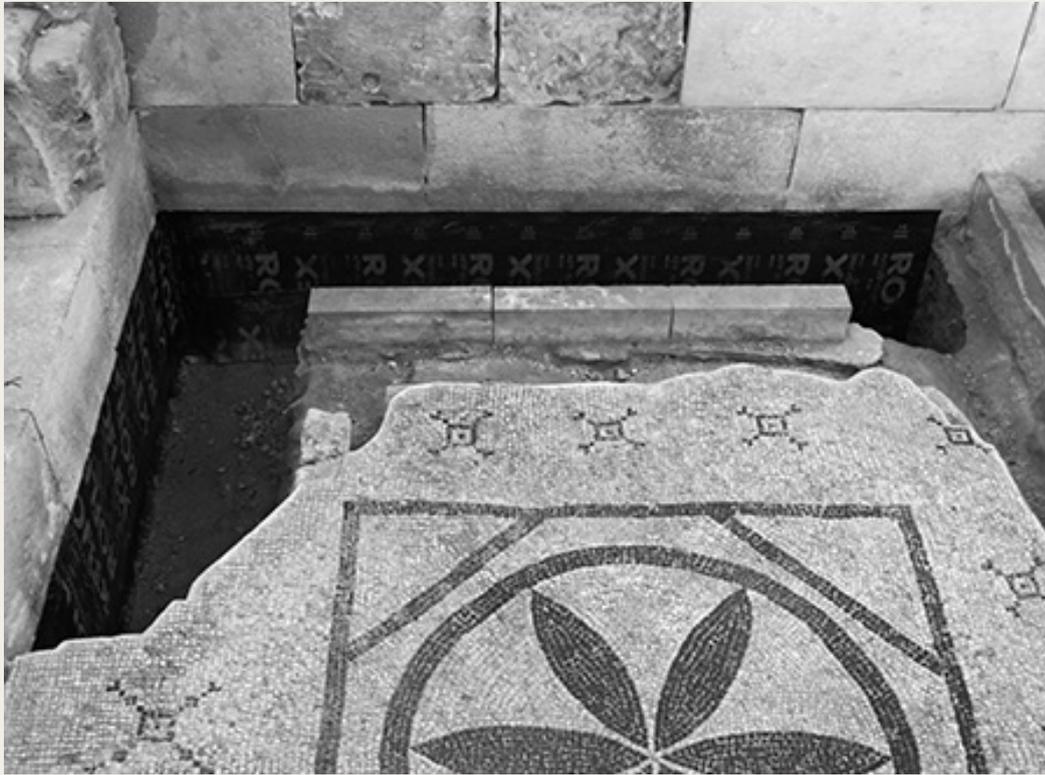
Figure 1 New installation of deep trenches around mosaic edges.

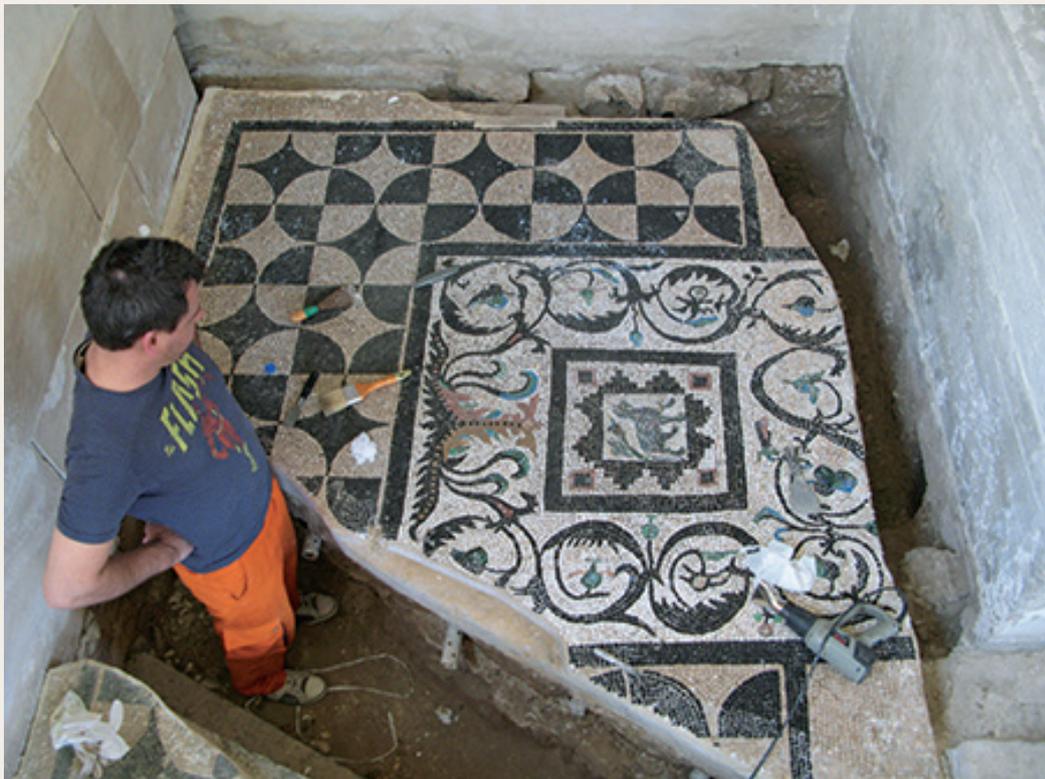
Figure 2 New drainage system with pierced tubes inserted into the bedding layer. Photo: E. Parandowska

In 2012, an innovative drainage system around one of the mosaics was implemented, and has so far proved to be sufficient. The following year, the same system was implemented around the foundations of two other mosaics. A deep trench, up to about 1 m deep, was dug around the mosaic's edges, and a new layer of bitumen coating was applied on the foundations of the surrounding walls. The trenches were left open and covered with metal grills hidden under a layer of washed and sifted gravel. Additional drainage was provided in narrow trenches where pierced, 8 to 15 m-wide PCV pipes were placed and buried under gravel (figs. 1–4).

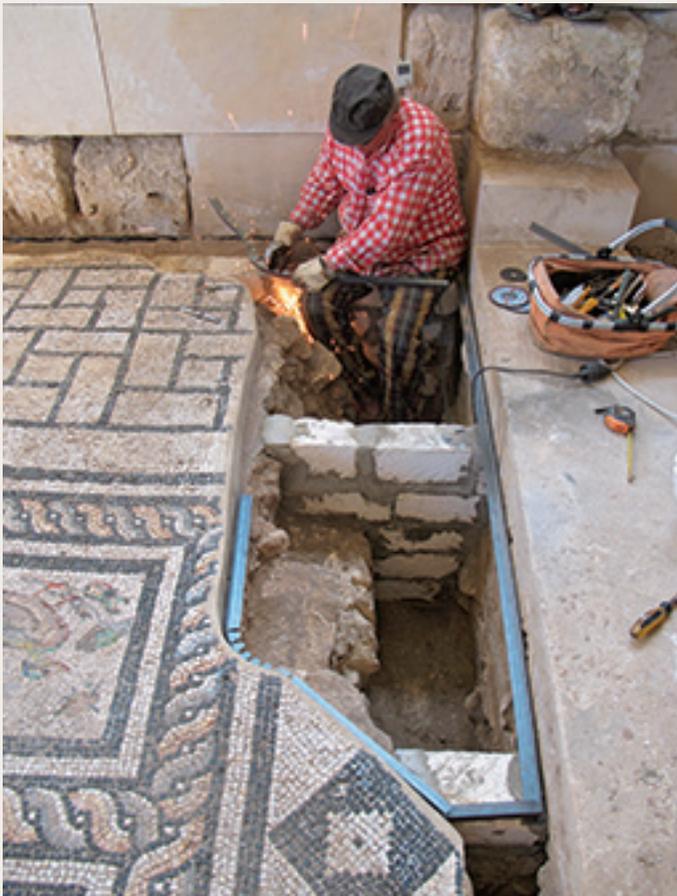
Figure 3 Placement of metal grills over the trenches around mosaic edges.
Photo: E. Parandowska

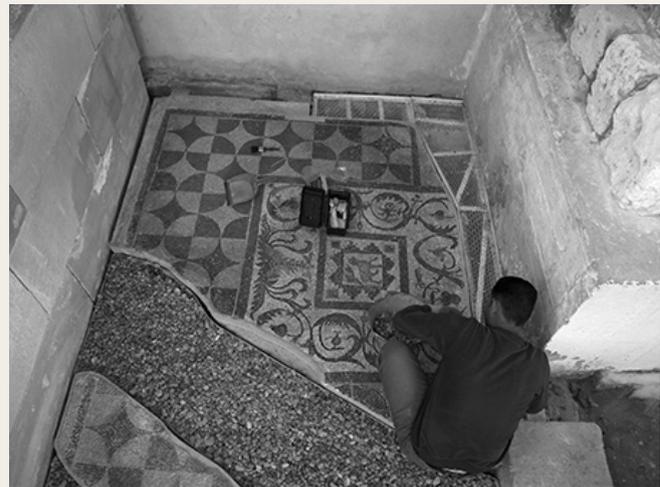
Figure 4 Grills hidden under a layer of gravel. Photo: E. Parandowska

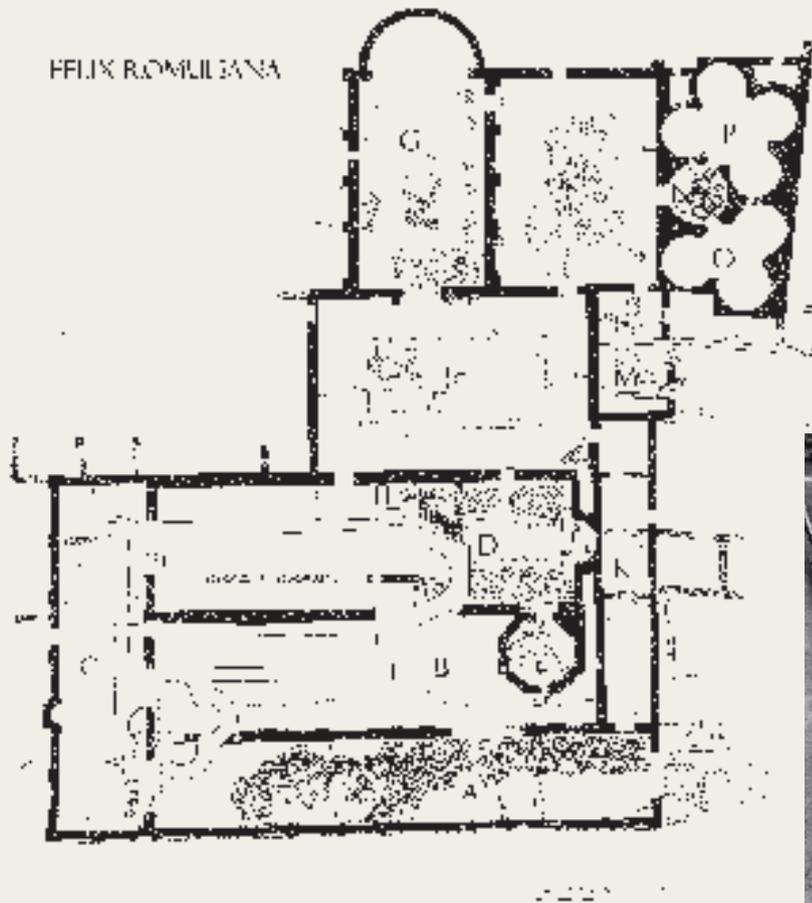
Figure 1 Layout of the Galerius Palace. Drawing: Marijana Protić

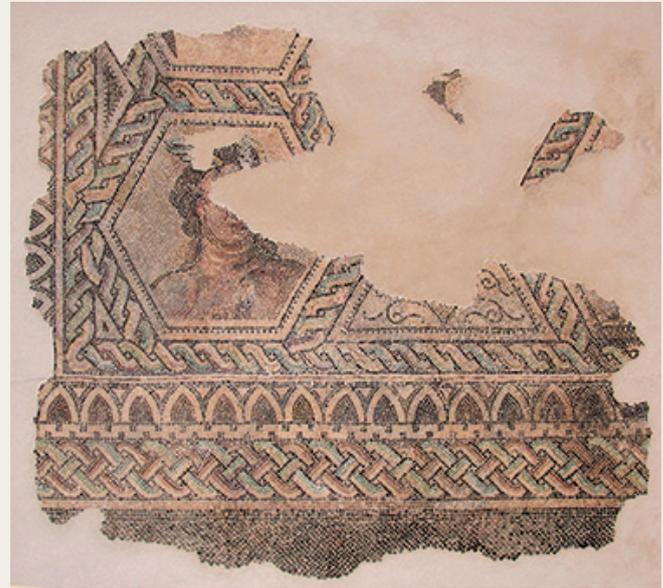
Figure 1 Mosaic depicting the god Mercury. Photo: Marijana Protić

The only figurative mosaic found at the archaeological site of the imperial palace, Sirmium Sremska Mitrovica, is a mosaic with the image of the god Mercury (fig. 1). It was discovered during archaeological surveys in the 1970s. The mosaic was discovered in an older layer of room 16, dating to the end of the third century, under a layer of the mosaic floor decorated with geometric motifs dating to the beginning of the fourth century. During excavations in the 1970s, both mosaics were lifted from the original site. It was decided that the older, figurative mosaics would be preserved for display under museum conditions and the newer mosaic, more than 70 percent preserved, would be put back in its original place and displayed in situ.

The mosaic with the image of Mercury was conserved with the now-classic method of placing it on an aluminum honeycomb backing using lime mortar and epoxy resins. The figure of the god and most of the braid forming the frame and hexagonal fields, which most likely contained figural scenes, were made using glass tesserae, which greatly complicated the conservation process. Glass tesserae were treated from the back with a mild solution of paraloid in acetone, while the face of the surface was treated with nano-lime. Since the fragments of the mosaics represented two diagonally positioned corners of the room, it was necessary to find a way to present them so that they would be comprehensible

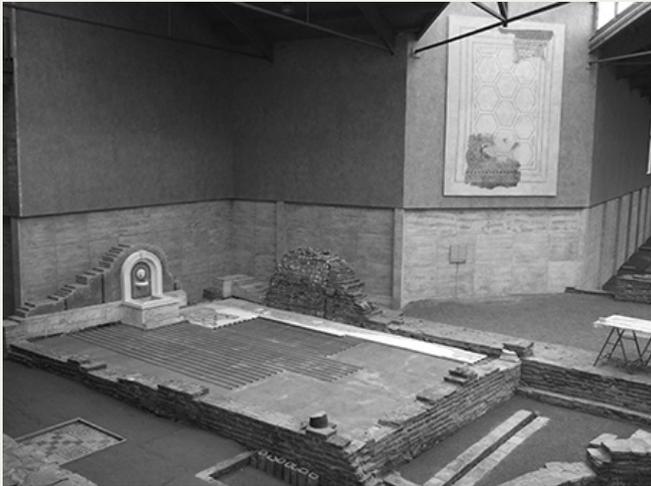
Figure 3 Presentation of the mosaic on the wall above room 16. Photo: Marijana Protić

to visitors. It also should be mentioned that fragments of the mosaics significantly differ from one another, even though they belong to the same period and were discovered in same room. The fragment depicting Mercury is meticulously executed, with very fine tesserae, rich in color and mainly made of glass, while the fragment opposite him is rough (fig. 2), made exclusively of natural stone and tesserae of twice the size, humble in color, but very accurate in drawing so it fits perfectly into a whole picture of reconstruction. It was decided to present the mosaic on the wall above room 16 (fig. 3) where it was found, placing fragments in their proper positions, and to reconstruct the rest of the room around them. The reconstruction was performed on panels with polyurethane foam, on which was applied a layer of lime mortar, identical to the one used on the original fragments. Then the drawing of the basic shape of the mosaic was reconstructed, using pigments and lime binder (fig. 4). In this way, visitors are given the opportunity to look at the whole mosaic and understand its position in room 16, as well as its position in the Imperial Palace.

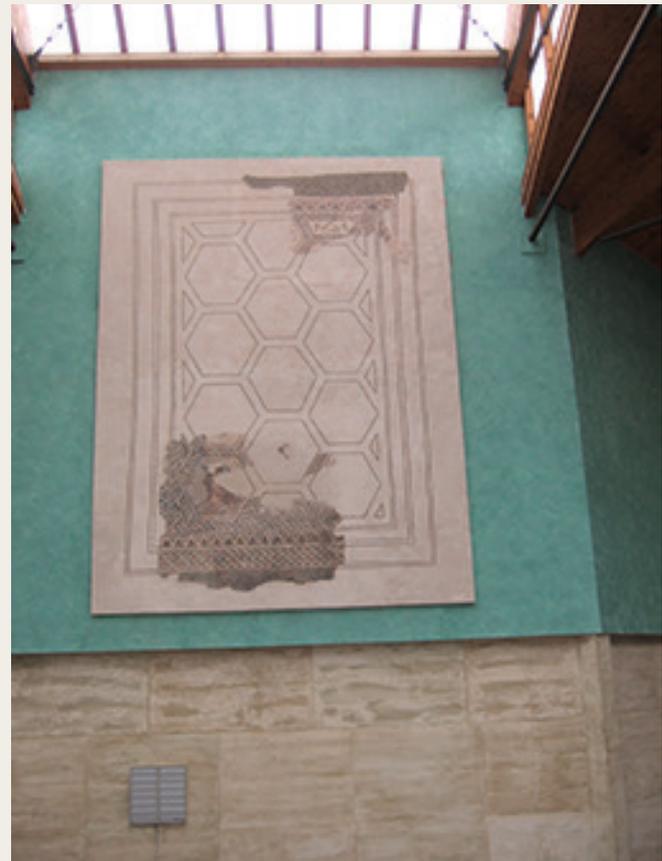
Figure 4 Reconstruction of the mosaic from the older layer with two fragments incorporated. Photo: Marijana Protić

The mosaic from the more recent layer was detached, and the fragments were placed on a thin support of aluminum honeycomb using lime mortar and polymer. The cracked and uneven concrete floor from the previous conservation, on which the mosaic had been laid, was replaced by a new, solid and even stratigraphy. In order to avoid direct contact of the fragments with concrete, aluminum box profiled bars 5 cm high were laid under the mosaic, which permits air flow. Fragments were then returned to their original place, and missing parts were partially reconstructed using a polymer mortar, which was later colored with watercolors.

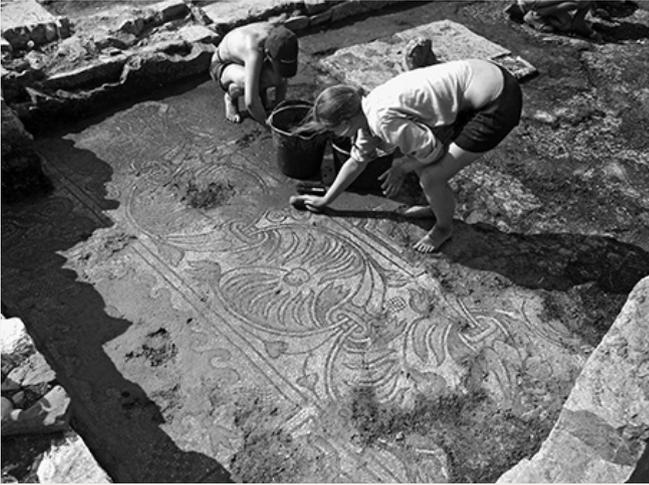
Figure 1 The Vrina Plain basilica mosaic during cleaning. Photo: Butrint Foundation

A major campaign of mosaic conservation began in 2006. Remedial action was to follow on the mosaics where required. In addition, an operation has been undertaken on the mosaics from the 2004–2005 excavations on the Vrina Plain (fig. 1) and Diaporit. Basic stabilization and conservation was carried out on the mosaics in the Early Christian basilica and Roman townhouses. Fifty percent of the basilica nave mosaic's surface was damaged by postholes, graves, and the like; elsewhere the pavement was disrupted by unstable foundations coupled with fluctuating groundwater levels, which had resulted in slumping, cracking, and detachment of tesserae. After the conservation work, because of these problems, it was decided that the mosaic should remain covered.

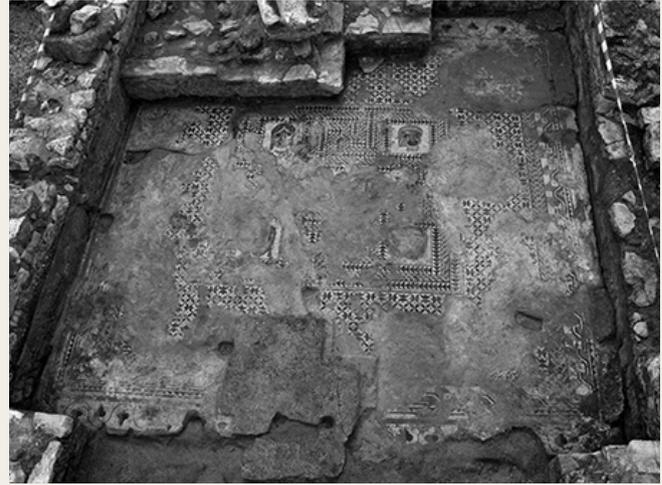
Figure 2 Room 18, east vestibule, mosaic with female and male masks after conservation (Triconch *Domus*). Photo: Agron Islami Institute of Monuments and Butrint Foundation

Archaeological excavations at the Triconch Palace revealed a number of mosaics in the late Roman residence. In 2007 four mosaic pavements were uncovered, cleaned, and documented. An exciting discovery was made in the eastern vestibule of the long southern gallery and the main third- to -fourth-century entrance to the property. Under a later mortar floor were striking, finely executed images of Greco-Roman theatrical masks (fig. 2) (Mitchell 2011). These are buried below netting and sand but remain under threat from the seasonal flooding to which all parts of the Triconch Palace are prone. Further pavements were conserved in 2010 in the western peristyle portico, an adjoining, colonnaded entrance vestibule room, the apsidal triclinium room (or reception hall) (fig. 3), and the vestibule and gallery.

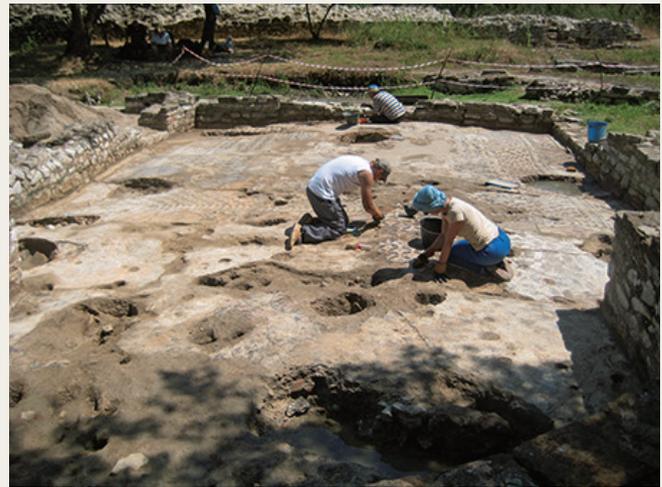
Figure 3 Room 24, reception hall, mosaic during conservation (Triconch *Domus*). Photo: E. Thomagjini, Butrint National Park

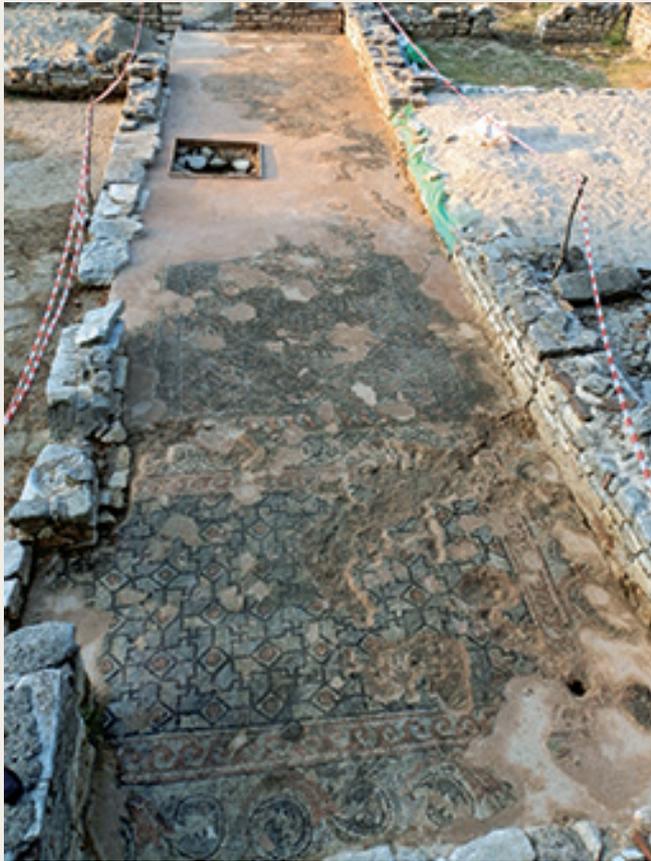
Figure 4 Room 16, west portico of peristyle, after conservation (Triconch *Domus*). Photo: Agron Islami Institute of Monuments and Butrint Foundation

Most of the mosaics are now buried under a sufficient depth of sand to help prevent roots from penetrating (fig. 4), though

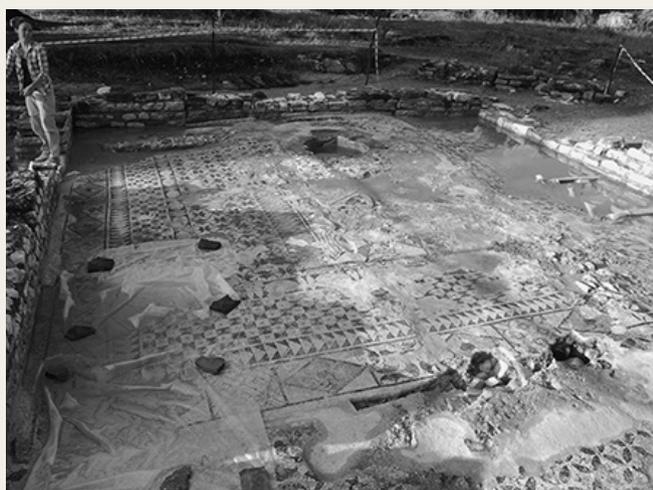
Figure 2 Butrint: view of a mosaic showing pooling water after a strong thunderstorm. Copyright © Corpus Albania—Mishko Tutkovski

No efficient means of draining the water seems available, and rainwater pools on the surfaces of the mosaics (fig. 2). Moreover, drainage is difficult to plan because of the omnipresent ruins, and regular seasonal flooding occurs (fig. 3).

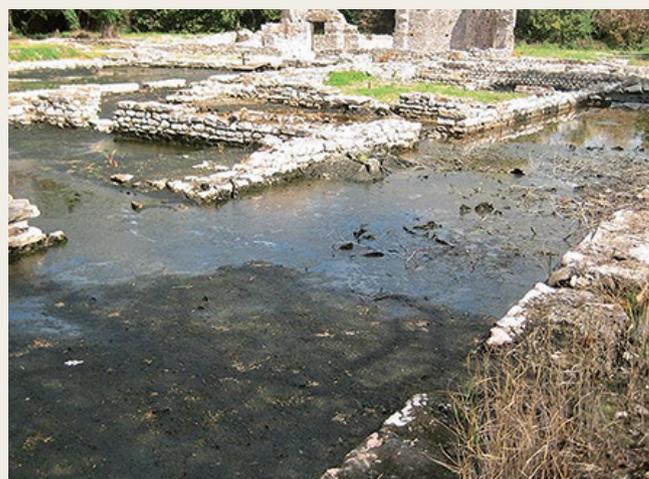
Figure 3 Butrint: view of the Triconch complex in spring showing deep standing water. Copyright © Corpus Albania—Evjeni Thomagjini

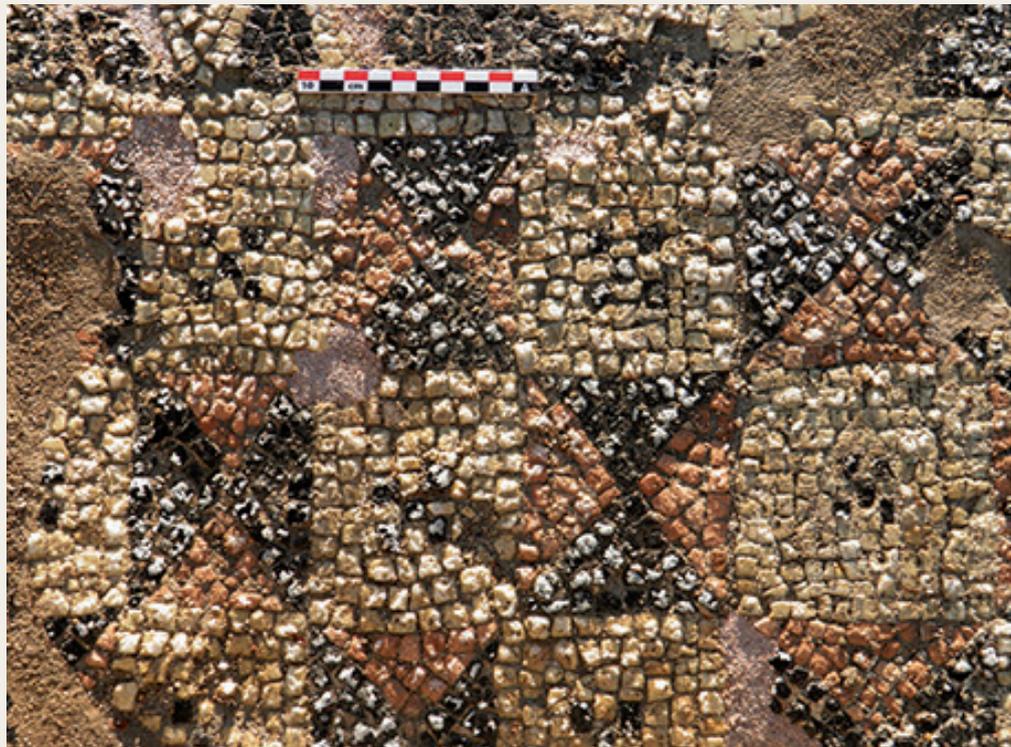
Figure 4 Butrint: salt crystallization on an opus tessellatum. Copyright © Corpus Albania—Astrid Maréchaux

Various biological sediments and calcite deposits, which have a significant impact considering the environmental humidity, were both mechanically and chemically removed. Ion exchange resins such as Amberlite were used for surface cleaning tests, to remove salt incrustations.

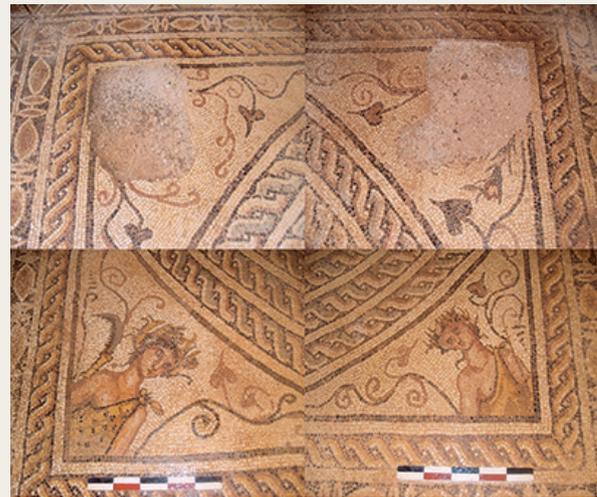
Figure 1 The corners of the Four Seasons mosaic, with two pieces missing, Cyrene, Libya. Photo: Courtesy of the Department of Antiquities, Libya

In 2011, given the lack of security for the site, the entrance gate to the structure was broken and two of the Four Seasons figures were stolen (fig. 1). The roof, damaged over time and never repaired, does not provide protection against rainwater. The external system for collection and runoff of rainwater has collapsed, and water infiltrates at the base of walls. In the mosaic itself, there are large detachments from the original support and tesserae are loose. In addition to the lacunae of the stolen parts, tesserae along the borders continue to detach because of vegetation growth; erosion of the tesserae and insoluble deposits are occurring, and discoloration on the surface is also present.

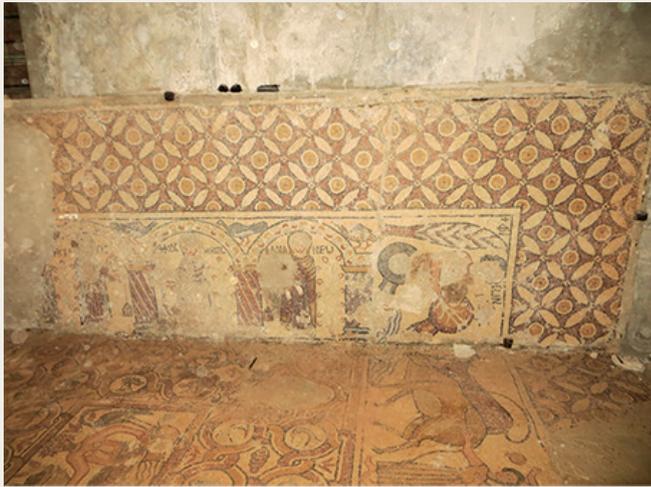
Figure 2 The south church mosaic in storage, Tukrah, Libya. Photo: Courtesy of the Department of Antiquities, Libya

After its discovery the mosaic was detached, mounted on reinforced concrete panels, and transported to a building next to the sea, which was built in the 1930s for storage. The mosaic is mounted on two large panels; one panel sits on the floor and the other is on the wall (fig. 2). Underneath the Byzantine mosaic an older mosaic was discovered, but this was left *in situ* and backfilled.

The mosaic left *in situ* and backfilled is in very stable condition. On the contrary, the mosaic in the deposit is in disastrous condition. The building is collapsing due to extensive corrosion of the reinforced concrete structure because of the proximity to the sea and because of overall neglect. Consequently, water infiltrates the building, directly on the mosaic on the floor. Through fractures in the masonry, moisture enters into contact with the mosaic panel on the wall.

The mosaic panels suffer from corrosion, cracks, detachment of tesserae, and efflorescence of soluble salts, resulting in an almost 50 percent loss of tesserae.

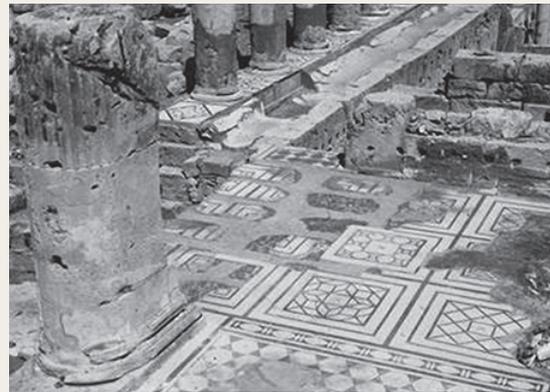
Figure 3 Palace of the Columns, Tulmaytha, Libya. The floor of the reception hall in 1949. Photo: Courtesy of the Department of Antiquities, Libya

The archaeological site of Tulmaytha is in northeastern Libya. Founded in the third century BCE, it grew in the Roman period, playing a strategic role until the seventh century CE. The Palace of the Columns, a rich house dating to the second–first century BCE, was discovered in the 1930s (fig. 3). Many rooms and corridors were originally decorated with geometric mosaics. After excavation most of them were detached and relaid *in situ* on reinforced concrete backings.

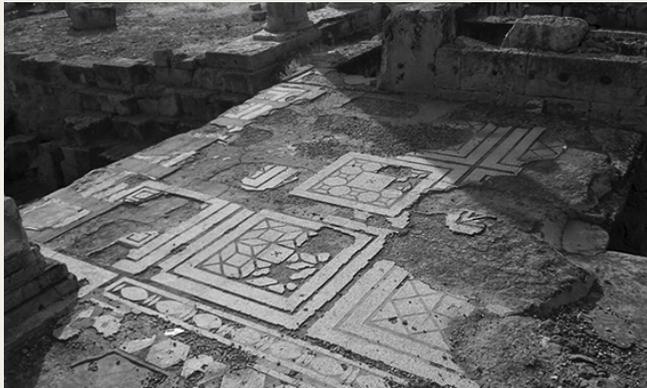
Figure 4 The same floor of the Palace of the Columns in 2014. Cement supports are still in place, but there is an almost complete loss of tesserae.

The mosaics suffer the problems of artifacts restored with reinforced concrete, exposed outdoors in a moist and salt-rich environment, without shelter and without regular care and maintenance plans. Due to the iron used in the cement support, entire portions of the surfaces are now destroyed. The expansion caused by the oxidation of the iron, along with continuous contraction and expansion caused by direct insolation of the surfaces, has resulted in extensive detachments and fractures and in the almost total loss of the tessellatum (fig. 4).

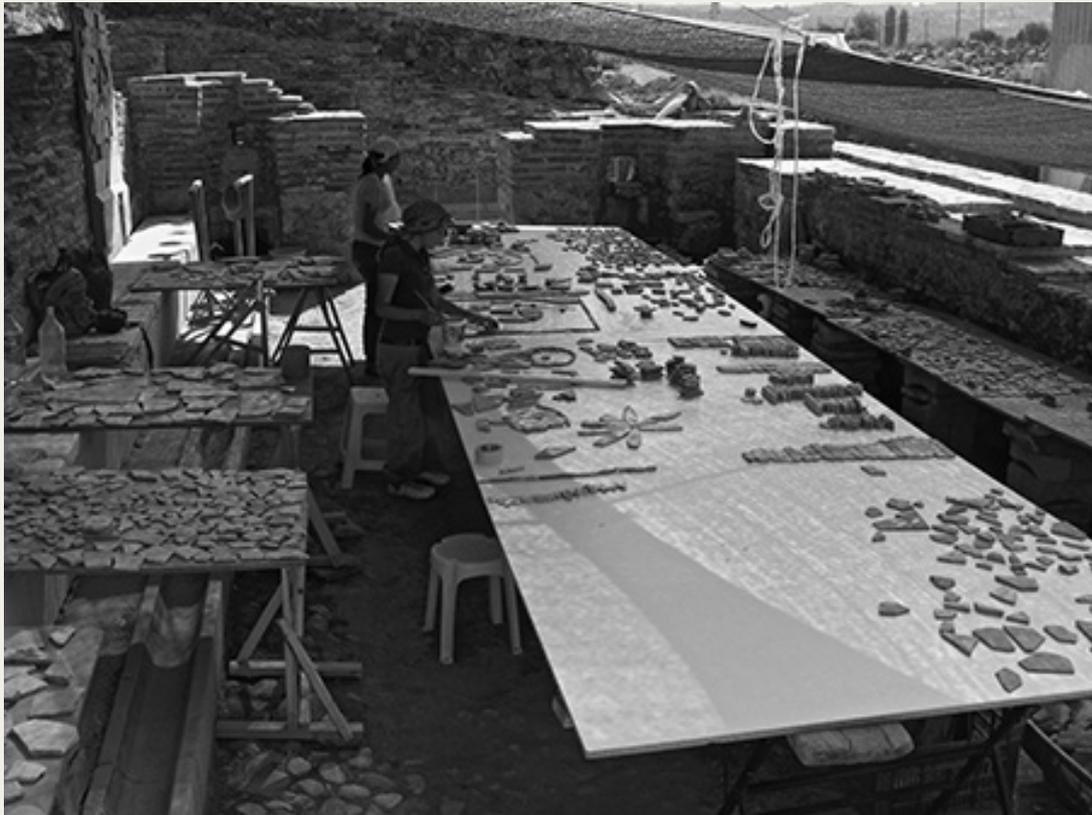
Figure 1 Piecing together the opus sectile, 2009–10.
Photo: Orhan Bingöl

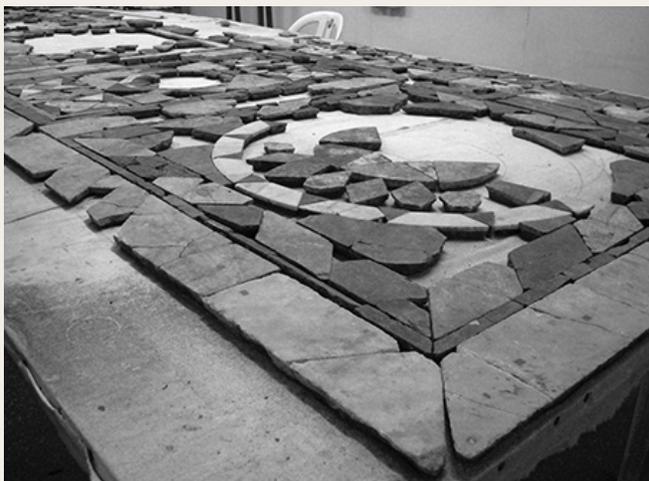
Figure 2 Attaching the panels to the new support, 2011. Photo: Orhan Bingöl

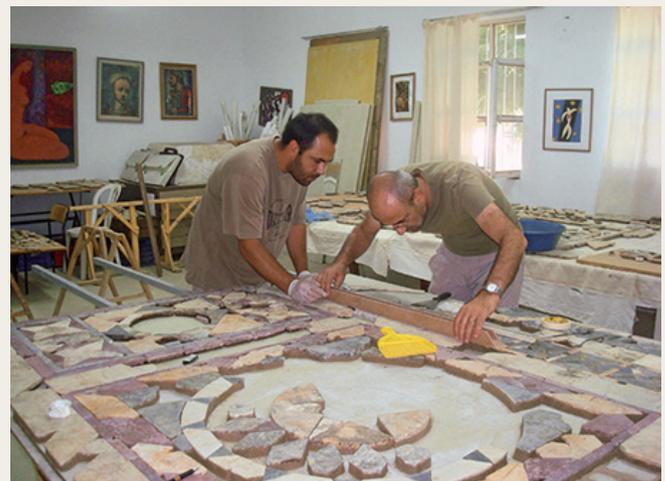
Figure 3 Leveling the panels and determining the composition, 2010.
Photo: Orhan Bingöl

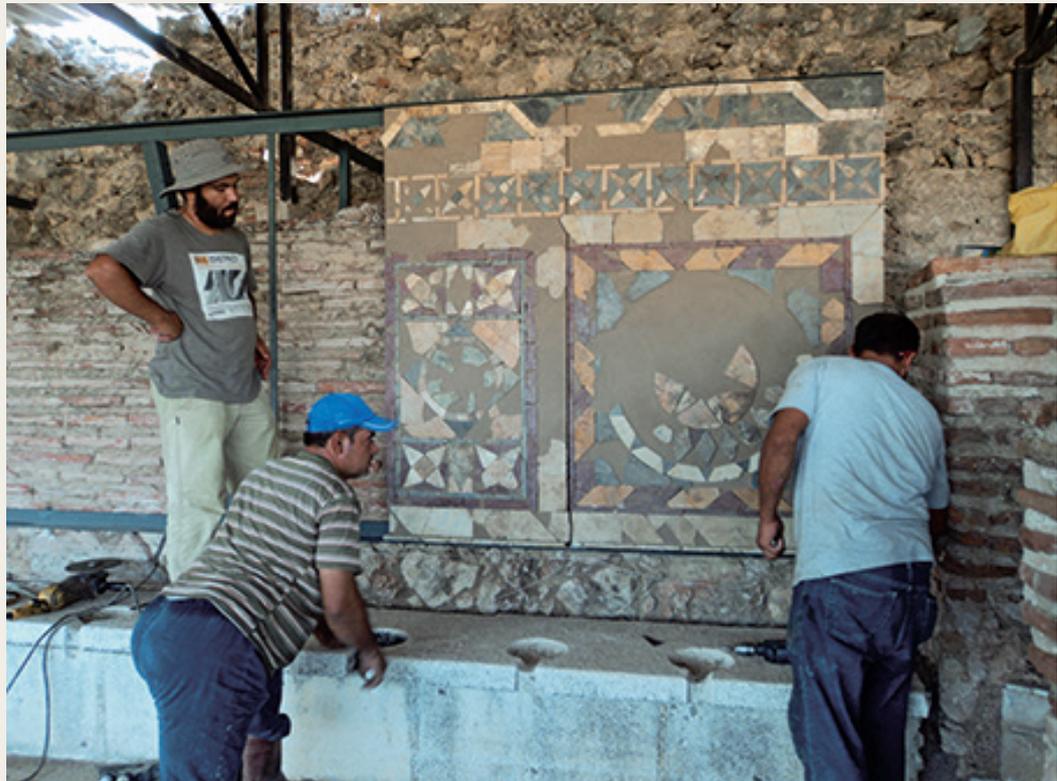
Figure 4 Mounting the opus sectile panels in place, 2012. Photo: Orhan Bingöl

Mounting the work was carried out in 2011. A total of seven panels (two 112×170 cm, two 72×170 cm, one 72×115 cm, and one 123×115 cm), the restoration of which was completed in 2011, were mounted on the north wall of the latrine building. Once the mounting of the panels was completed, the remaining thin gaps were filled with the mortar used to level the opus sectile panels. The final procedure was sifting sand onto the surface to even out the differences in appearance and achieve aesthetic unity.

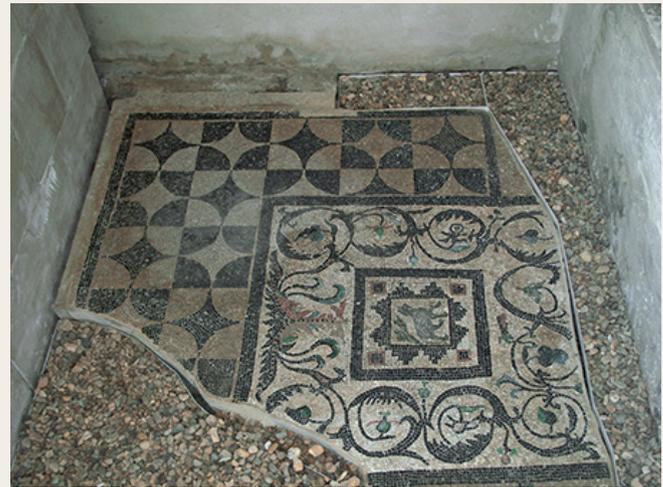
Figure 1 The panther mosaic, which consists of geometric decoration, branches of plants, and *emblema* with panther. Photo: Eman Shahawy

The floor is divided into two separate parts: the large part on the south side (2 × 2 m) consists of the whole of the frame and the *emblema*. The panel has an approximately square shape. At the edge is a pattern of circles in black and white, then branches of plants, then the complete *emblema* with a panther (fig. 1). The whole floor is 4 × 2.30 m, while the *emblema* is 1.20 × 1.20 m. The

outside part is executed in opus tessellatum, while the emblema is executed in opus vermiculatum. It has lost about 20 percent of its area. The emblema was executed with fine tesserae from colorful marble stones, including white, black, brown, and red; the turquoise color is made of glass faience, which is rare in the implementation of Roman mosaics but was common in Egypt. The lower edge of the emblema was restored in antiquity, so it is missing the original design, which seems to have been a hunting scene, of which a small goat beside the left foot of the panther remains.

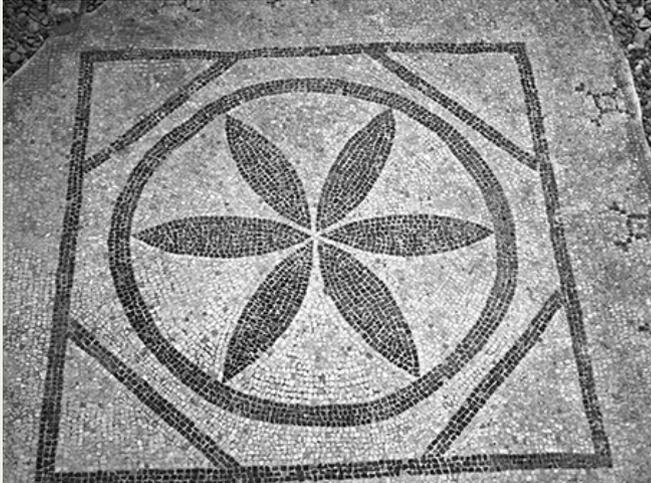
Figure 2 The rosette mosaic, which is black and white and decorated with a sixfoil rosette. Photo: Eman Shahawy

The entire rosette floor is 4×3.90 m (fig. 2). It has lost approximately 15 percent of its area. It is located in the northeast corner of the villa. The design is a circle in a square ($1:52$ m²). The corners of the square are cut off by triple black filets, turning the inside field into an octagon. It is decorated inside with a sixfoil rosette. The floor is executed in opus tessellatum in black and white. The outside edges are decorated with crosslets.

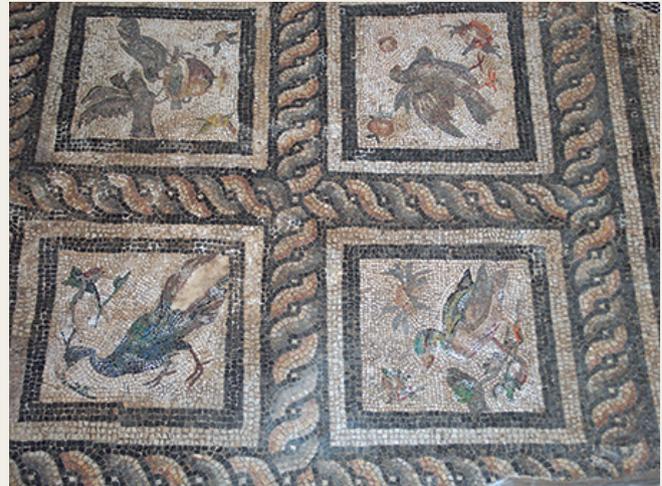
Figure 3 The birds mosaic, with a geometric pattern in black and white and seven squares with different birds. Photo: Eman Shahawy

The birds mosaic is composed of geometric decoration (3.10×95 cm) and squares with birds (2.26×2.26 m) (fig. 3). It has lost 30 percent of its surface: some of the geometric decoration and two squares with birds. Originally there were of nine squares, only seven of which have been found. In addition, parts of the geometric frame with rhombus decoration are missing. The tesserae in the geometric decoration appear regular (0.6–1.0 cm), as do the tiny glass and stone tesserae composing the figures (0.3–0.6 cm). The central panel is a square, decorated along the outside with nine small squares (each 45 cm). It is decorated on the inside with white and black bands (4 cm wide). The seven remaining squares depict different kinds of birds: a wild duck, a parrot, a waterbird, two pigeons drinking from a cup, a pigeon spreading its wings, and a peacock. There is a bird in each square, with two squares of decoration, and another square that depicts part of a bird. Each square is similar to the others in their outer decoration.

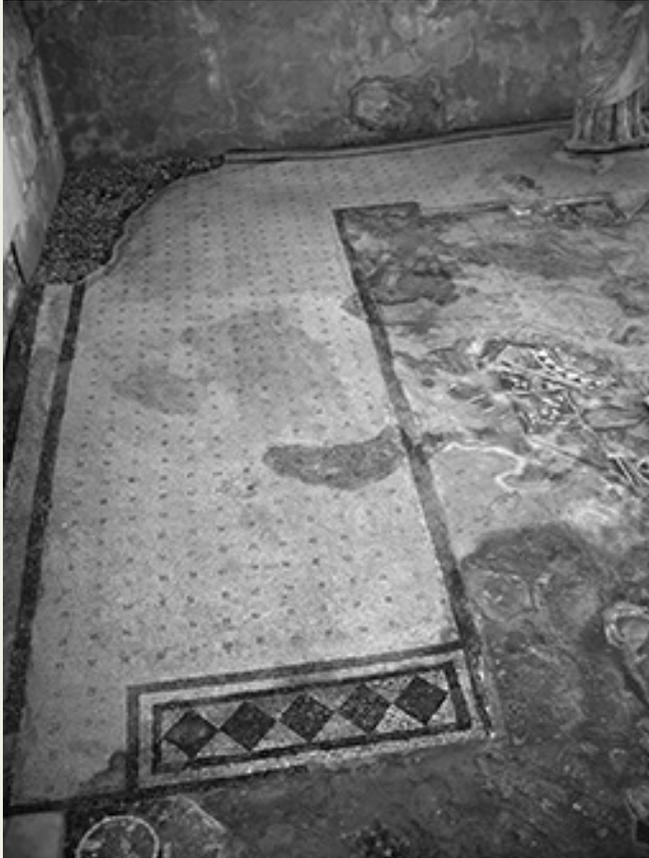
Figure 4 The dining room mosaic, executed in black-and-white opus tessellatum and opus sectile of different stones. Photo: Eman Shahawy

The dining room panel is large (7.50×6.20 m) and is executed in two styles, opus tessellatum and opus sectile (fig. 4). The slabs used for this floor represented a variety of contrasting materials: white and gray marble, green and red porphyry, and local limestone. Most of the slabs are lost; only some traces are still there, and they show it fixed on terracotta.

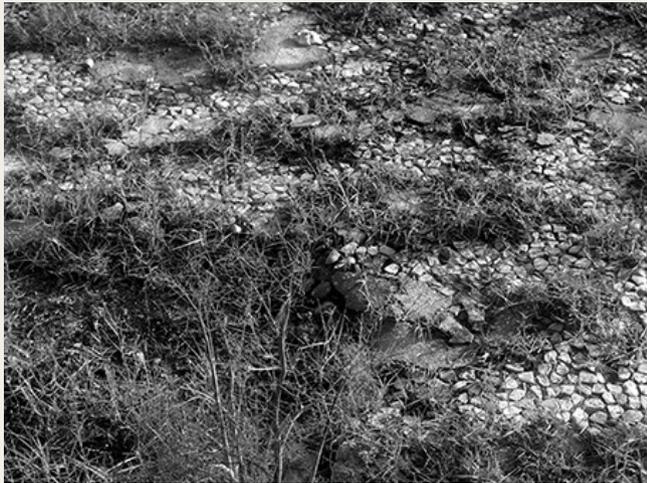
Figure 2 General view of the agrosti over the mosaic

The mosaic's overall condition was documented as general deterioration, loss of cohesion in all the substrates' interfaces, cracks, losses, vigorous growth of plants and root systems, extensive biological attack, and soluble and insoluble deposits (GCI and IAA 2003) (fig. 2).

Mosaic strata create the perfect ground for agrosti's roots' "crawling abilities." In soil, it may be possible to loosen the earth around the plant and carefully pull out the complete rhizome, but this is quite difficult to do in a mosaic without dislodging the tesserae (fig. 2).

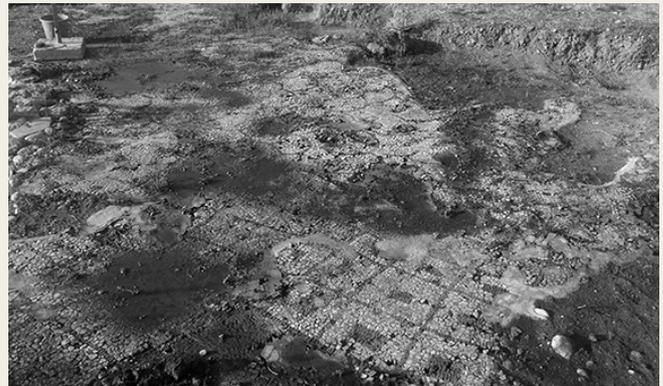
Figure 3 Condition of the mosaic before conservation. Author's personal archive

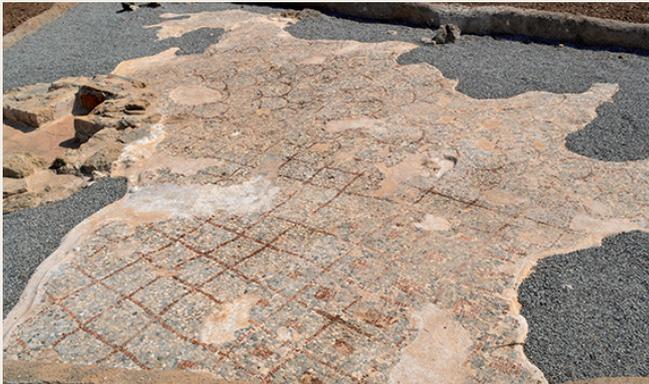
Figure 4 Condition of the mosaic six months after conservation.

The mosaic conditions, as well as the external climatic conditions in which the construction will remain exposed and its archaeological significance—which dictates minimum intervention and reversibility principles—all favored the in situ overall conservation approach that required less time, effort, and financial resources (fig. 4).

The state of the mosaic six months after the conservation procedures is shown in figure 4. It seems that the use of the product, employing the methods discussed above, has been effective in preventing growth of flora within the mosaic structure. The maximum period of time that the mosaic retains its resistance to agrosti and other weeds remains to be established.

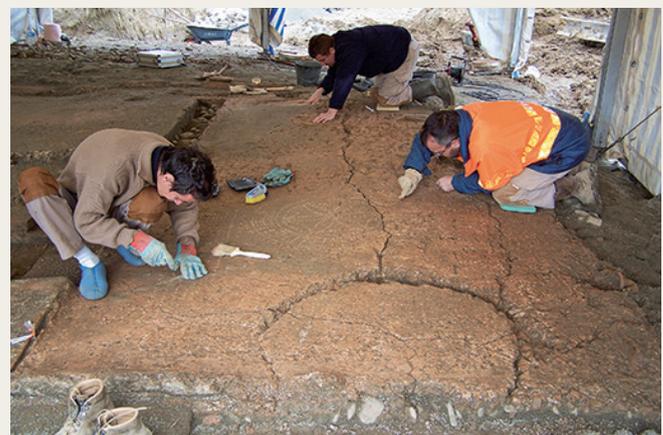
Figure 1 Nettoyage de la surface du pavement. © Inrap. F. Veyssière

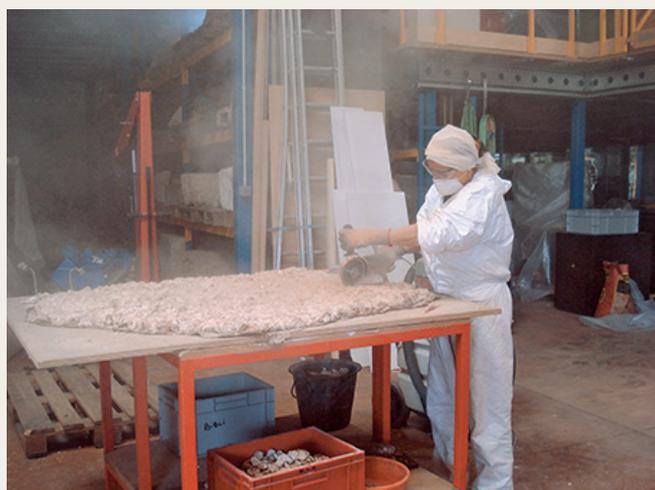
Figure 2 Allégement du mortier au revers, avant restauration. © Inrap. F. Veysière

Le travail de désépaississement du revers est une opération longue et délicate, car il y a des risques de fissures profondes. Le mortier antique a été allégé au revers des panneaux à l'aide du burin ou de la disqueuse (fig. 2).

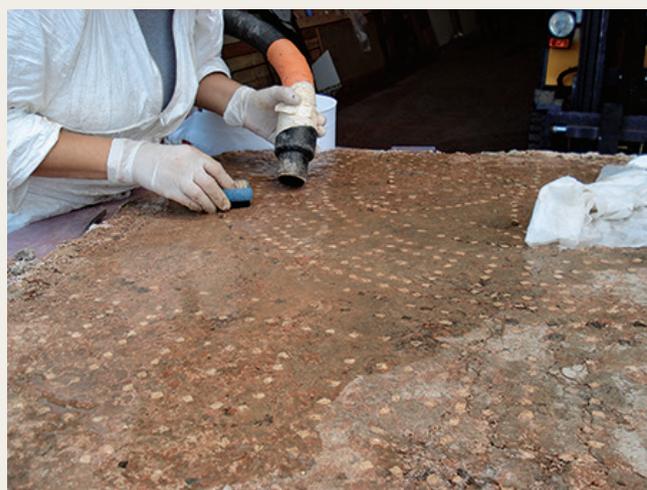
Figure 3 La surface est épurée de tous les résidu de colle et de concrétions. © Inrap. F. Veysière

Les panneaux ont été retournés, et la toile de jute et la gaze ont été retirées à l'aide d'éthanol. Le nettoyage de la surface est aussi une étape sensible ; du fait de sa porosité, nous l'avons appréhendée comme une peinture murale. La surface a été épurée de tous les résidus de colle et de concrétions (fig. 3). Les fissures et les lacunes les plus gênantes pour la lecture du motif ont été rebouchées avec un enduit à base de chaux, de poudre de tuileau et de poudre de marbre. En toute dernière intervention, une couche de cire microcristalline est posée au pinceau. Il n'a pas été nécessaire de faire un enduit de présentation autour, puisque le pavement a été intégré dans un sol plastique imprimé du reste du décor.

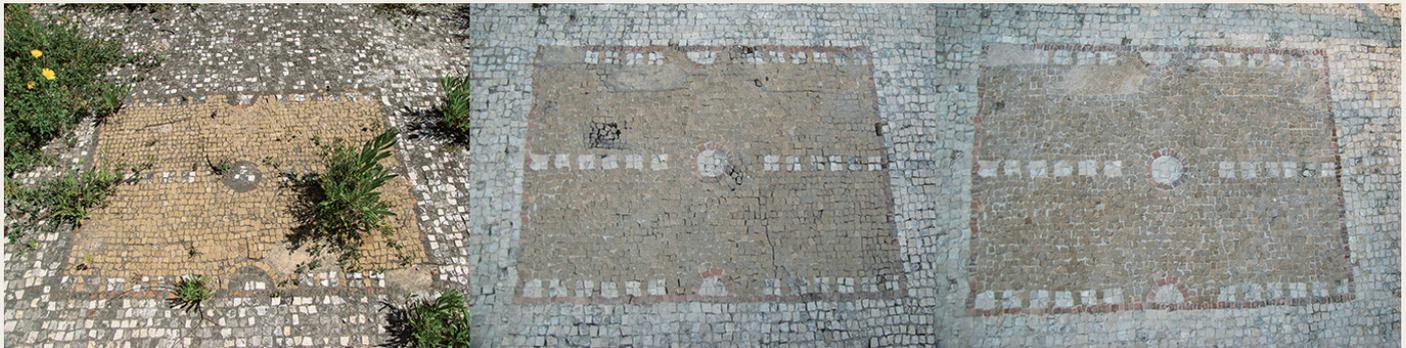
Figure 2 Evolution of the work. Photo: Myriam Ziadé

replaced. The new edging was also done in two layers, as some areas were very deep and needed inclusions of larger stones to create a level base for the final mortar. The first layer of mortar contained larger aggregates than the final layer (fig. 2).

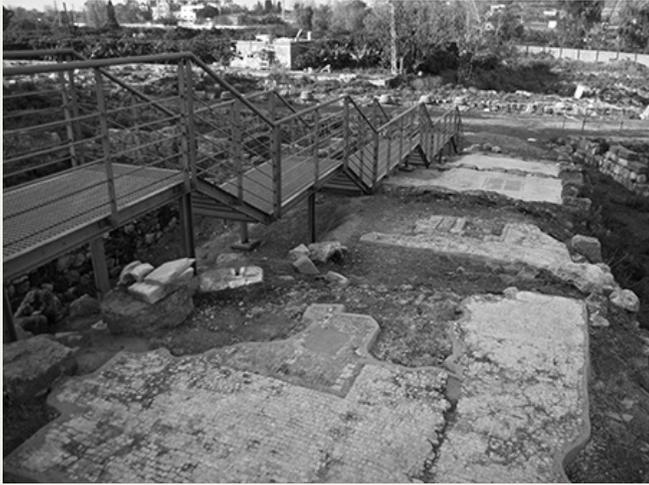
Figure 3 The Roman stairway and the new stairway. Photo: Myriam Ziadé

Alongside the archaeological stairway, a new stairway was constructed. This is now the only way to get to the top of the site, thus allowing visitors to see the mosaics without stepping on them (fig. 3). It is important to note that the impact of a modern

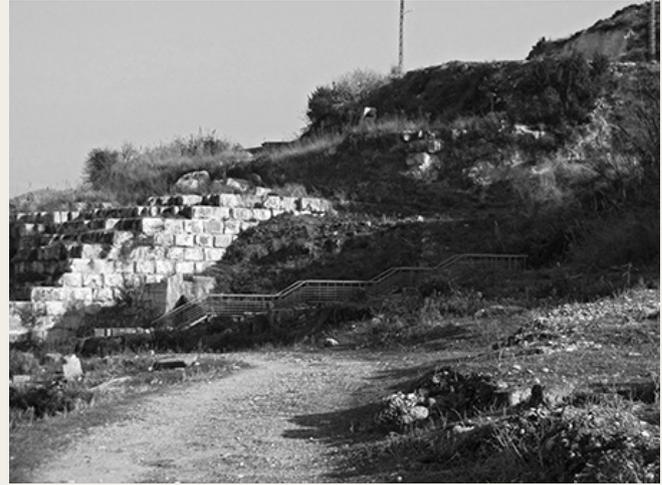
Figure 4 The new stairway on-site. Photo: Myriam Ziadé

structure on the archaeological site was well studied. As a result, the shape of the stairway and the materials used in its building have not affected the authenticity of the site (fig. 4).
