Planning and Engineering Guidelines for the Seismic Retrofitting of Historic Adobe Structures

E. Leroy Tolles

GCI Scientific Program Reports

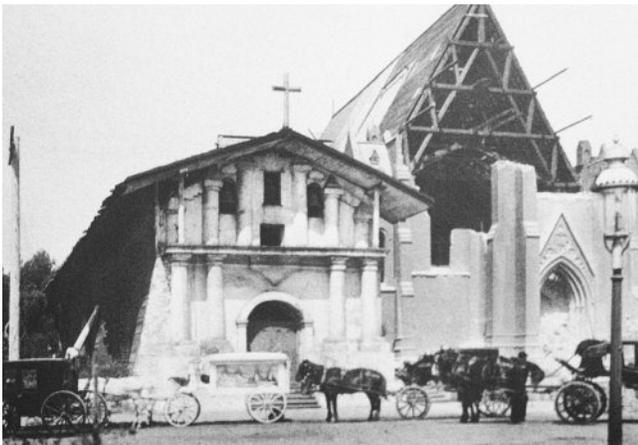
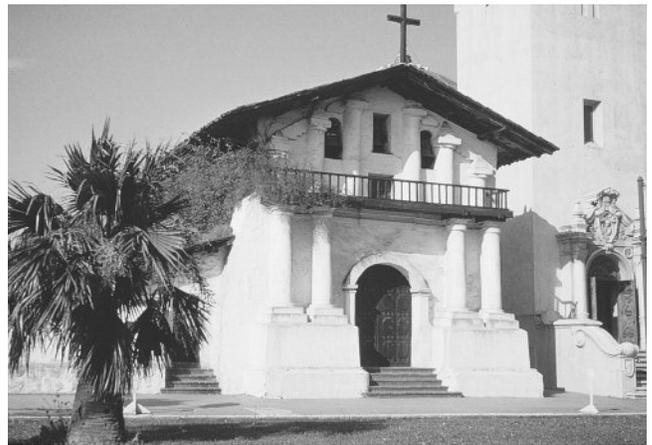
Figure 1.1

Mission San Francisco de Asis (Dolores), San Francisco, Calif.: (a) after the 1906 San Francisco earthquake (courtesy Santa Barbara Mission archives), and (b) after the 1989 Loma Prieta earthquake.

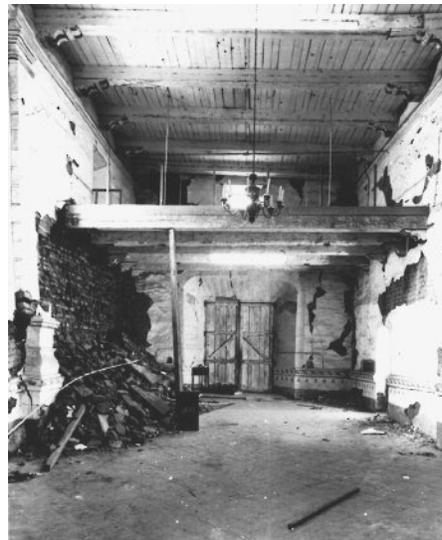
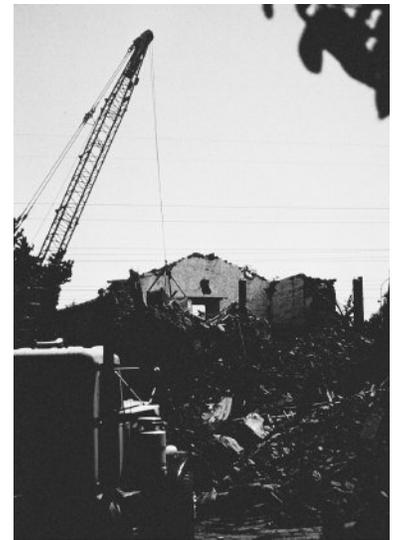
Figure 1.2

San Fernando Mission Church, Mission Hills, Calif.: (a) interior after the 1971 Sylmar earthquake (courtesy estate of Norman Neuerburg), and (b) exterior demolition after the 1971 earthquake (courtesy San Fernando Valley Historical Association).

In recent years, the toll on historic California adobes that did not receive such preservation efforts has been dramatic. Recent losses to unstrengthened buildings include destruction of the San Fernando Mission Church in 1971 (fig. 1.2); heavy damage to the Pio Pico Mansion in 1987 (fig. 1.3); damage to the Rancho San Andres Castro Adobe and Juana Briones Adobe in 1989; and severe damage to the Del Valle Adobe at Rancho Camulos (fig. 1.4), the Andres Pico Adobe (fig. 1.5), the De la Ossa Adobe (fig. 1.6), and the *conventos* of the San Gabriel and San Fernando missions in 1994.

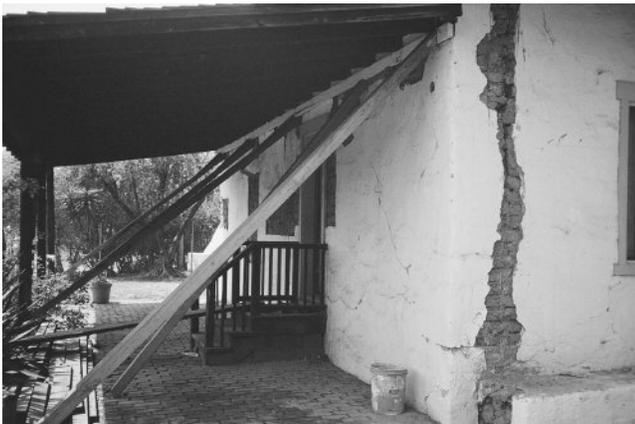
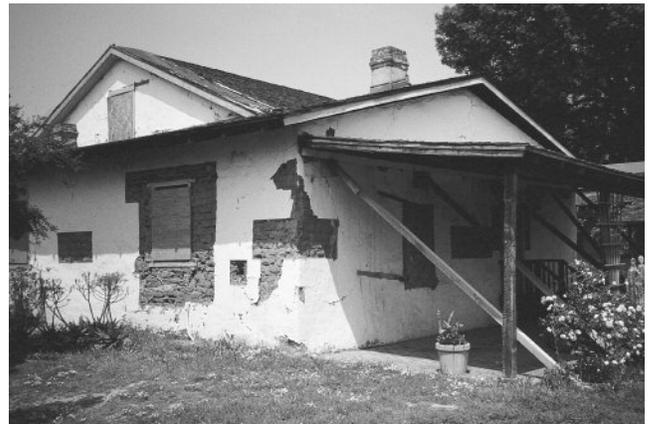
Figure 1.3

Two exterior views of Pio Pico Mansion, Whittier, Calif., after the 1987 Whittier Narrows earthquake.

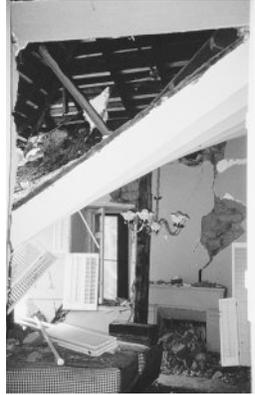
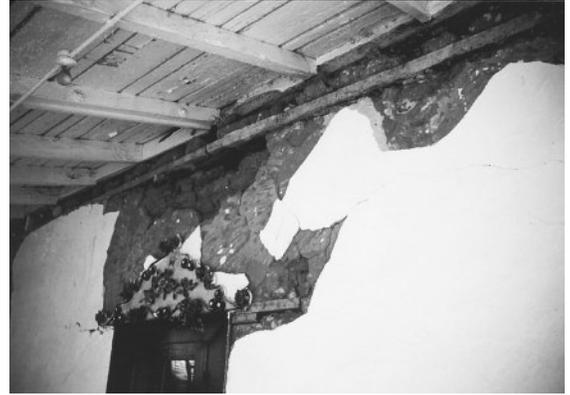
Figure 1.4

Rancho Camulos Museum, Piru, Calif., after 1994 Northridge earthquake: (a) collapse of southwest corner bedroom, and (b) damage at top of wall.

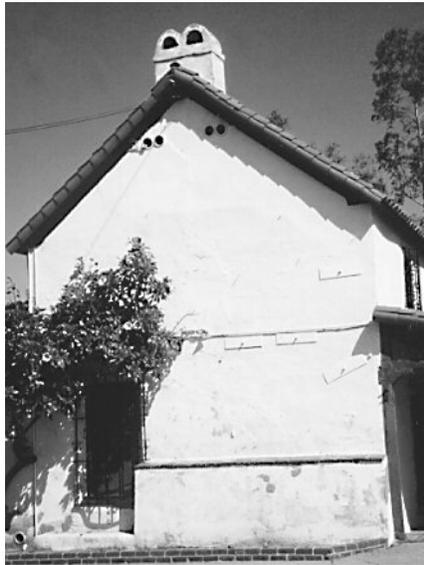
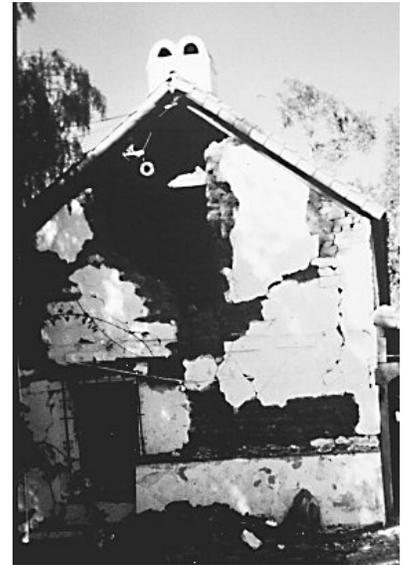
Figure 1.5

Andres Pico Adobe, Mission Hills, Calif.: (a) before 1994 earthquake, and (b) after 1994 earthquake.

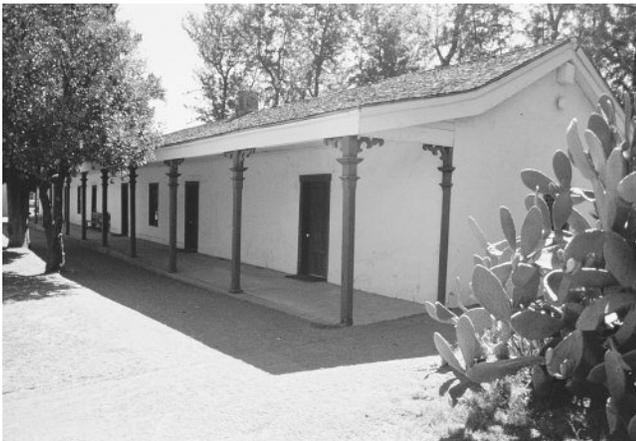
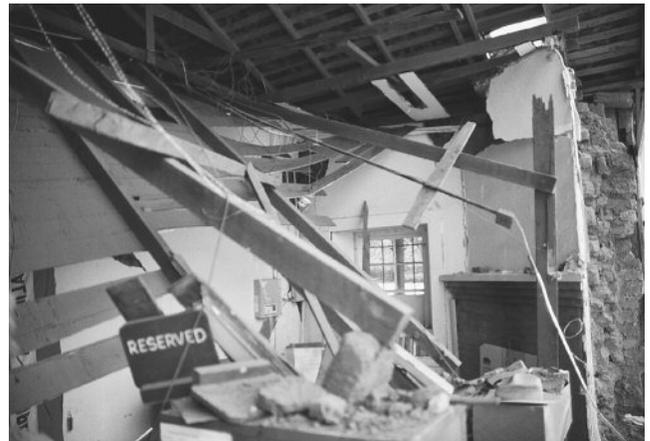
Figure 1.6

De la Ossa Adobe, Encino, Calif.: (a) before 1994 Northridge earthquake, and (b) after 1994 Northridge earthquake.

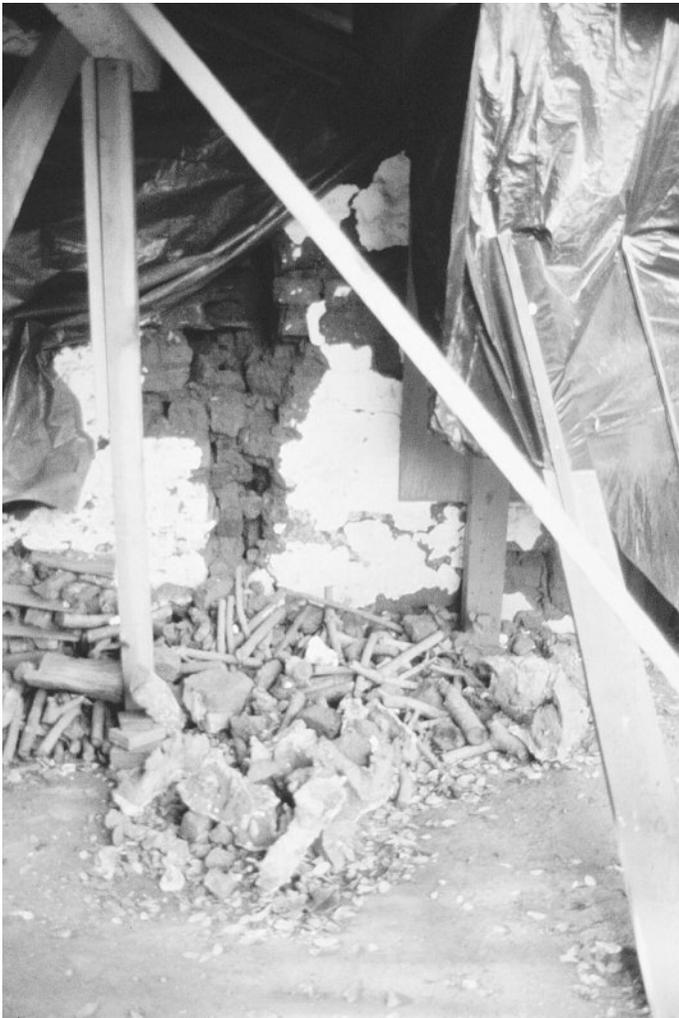
Figure 1.8
Rancho San Andres Castro Adobe,
Watsonville, Calif., showing failure of
early concrete repairs to adobe after the
1989 Loma Prieta earthquake.

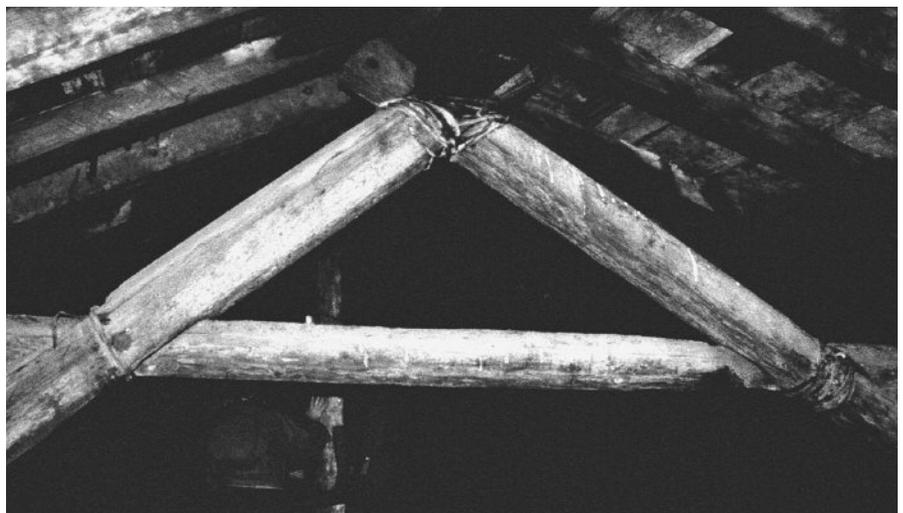
Figure 2.5
Mission Dolores, San Francisco, Calif.,
original roof support truss structure.

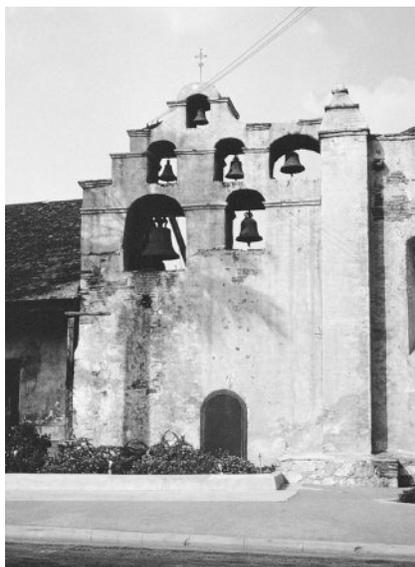
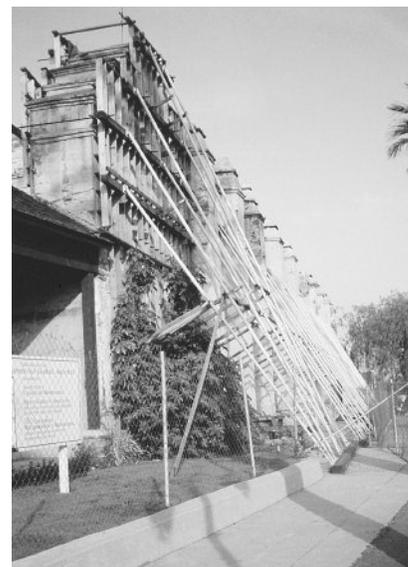
Figure 3.4

Mission San Gabriel, San Gabriel, Calif.:
 (a) bell tower before the 1987 earthquake
 (photo courtesy David L. Felton), and
 (b) bracing and shoring of the tower following the 1987 earthquake.

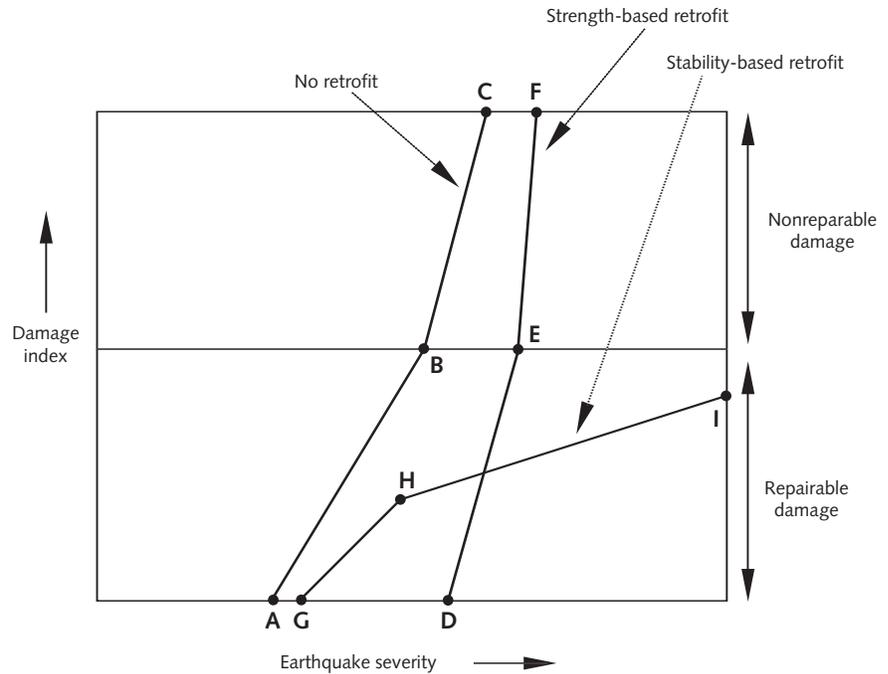
Figure 4.1

Plot of damage-progression index versus earthquake severity for unreinforced structures (*ABC*) and for stability-based (*GHI*) and strength-based (*DEF*) retrofitted structures.

strengthening approaches delaying the initiation of damage, and stability-based retrofitting limiting extensive damage and preventing collapse.

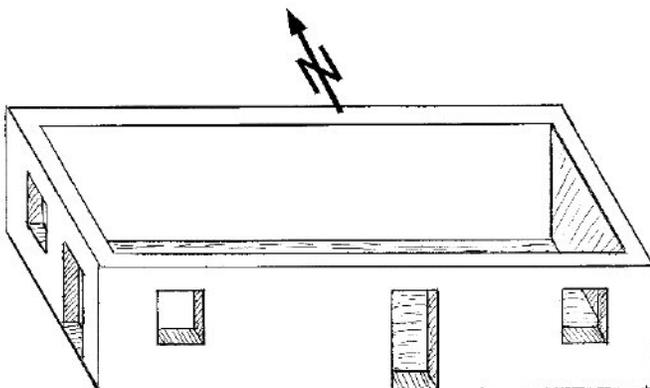
Figure 4.2
Undamaged small adobe building.

As an example, assume we are designing a simple rectangular adobe building that is 6.1 meters (20 feet) wide and 24.4 meters (80 feet) long, as shown in figure 4.2. The walls have a height-to-thickness ratio of 4. They are very stout, and overturning is unlikely if the condition at the base is good.

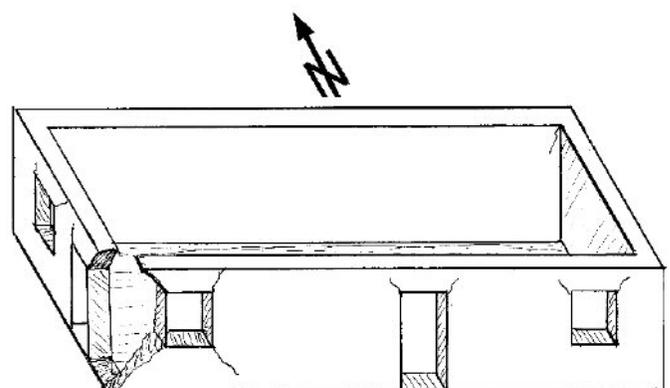
Figure 4.3
Damaged small adobe building.

The most serious problem for this building may be the southwest corner. The window and door are located very close to this corner, and collapse of the entire corner might occur even with the presence of top-of-wall anchors (fig. 4.3). Simple adherence to the strength-based procedures could lead to a false sense of security.

A proper stability-based analysis would recognize this area as a problem. A map of the predicted and possible crack patterns (see chap. 7) would allow the potential areas of instability to be identified and allow for additional retrofit measures (straps, cables, or center-core elements) to prevent this type of local instability.

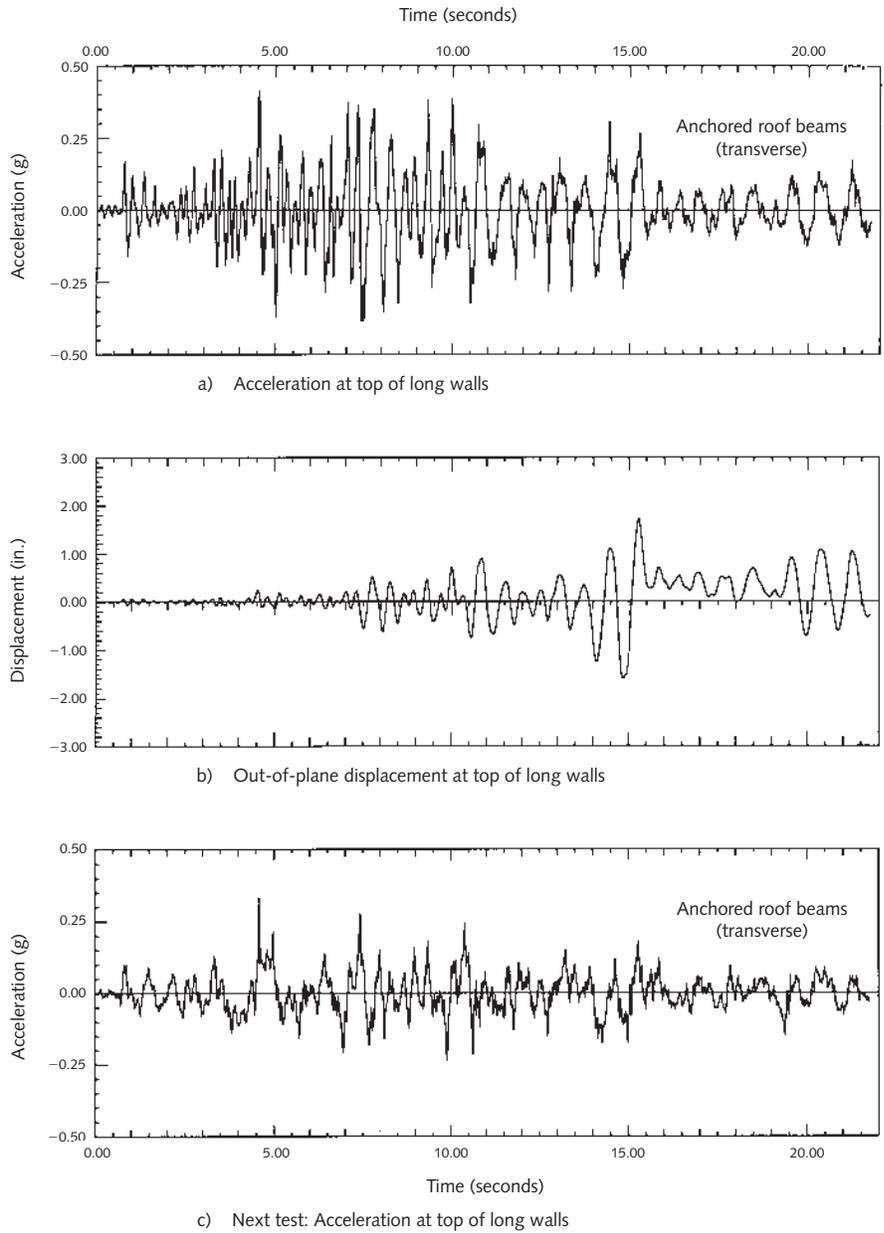
Figure 5.1

Plots of out-of-plane acceleration of the tops of walls, showing decrease as damage develops. The first test shows (a) decrease in wall accelerations with time during shaking and (b) increasing displacements with time. During the next test (c) accelerations are much lower, even though the input shaking-table displacement was about 30% higher.

The dynamic characteristics of an adobe building change dramatically as cracks develop. For long, out-of-plane walls, the effective frequency of motion decreases and the dynamic displacements increase. The term *effective frequency* is used to represent the apparent frequency of motion for nonlinear materials. This change in behavior can be demonstrated by an example taken from GSAP experimental data on a shaking-table test of a model adobe building, given in figure 5.1. The first plot (fig. 5.1a) shows out-of-plane wall accelerations; the second plot (fig. 5.1b) shows displacements of a building during ground motion, as a function of time, while damage is developing. About midway through the time history, the

wall accelerations begin to decrease, the fundamental vibration frequency decreases, and the displacements began to grow dramatically. The third plot (fig. 5.1c) shows the wall acceleration in the subsequent test. Even though the input motion is approximately 30% higher than that of the previous test, both the peak wall accelerations and the effective frequency have decreased.

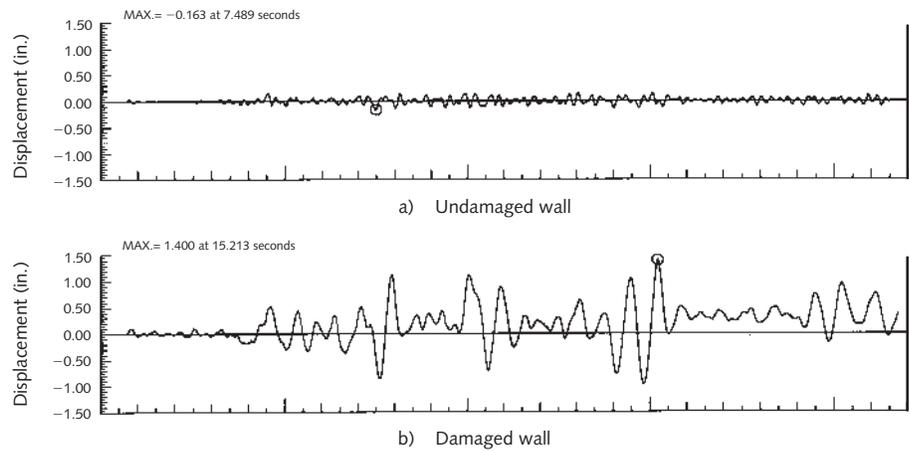
Figure 5.2

Comparison of out-of-plane displacements during shaking-table test: (a) undamaged wall, and (b) wall after substantial cracking had occurred.

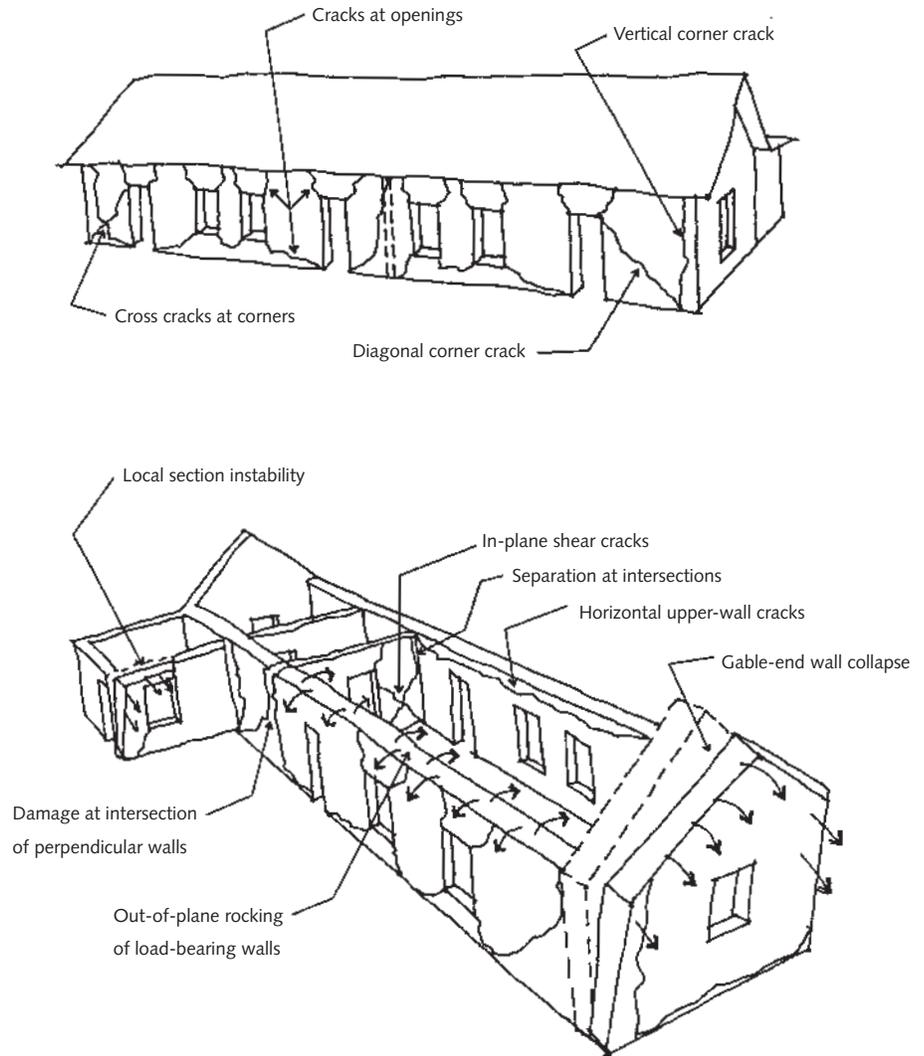
Figure 5.3

Typical damage modes observed in historic adobe buildings after the 1994 Northridge earthquake.

The following subsections include descriptions, figures, and photographs of the damage types observed in historic adobe buildings. The typical damage types are illustrated in figure 5.3, and a more complete listing is presented in table 5.2.

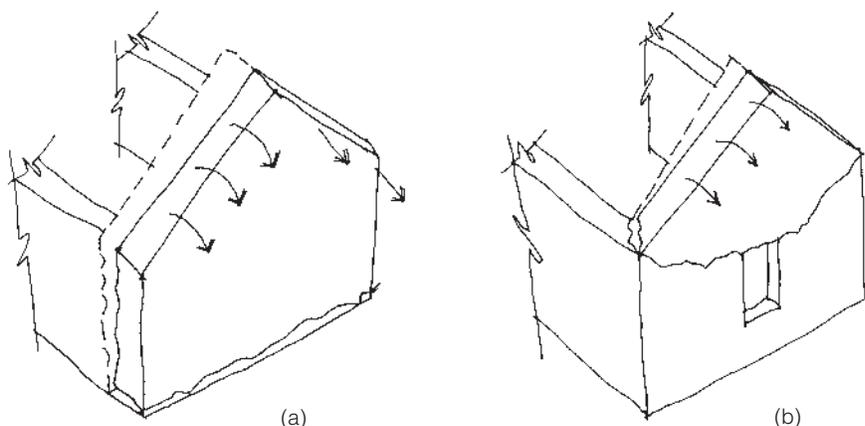
Figure 5.4

Gable-end wall collapse: (a) overturning at base of wall, and (b) mid-height collapse.

The most severe damage results in the collapse of an entire wall, which destroys extensive amounts of historic fabric and poses a serious threat to life safety (fig. 5.4a). Out-of-plane flexure may or may not be severe, depending on the extent of cracking and permanent displacement. Of particular concern is a section of wall that becomes independent of the rest of the structure by virtue of the crack pattern (fig. 5.4b). The instability of such a section is considered serious because,

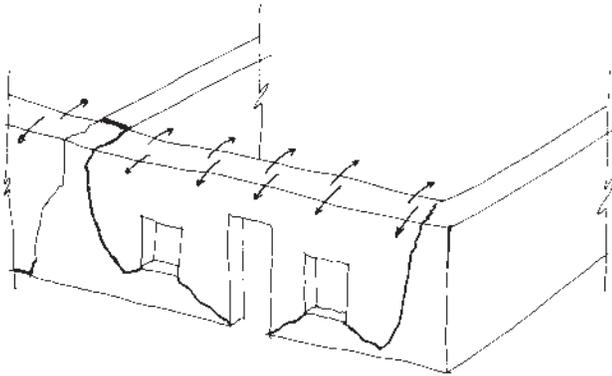
Figure 5.5
Out-of-plane flexure of load-bearing wall.

Out-of-plane flexural cracking is one of the first crack types to appear in an adobe building during a seismic event. This damage type and the associated rocking motion are illustrated in figure 5.5. Freestanding walls, such as garden walls, are most vulnerable to overturning because there is usually no horizontal support along their length, such as that provided by cross walls or roof or floor systems. Such a wall, a garden wall on the north side of the *convento* at the San Fernando Mission, overturned during the Northridge earthquake (fig. 5.6).

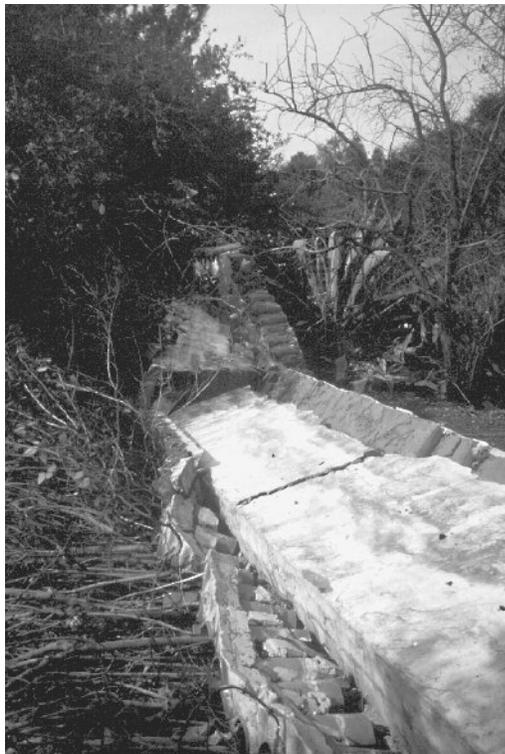
Figure 5.6
Overturned, unsupported garden wall ($S_L = 5$). Mission San Fernando after 1994 Northridge earthquake.

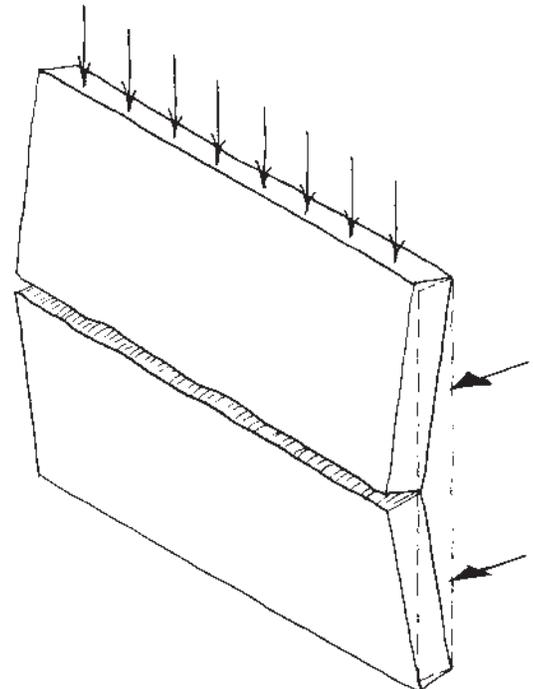
Figure 5.7
Mid-height, out-of-plane flexure damage.

For the most part, historic adobe buildings are not susceptible to mid-height, out-of-plane flexural damage because the walls are usually thick and have small slenderness ratios. However, horizontal cracks may develop when load-bearing walls are long and the top of the wall is restrained by a bond beam or a connection to a roof or ceiling system (fig. 5.7). This type of damage and potential failure mechanism is usually observed only in thin-walled ($S_L > 8$) masonry buildings.

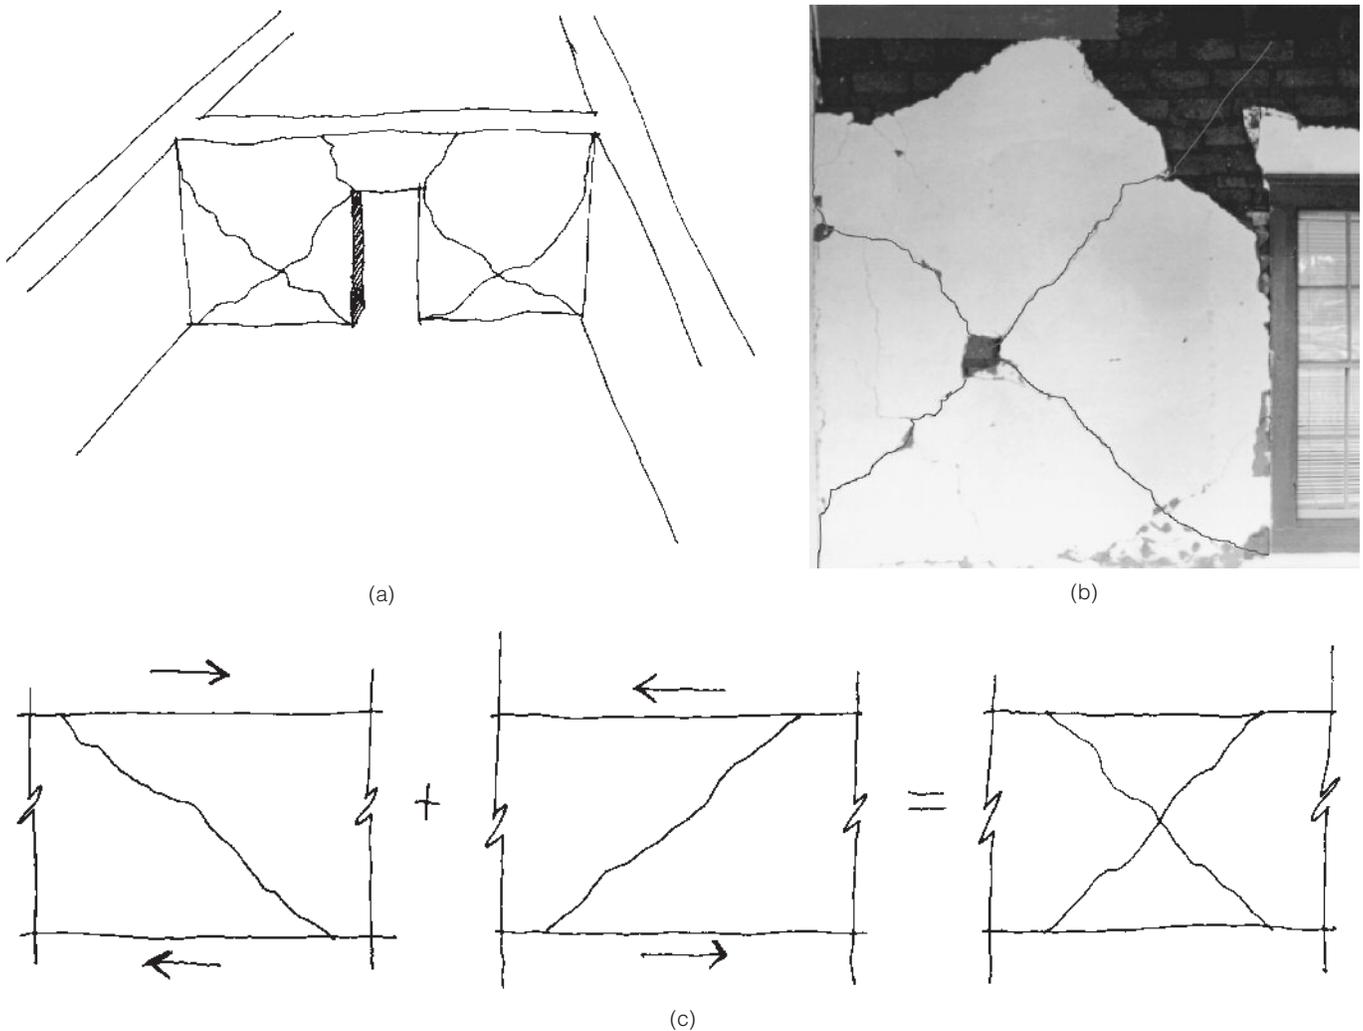
Figure 5.8
Illustrations show (a) drawing of X-shaped shear cracks in an interior wall; (b) typical X pattern (Leonis Adobe, Calabasas, Calif.); and (c) how X-shaped cracks result from a combination of shear cracks caused by alternate ground motions in opposite directions.

However, while in-plane shear is not considered hazardous from the perspective of life safety, it is often costly in terms of loss to historic fabric. In-plane shear cracks often cause severe damage to plasters and stuccos that may be of historic importance, such as those decorated with murals.

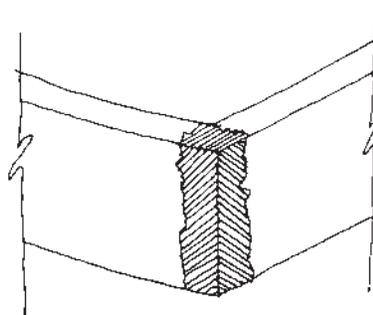
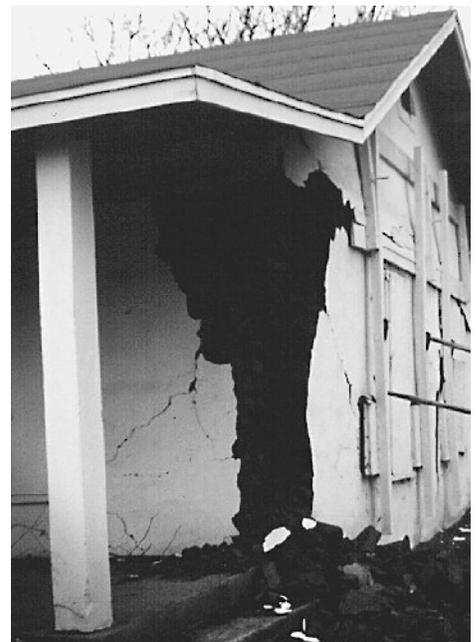
Figure 5.9

Illustrations showing (a) how vertical cracks at corner can lead to instability of intersection, and (b) example of corner collapse (Sepulveda Adobe, Calabasas, Calif.).

Vertical cracks often develop at corners during the interaction of perpendicular walls and are caused by flexure and tension due to out-of-plane movements. This type of damage can be particularly severe when vertical cracks occur on both faces, allowing collapse of the wall section at the corner (fig. 5.9).

A combination of diagonal and vertical cracks can result in an adobe wall that is severely fractured, and several sections of the wall may be susceptible to large offsets or collapse. An example of a wall section that is highly vulnerable to serious damage is illustrated in figure 5.11 (see also fig. 5.9a). The diagonal cracking at that location allows the cracked wall sections freedom to move outward. Corners

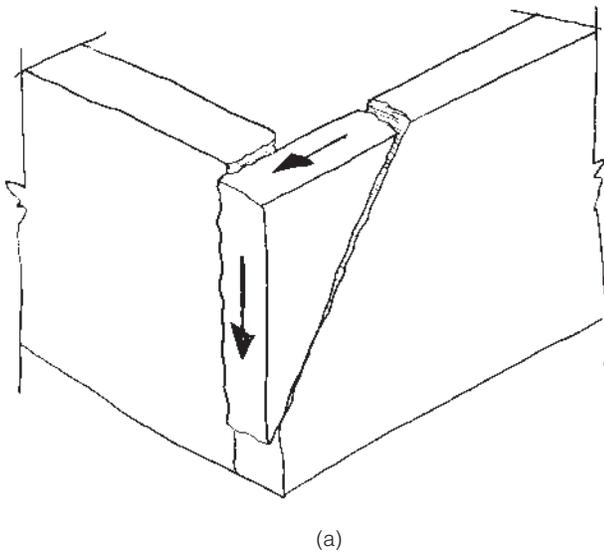
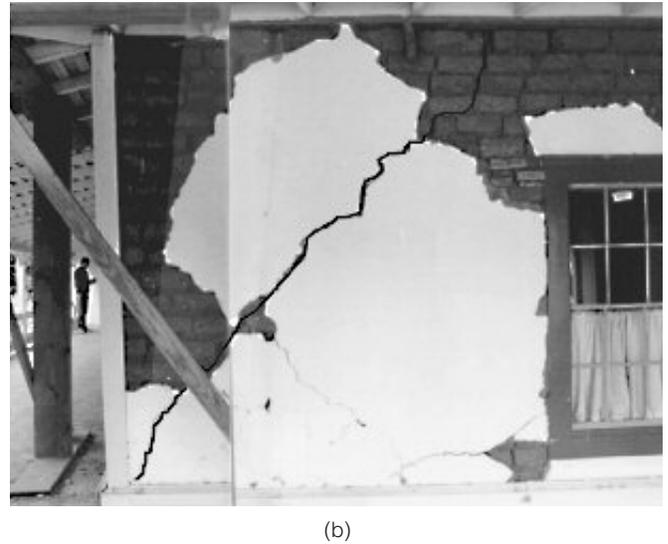
Figure 5.10

Corner cracks: (a) illustration of vertical downward and horizontal displacement of a corner wall section, and (b) example of displaced wall section (Leonis Adobe).

In-plane shear forces cause diagonal cracks that start at the top of a wall and extend downward to the corner. This type of crack results in a wall section that can move laterally and downward during extended ground motions. Damage of this type is difficult to repair and may require reconstruction. Illustrations of this damage type are shown in figure 5.10.

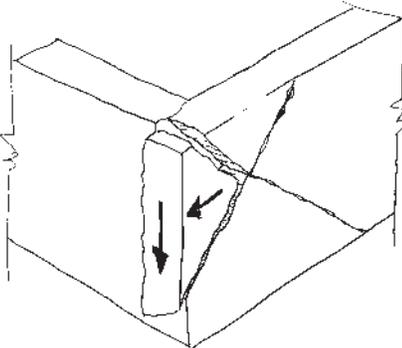
Figure 5.11

Illustration showing how combination of shear and flexural cracks can result in corner displacement or collapse.

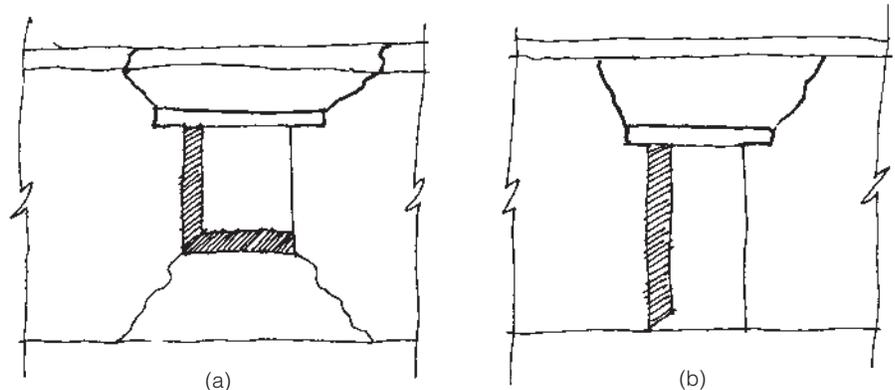
Figure 5.12

Illustration of cracks originating at stress concentration locations: (a) cracks appearing first at upper corners of window opening, followed by lower corner cracks; and (b) cracks at upper corners of door opening.

Cracks occur at window and door openings more often than at any other location in a building. In addition to earthquakes, foundation settlement and slumping due to moisture intrusion at the base can also cause cracking. Cracks at openings develop because stress concentrations are high at these locations and because of the physical incompatibility of the adobe and the wood lintels. Cracks start at the top or bottom corners of openings and extend diagonally or vertically to the tops of the walls, as illustrated in figure 5.12.

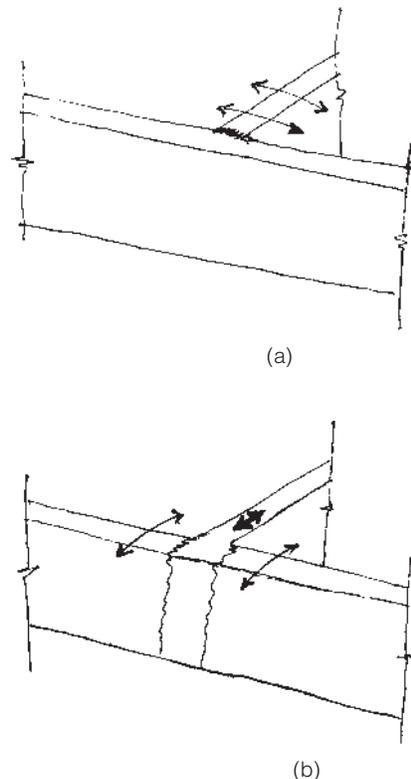
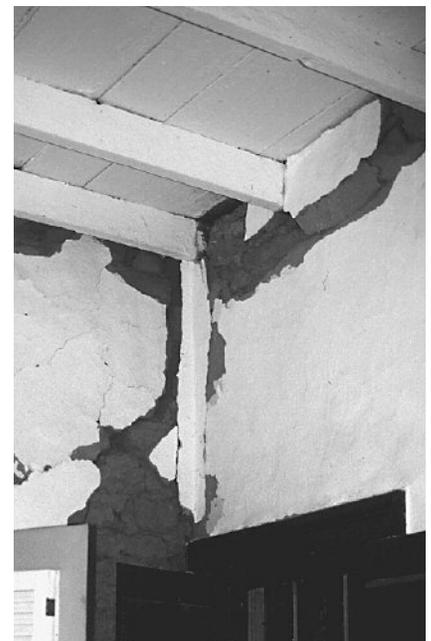
Figure 5.13

Illustrations showing (a) how separation can occur between in-plane and out-of-plane walls, and (b) how vertical cracks develop in out-of-plane walls at the intersection with perpendicular, in-plane walls.

stiff. Damage at these locations is inevitable during large ground motions and can result in the development of gaps between the in-plane and out-of-plane walls (fig. 5.13a) or in vertical cracks in the out-of-plane wall (fig. 5.13b). Damage may be significant when large cracks form and associated damage occurs to the roof or ceiling framing. Anchorage to the horizontal framing system or other continuity elements can greatly reduce the severity of this type of damage.

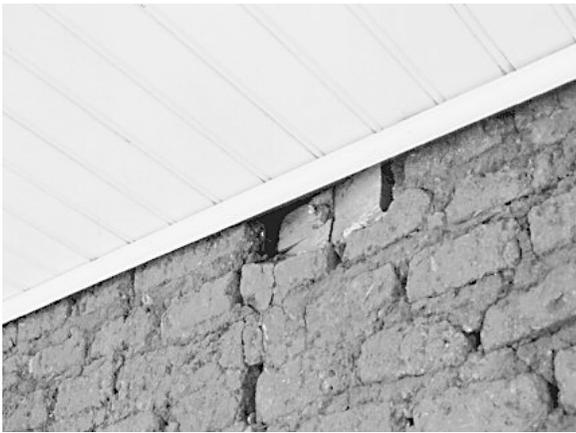
Figure 5.15
Anchorage failure of steel tie-rod; anchor plate has pulled into the wall.

Wall anchors (tie-rods) are intended to hold a wall snugly against a perpendicular wall or diaphragm. It is common for wall anchors to have been installed following an earthquake or settlement damage. Subsequent damage to walls can then occur at wall anchorages because of the stress concentrations that are created during ground motions (fig. 5.15). It is difficult to attach anchors to adobe walls successfully because the adobe itself is weak in shear and tension. To design more effective anchorages, it is important to understand the physical behavior of the adobe bricks and mortar materials around anchors.

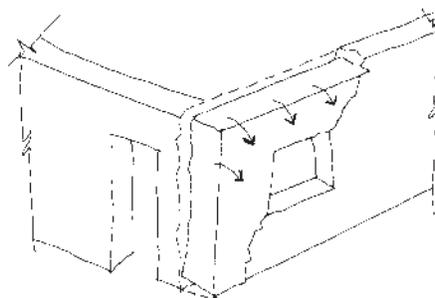
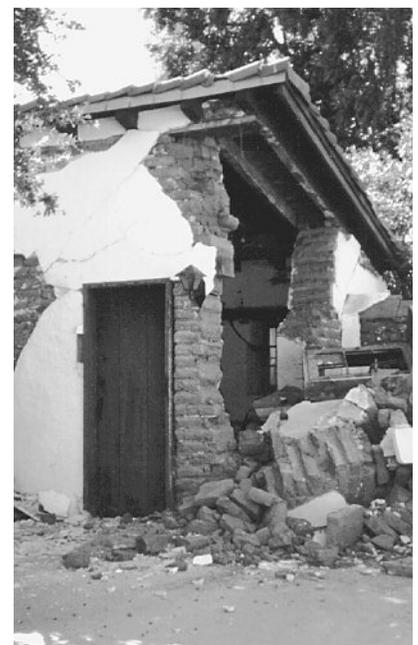
Figure 5.16
Local section instability: (a) illustration of how a local wall section may become unstable if the crack pattern results in an isolated block that can collapse; and (b) example of failure of garage wall section resulting from cracks at window and door openings (Andres Pico Adobe, Mission Hills, Calif.).

Sections of an adobe building may become unstable after cracks have developed, and this is particularly true for sections of a wall that have become isolated from the building because wall openings are located too close to the corners. An example of this problem is shown in figure 5.16. The susceptibility to local section instability can be anticipated by evaluating the predicted general crack pattern that may result from an earthquake. The occurrence of cracks at openings and corners is

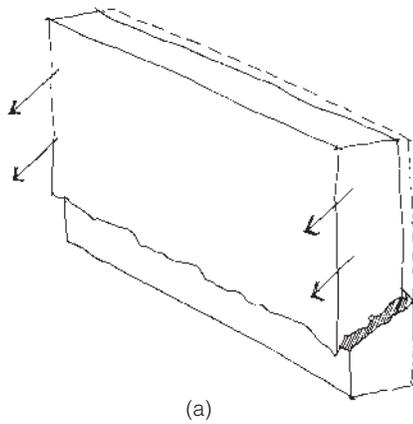
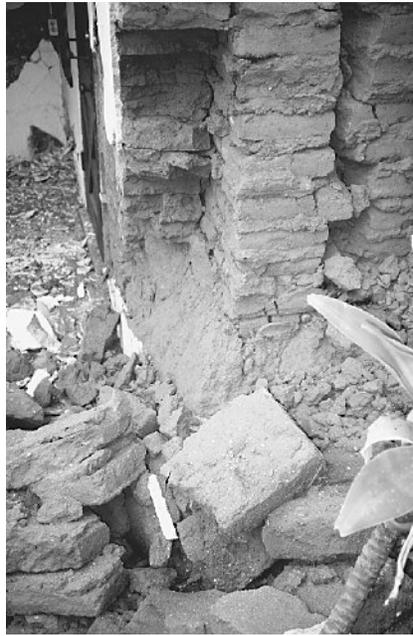
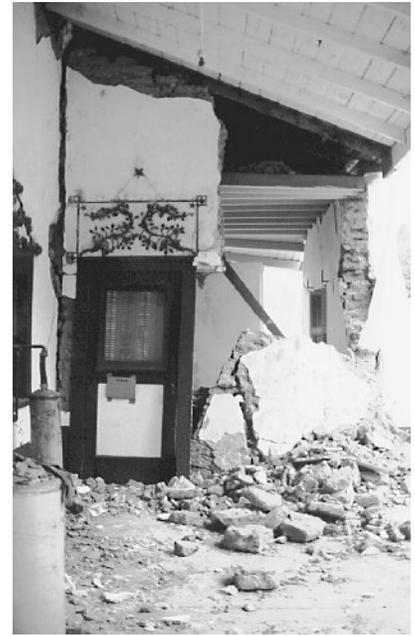
Figure 5.18

Illustration showing (a) how moisture damage can result in development of a plane of weakness along which a wall section can slide; examples showing how (b) moisture damage contributed to the collapse of the corner in this kitchen wall (Andres Pico Adobe), and (c) lower-wall moisture damage contributed to the catastrophic collapse of these two walls (Del Valle Adobe).

When the adobe at the base of the wall is weakened by moisture damage, a weak plane can develop, and the upper section of the wall can slip and collapse along this plane, as illustrated in figure 5.18a. This condition is most clearly shown in figure 5.18b, where a corner of a kitchen wall failed. The adobe at the base of the wall had been weakened by repeated exposure to moisture, which caused a weak failure plane to develop, and it appears that the wall slipped along this plane and collapsed. A similar failure mode was the probable cause of the failure shown in figure 5.18c. When a wall collapses, the location of the rubble can provide information on the probable location of the original failure. The wall shown in figure 5.18c appears to have collapsed down upon itself because the top of the wall is in the pile of rubble very near the original wall line. If overturning had occurred, the top of the wall would have been found some distance from the original wall location.

It is not necessary for an adobe wall to be wet at the time of an earthquake for water to have been a primary cause of failure. The lowered strength of water-damaged adobe results in a wall that is especially susceptible to damage or collapse. Spalling of adobe or cementitious stuccos can result from the combination of earthquake motion and a weakened bond between the adobe material and the surface rendering. This is shown in figure 5.19. If an entire wall section becomes wet or the adobe has been weakened by wet-dry cycles, the wall could fail suddenly (see fig. 5.18c).

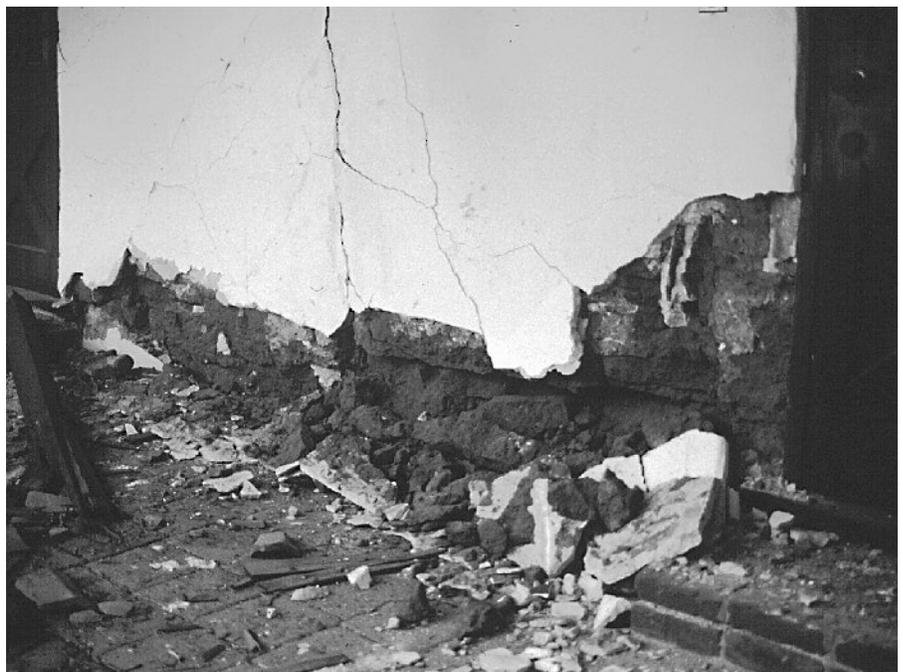
Figure 5.19

Spallation of exterior stucco and adobe in water-damaged lower wall area (Andres Pico Adobe).

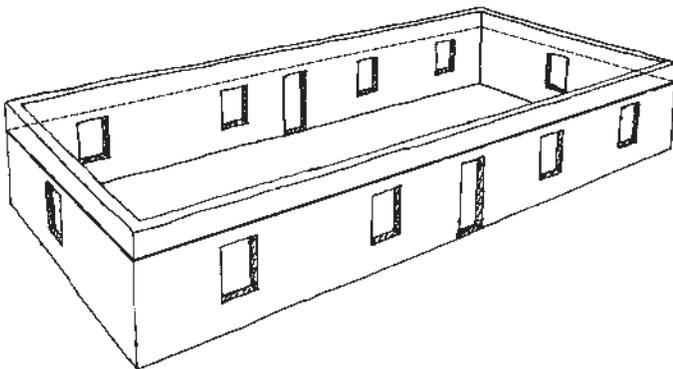
Figure 7.1

Illustration showing upper-wall horizontal elements used to prevent out-of-plane overturning and in-plane offsets. These can be a bond beam, straps in conjunction with the floor or roof system, or a partial diaphragm.

These elements are the most important part of a seismic retrofit for an adobe building because the principal mode of wall failure is overturning; upper elements are designed to prevent this type of failure. Therefore, the initial step in the global design is to provide upper-wall horizontal elements, as shown conceptually in figure 7.1, that can perform the following functions:

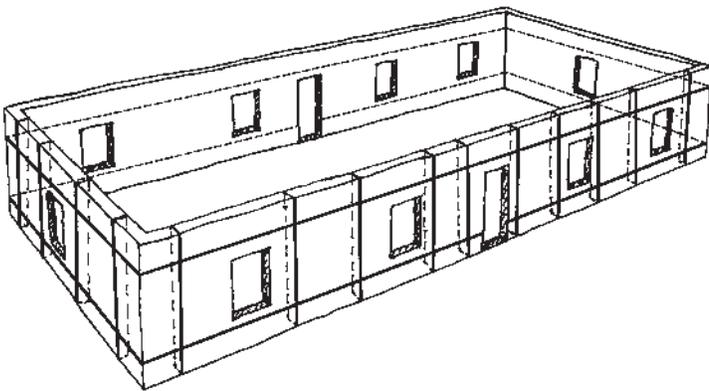
Figure 7.2

Diagram showing how vertical elements add resilience and redundancy to the structural system and restrict the displacement of cracked wall sections. These can be surface straps or internal center-core rods.

increase the “ductility” of the walls, as shown in combination with upper and lower wall elements in figure 7.2.

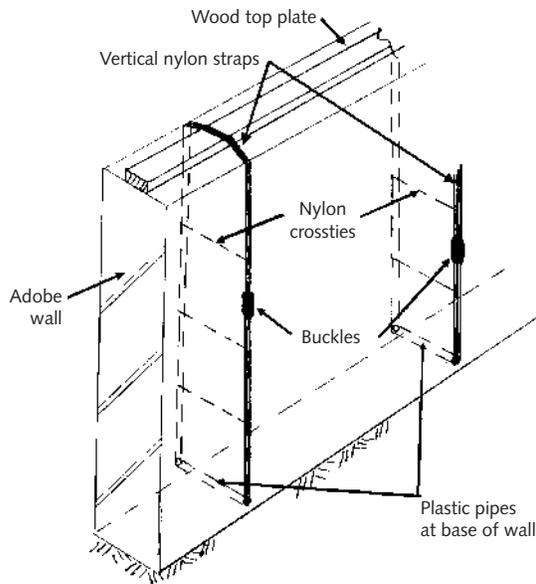
Figure 7.3
Diagram of vertical straps and crossties on adobe wall.

Thin adobe walls ($S_L \geq 8$) require vertical straps (fig. 7.3), center-core rods (fig. 7.4), or some other type of treatment to prevent out-of-plane failure. Center-core rods, grouted into oversized holes using an epoxy, polyester, or cementitious grout, or vertical straps on both sides of a wall, can be used as reinforcing elements to prevent out-of-plane failure. Grouted center-core rods bond well to adobe because the grout material is absorbed irregularly into the adobe. For thicker adobe walls, center-core elements tend to act as shear dowels rather than as flexural reinforcements. Although the wall behavior when dowels are used could be analyzed in terms of a flexible reinforcement, the principal function of the center-core rods is that of shear dowels, and an analysis based on this function should be used.

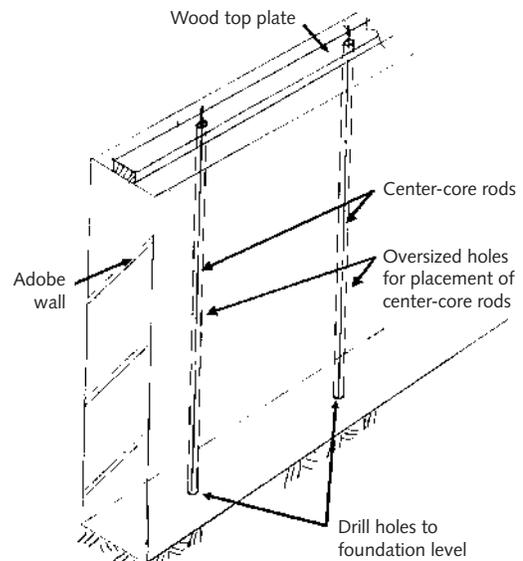
Figure 7.4
Diagram of center-core rods in adobe wall.

The diameter of center-core rods used in full-scale walls can range from 12 to 25 mm (0.5–1 in.), and the rods should be inserted in holes that are sized according to the needs of the material used for anchoring the center-core rods. The GSAP research was based on a prototype adobe wall that was 41 cm (16 in.) thick, and 17 mm (0.67 in.) diameter center-core rods worked well even when used without grout. Small-diameter rods and holes less than 50 mm (2 in.) in diameter should be used because larger-diameter center-core elements may act as “hard spots” and serve to split the low-strength adobe wall.

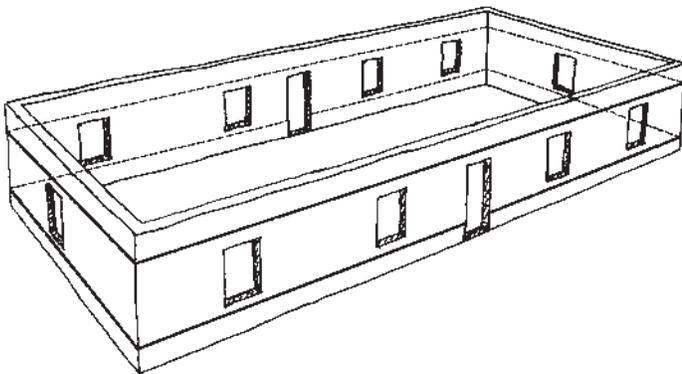
Figure 7.5
Illustration showing how lower horizontal elements prevent displacements at the base of the walls.

Lower-wall horizontal elements can be used to improve the performance of adobe walls by preventing cracked wall sections from “kicking out” in plane, along the length of the wall. In some instances, a wall section may be displaced into a door opening, but more serious problems tend to occur at the ends of the walls where cracked wall sections are unrestrained and can move outward at the base. In some instances, repairs may consist only of filling cracks, but in other cases, if it is not adequately restrained, the entire wall may need to be reconstructed. A schematic design using upper- and lower-wall horizontal elements is shown in figure 7.5.

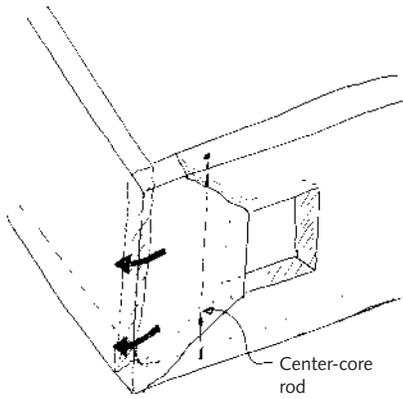
Figure 7.6
Diagram showing stabilization of corner wall section near a wall opening by use of a center-core rod.

figure 7.6. The core element extends across the diagonal crack and prevents slippage of the cracked wall section by acting as a shear dowel.

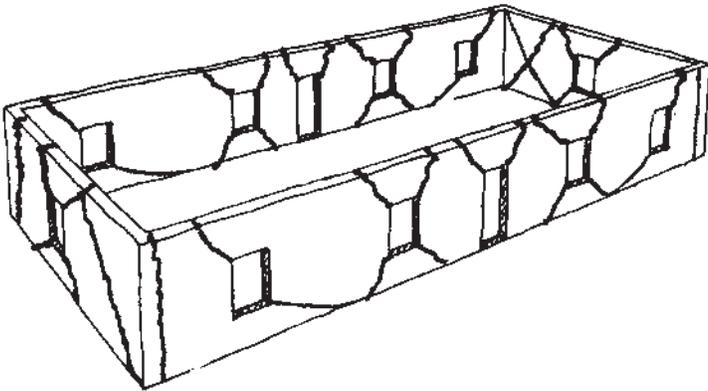
Figure 7.7
A map of potential adobe-block formation, resulting from crack pattern prediction, a necessary prerequisite to the design of a stabilizing retrofit system.

During earthquakes, adobe walls crack into large sections. Most collapses are localized and occur because of the instability of the cracked wall sections. Each section can be displaced and overturn independently of the remainder of the building. However, if the basic crack patterns of a structure are predicted first, the overall retrofit system can be designed to stabilize the numerous wall sections that may collapse or sustain substantial permanent damage. After cracks have developed, the behavior of the building is largely dependent upon the stability of the cracked wall sections, and the design of the retrofit system should be directed toward stabilization of each of the sections. Wall sections are formed by cracks that develop at wall openings, at corners and other wall intersections, at mid-walls, and at locations such as regions of material incompatibilities. A predicted crack pattern is shown in figure 7.7 (see chap. 5 for a discussion of typical damage typologies).
