Planning and Engineering Guidelines for the Seismic Retrofitting of Historic Adobe Structures

E. Leroy Tolles

GCI Scientific Program Reports

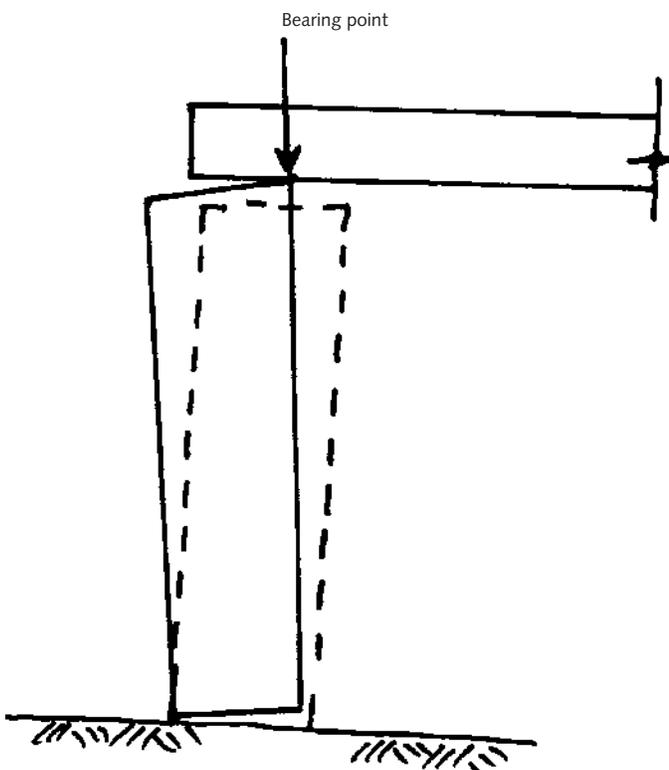
Figure 7.8

Illustration of thick, load-bearing walls, which are more stable than non-load-bearing walls because of the upper restraints provided by roof or floor framing.

Load-bearing adobe walls are more resistant to damage in earthquakes than are non-load-bearing walls. The improved performance is the result of the stabilizing effects provided by the framing that is supported by the walls. This occurs even when a positive connection between the framing and the walls does not exist, which is typical of historic adobe buildings constructed during the 1800–1900 period. Framing will result in additional lateral restraint for two reasons: it provides direct resistance to the out-of-plane motions of the walls, and framing exerts a downward force on the wall as the wall starts to rock upward (fig. 7.8). The vertical force resulting from the weight of the roof system provides stability to the wall by resisting the overturning forces.

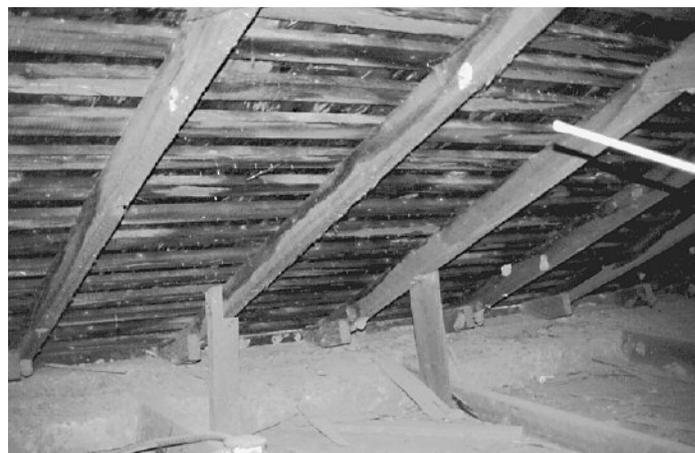
Figure 7.9
Roof framing resting on, but not attached to, the top course of adobe bricks.

Roof framing in historic adobe buildings is often only lightly attached to the walls. Very often, the framing is not actually attached at all and just rests on top of the wall, as shown in figure 7.9. Thus, the roof framing can slide relative to the wall or can dislodge bricks at the top of the wall.

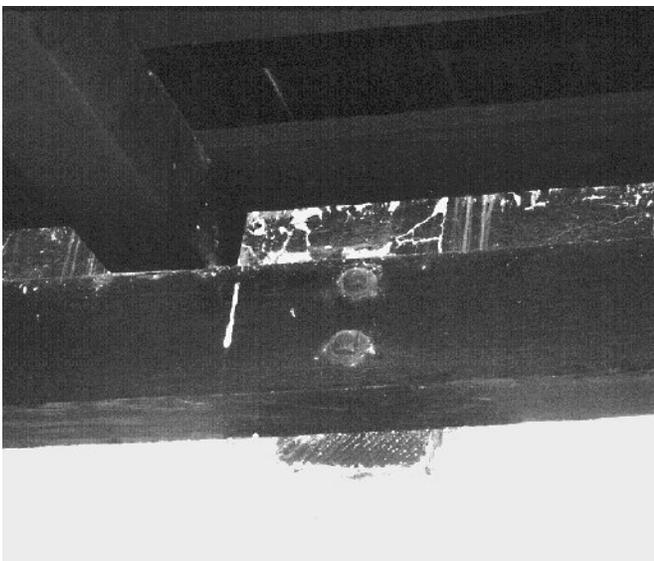
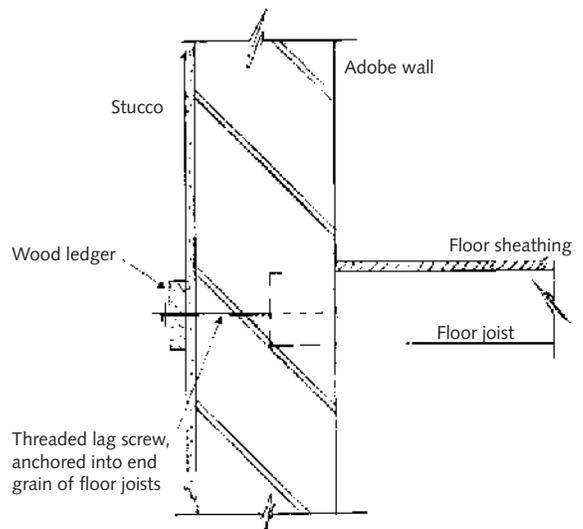
Figure 7.10

Floor-to-wall connections: (a) side of wall showing continuous ledger and lag screws driven into the end of a joist; and (b) section diagram showing lag screw, ledger, and joist.

Floor-to-wall connections can be difficult to implement but, when done properly, can be effective because of the significant overbearing pressure from the wall above. Where no anchorage exists, slippage of the floor joists relative to the wall may occur (see chap. 5, fig. 5.14). One example of an effective floor-to-wall connection is shown in the details at the second-floor level of the Andres Pico Adobe. This connection was effective during the 1994 Northridge earthquake, despite heavy damage to much of the building. An exterior continuous plate was attached to the through-wall floor joists. Lag screws were anchored into the end grain of the joist (fig. 7.10) to prevent the relative movement of the walls and the floor joists. Bolting into the end grain of a joist is not generally recommended, but in this case, the joint had sufficient strength to prevent relative movement during the earthquake. This detail is diagrammed in figure 7.10b.

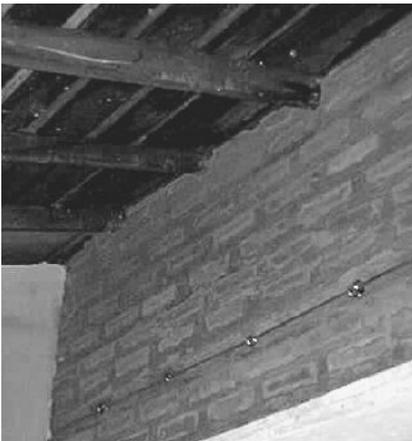
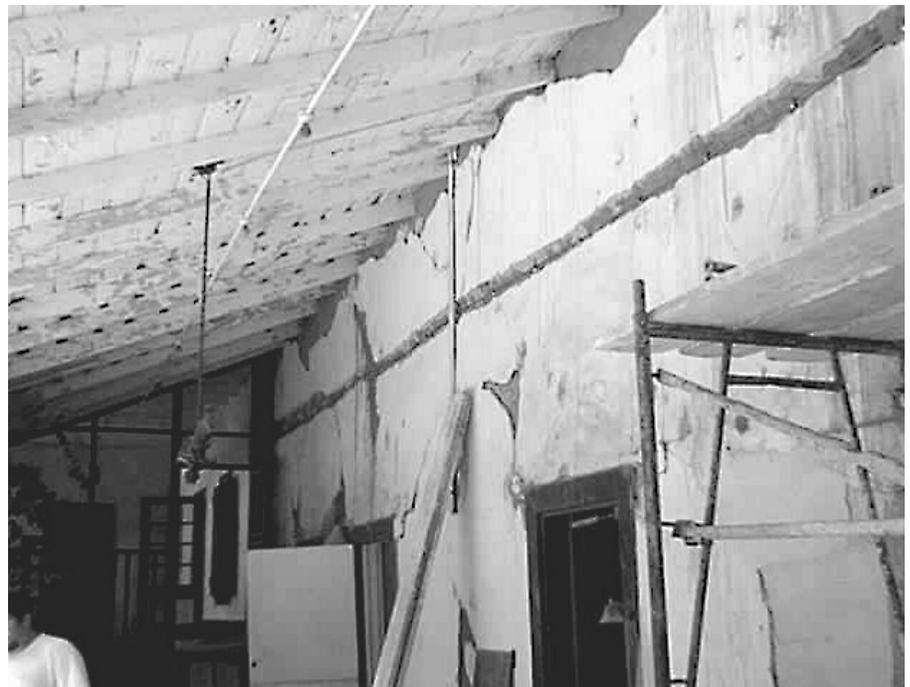
Figure 7.12

Retrofit at Del Valle Adobe, Rancho Camulos, Piru, Calif.: (a) interior view of eyebolts used to attach the exterior horizontal cable to the floor joists, and (b) exterior view of the eyebolts.

exterior perimeter cable was placed (fig. 7.12). This detail is shown in figure 7.13a. Another option, shown in figure 7.13b, can be used if the floor joists are not visible from below or if visibility of the attachment is not a significant factor.

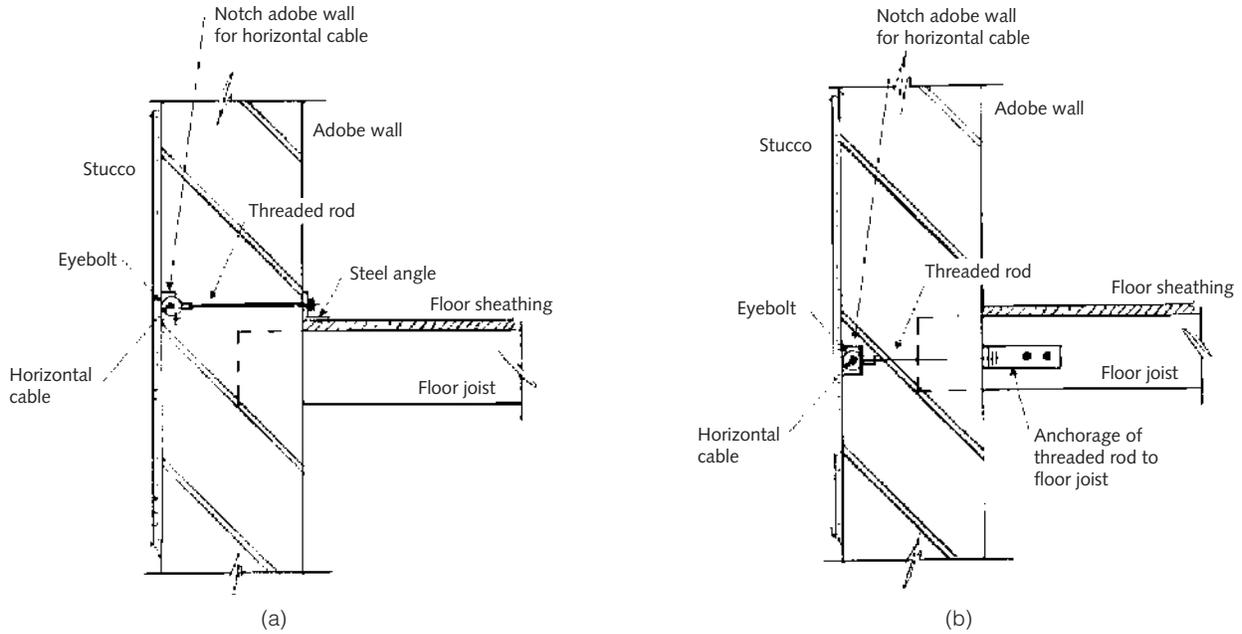
Figure 7.13
Diagrams of Del Valle Adobe retrofit: (a) cross section of eye-bolt attachment between the horizontal cable and floor sheathing and joist, and (b) cross section of eye-bolt attachment between the horizontal cable and joist—alternative method.

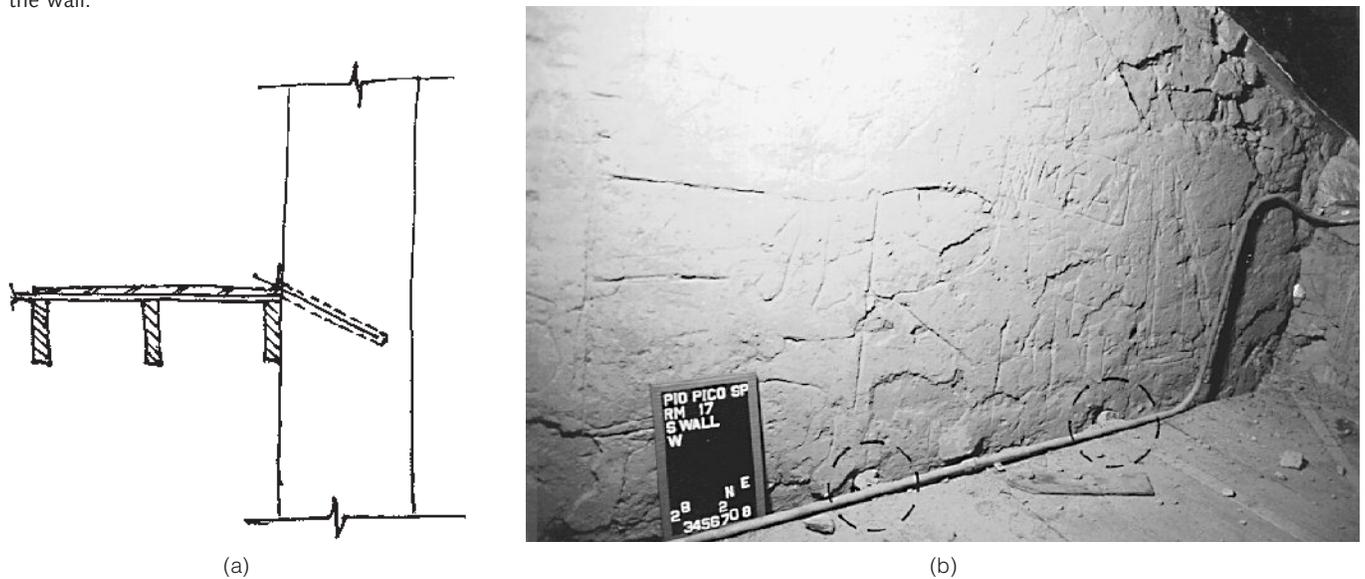
Figure 7.14
Pio Pico Mansion, Whittier, Calif.: (a) section diagram showing steel flat-strap connection anchored into an adobe gable-end wall using a low-shrinkage mud-fly ash grout, and (b) photo taken after the 1994 Northridge earthquake; the connection failed when the grout plug pulled out of the wall.

Another type of anchoring system, used at the attic-floor level of the Pio Pico Mansion, failed during the Northridge earthquake, where the relatively minor peak ground horizontal acceleration was less than 0.15g. A section detail of this anchorage is shown in figure 7.14a. A flat strap was anchored into the wall using an adobe-mud-fly-ash mixture. The anchorage seemed to have worked, except that the entire plug pulled out of the wall, as shown in figure 7.14b. Loads on these connections to the gable-end wall can be very large. This type of connection was brittle and had no redundant elements in other parts of the retrofit system to serve as backup.

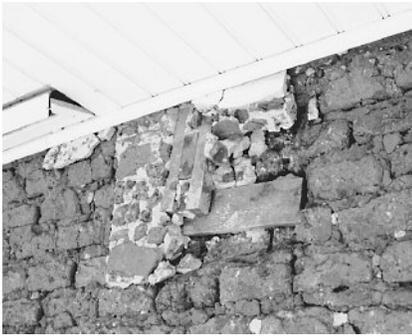
Figure 7.15
Numerous repairs to wall at tie-rod end plate (De la Ossa Adobe, Encino, Calif.).

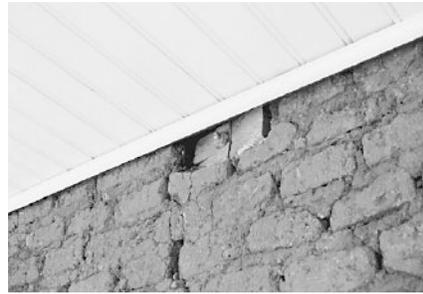
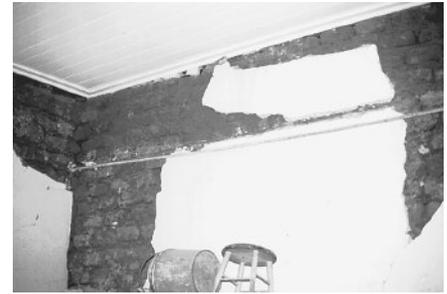
Figure 7.16
Photos showing (a) tie-rod stress-distribution plate pulled into the wall; and (b) sagging, ineffective tie-rod.

Tie-rods are often installed in historic adobe buildings either after earthquake damage or beforehand, to forestall overturning of thin, parallel walls. Tie-rods are generally threaded steel rods that are secured by nuts and stress-distribution plates on the exteriors of parallel walls. Tie-rods can add needed support, but may also create extended damage. Figure 7.15 shows the numerous repairs that were carried out at the end of a tie-rod in an attempt to repair damage. The anchorage shown in figure 7.16a has pulled into the wall and has allowed the steel tie-rod to sag and lose its effectiveness, as shown in figure 7.16b. Anchorages can also lead to wall

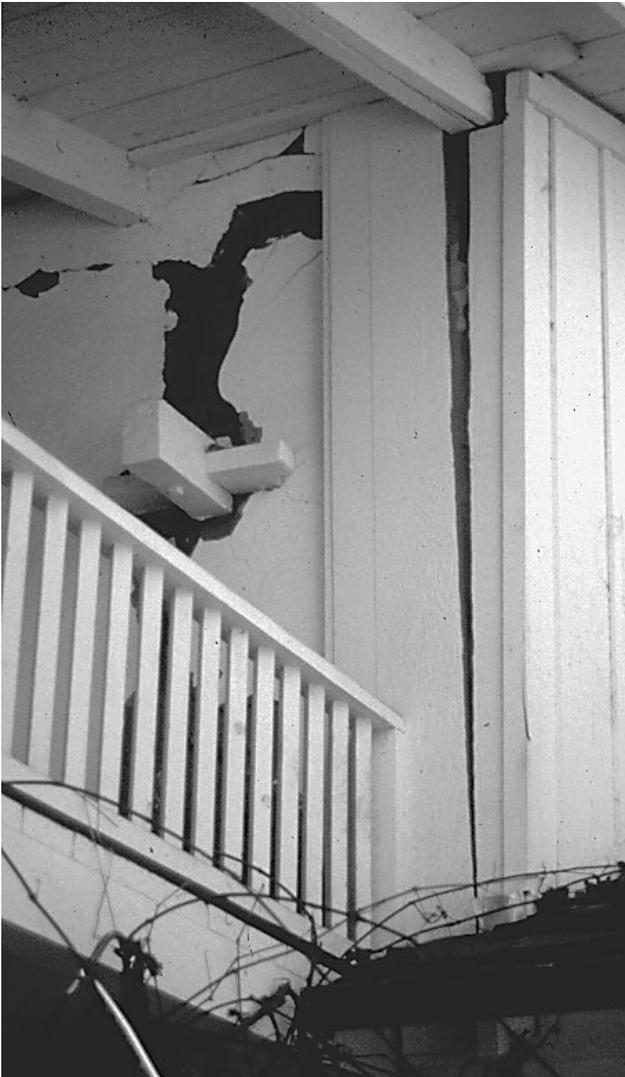
Figure 7.17
Damage to wall adjacent to wood anchor (Rancho San Andres Castro, Watsonville, Calif.).

damage adjacent to the anchor. The severe cracking at the anchorage shown in figure 7.17 is typical and has led to the instability of the wall to the left of the anchorage. This type of tie has often been used in an attempt to stabilize the out-of-plane walls of unreinforced masonry buildings. Unfortunately, these ties can encourage vertical cracking of end walls that can enhance the instability of such non-load-bearing walls.

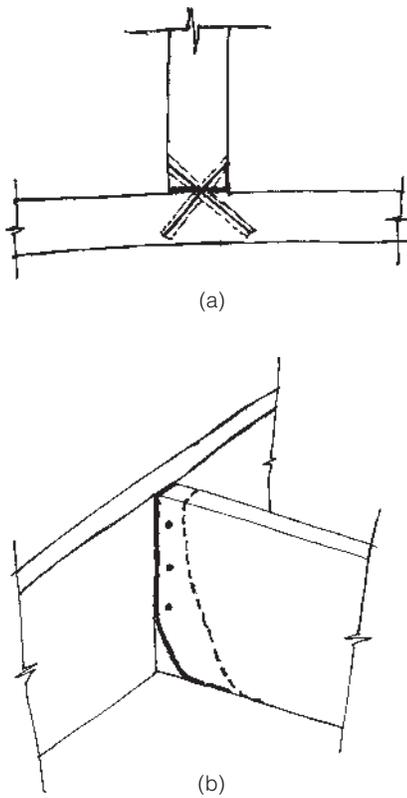
Figure 7.18

Illustrations of regrouting and doweling, showing how (a) anchoring dowels can be effective at perpendicular interior walls during moderate ground motions; and (b) during strong motions, cracks can occur adjacent to the dowels (dotted line).

Achieving effective connections between perpendicular walls can be difficult because of the very different in-plane and out-of-plane motions of thick adobe walls. Connections between intersecting walls can have sufficient strength to withstand moderate ground motions if the original construction consisted of overlapping bricks or contained overlapping reinforcements. Regrouting or doweling of existing cracks gives the structure some ability to withstand moderate ground motions. An illustration of this type of repair is shown in figure 7.18a. However, during strong ground motions, damage will occur to adobe walls at or near the junction. Although regrouting and doweling may result in a significant benefit during moderate ground motions, they will have little effect during very large ground motions. The cracks that would have occurred at the corners, if doweling had not been present, would probably occur just beyond the location of the dowels, as illustrated in figure 7.18b.

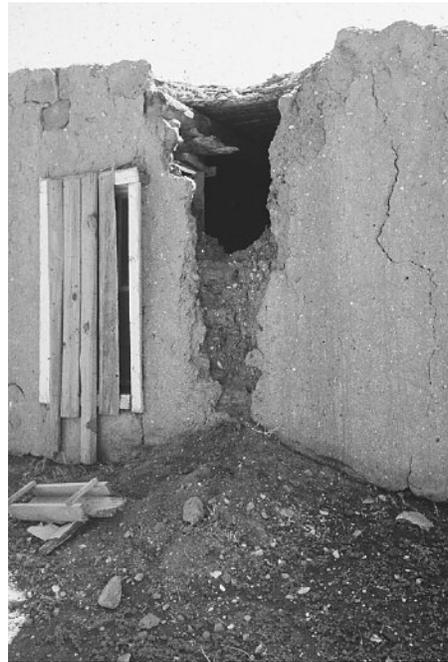
Figure 7.19

Example of adobe wall slumping and washout resulting from moisture damage (photo courtesy Tony Crosby).

Moisture damage at the base of adobe walls is a common problem that must be addressed and solved as a part of any retrofitting design. Some results of moisture-related problems are shown in figures 7.19 and 7.20. Sliding of an entire wall section (see fig. 5.18a) is another possible consequence of water damage. The resistance of thick adobe walls to overturning is greatly diminished when moisture damage is not corrected. Deteriorated adobe bricks at the base of walls (see fig. 5.19) may need to be replaced before the inherent resistance to overturning provided by the thickness of the walls can be realized.

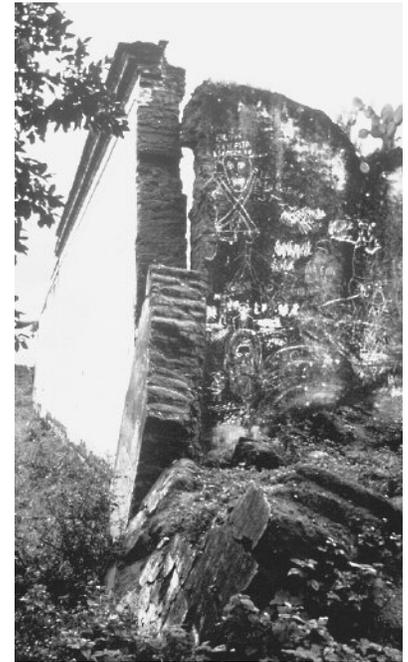
Figure 7.20

Example of wall collapse due to water damage at base (photo courtesy Tony Crosby).

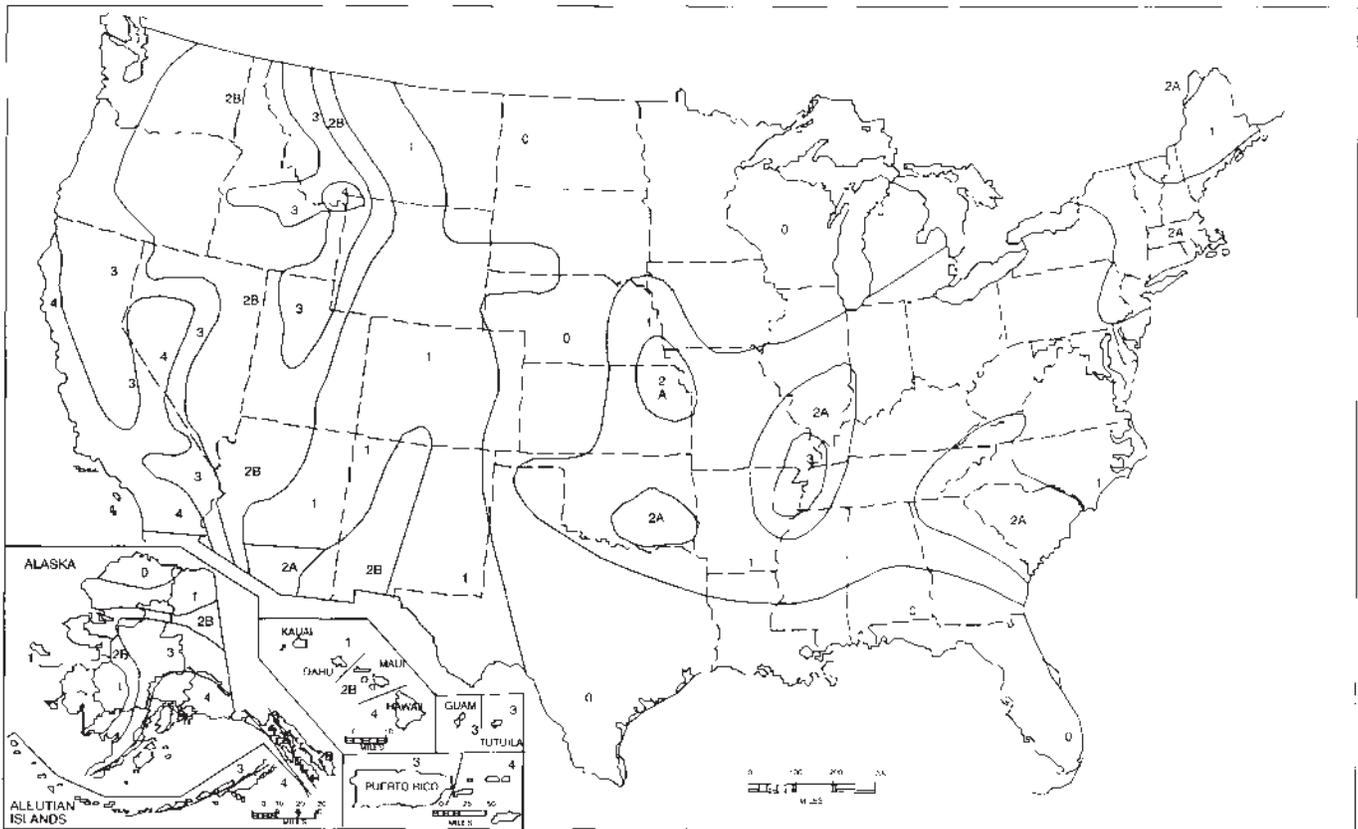
Figure 8.1

Seismic zone map of the United States of America (UBC 1997).

The level of seismicity to be expected in the area where a building is located defines lateral force levels. The seismic map of the United States shown in figure 8.1 was taken from the UBC (1997). Lateral forces, as prescribed by the 1997 UBC, may be higher than those given in previous versions of the UBC because the more recent edition provides for near-source effects (Structural Engineers Association of California 1999). The codes define earthquake faults of Types A and B and zones that are 5, 10, and 15 km from the faults (fig. 8.2). If the site lies within these zones, the seismic loading factor is increased accordingly.

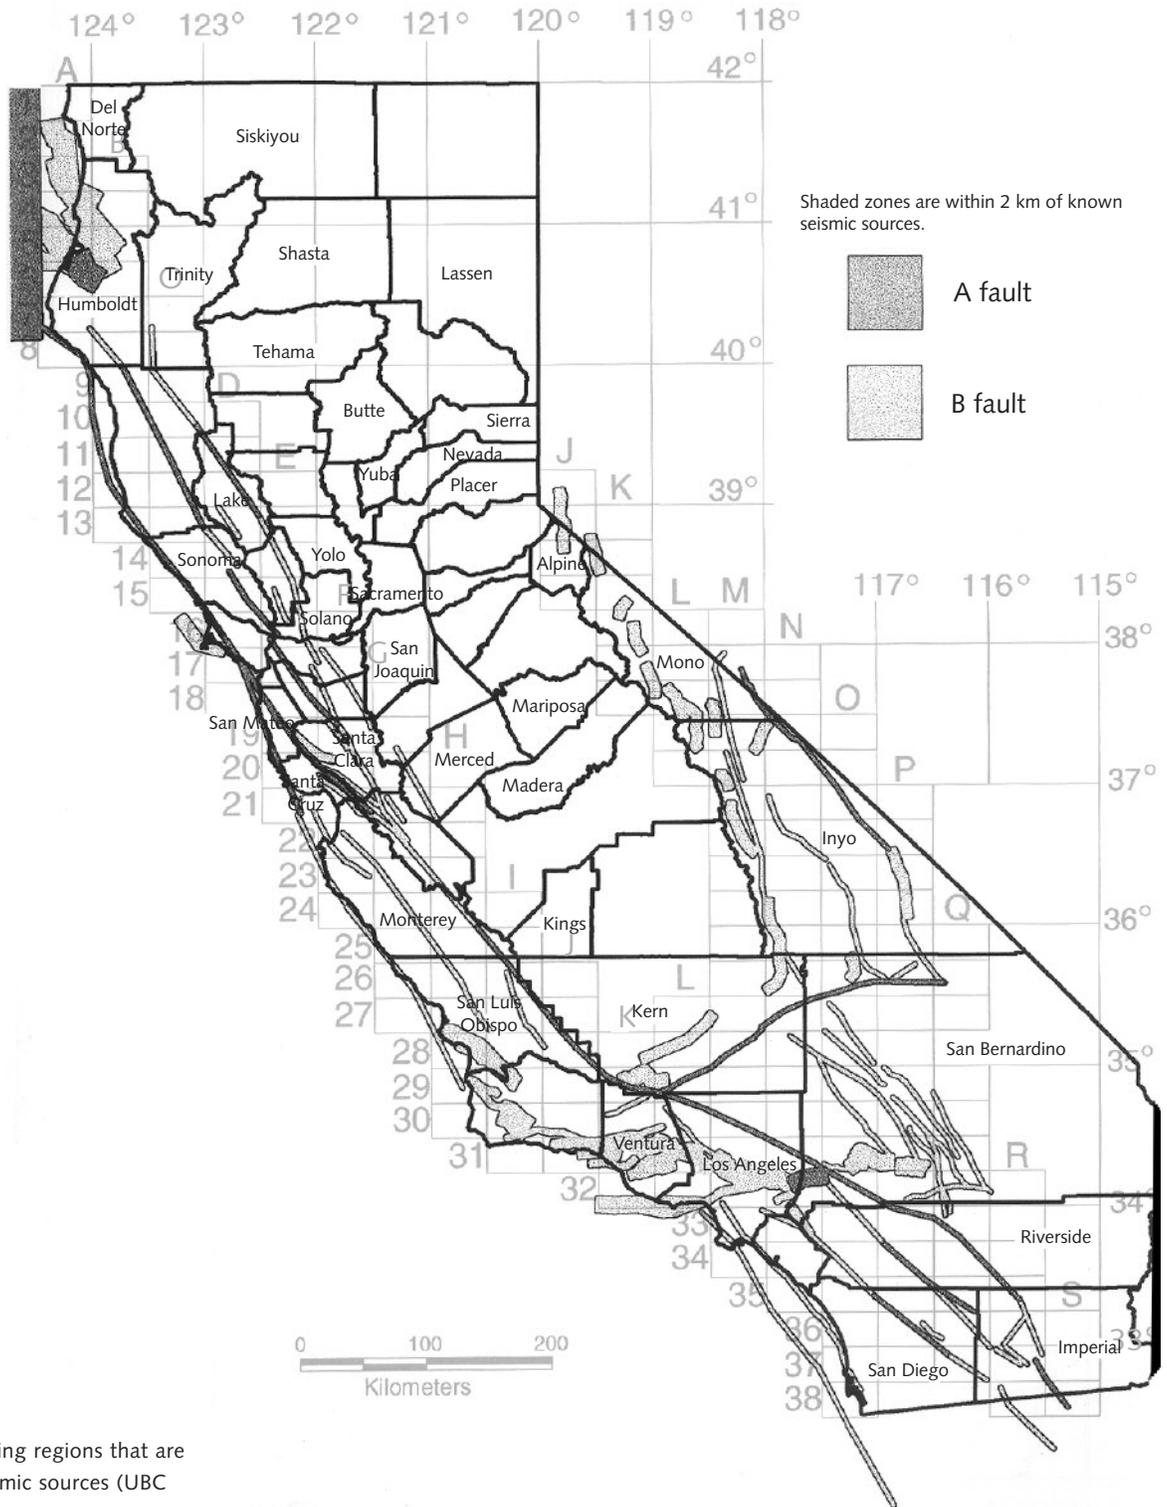
Figure 8.2
 Map of Calif. showing regions that are close to known seismic sources (UBC 1997).

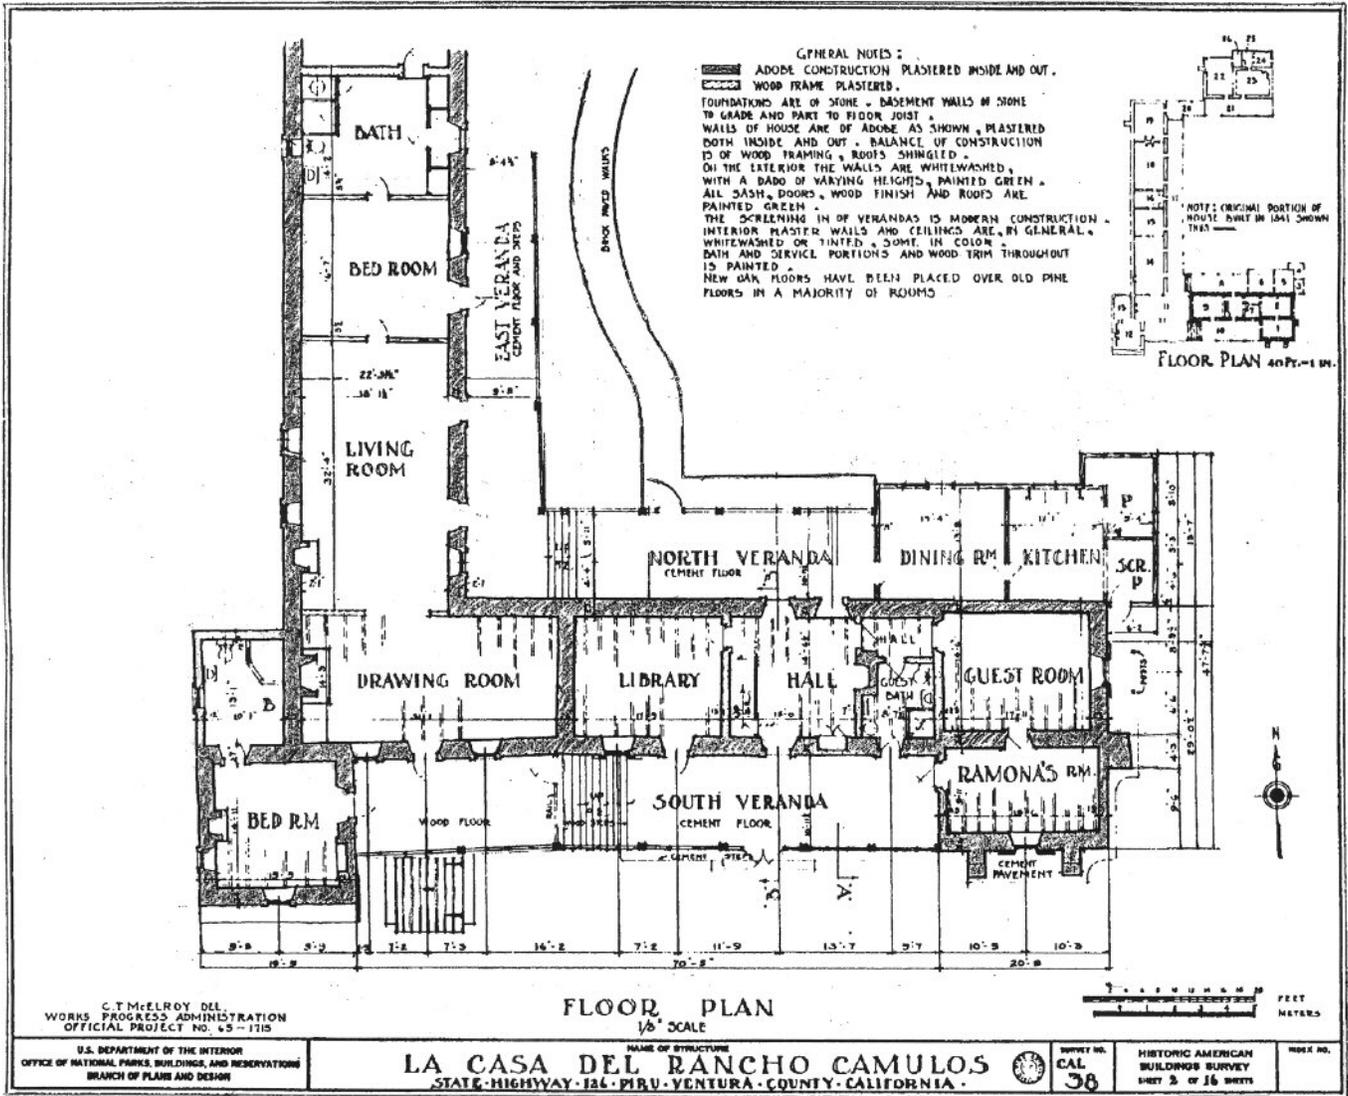
Figure 8.3
 Floor plan of Del Valle Adobe, Rancho Camulos Museum, Piru, Calif. (courtesy Historic American Buildings Survey).

A plan of the building complex is shown in figure 8.3. Figure 8.4 is a drawing of the building without the roof, showing the extent of the damage after the 1994 Northridge earthquake. The need for seismic retrofitting of the structure was specified in the historic structure report that was prepared prior to finalization of the design of the structural modifications. Preparation of the HSR was funded by the California Heritage Fund.

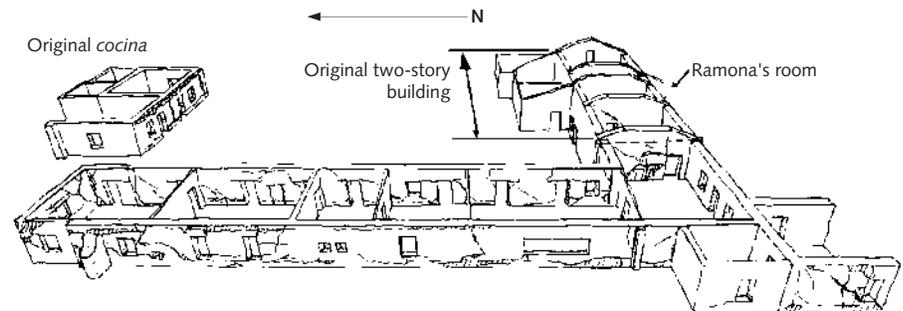
Figure 8.4
 Earthquake damage to Del Valle Adobe (Tolles et al. 1996).

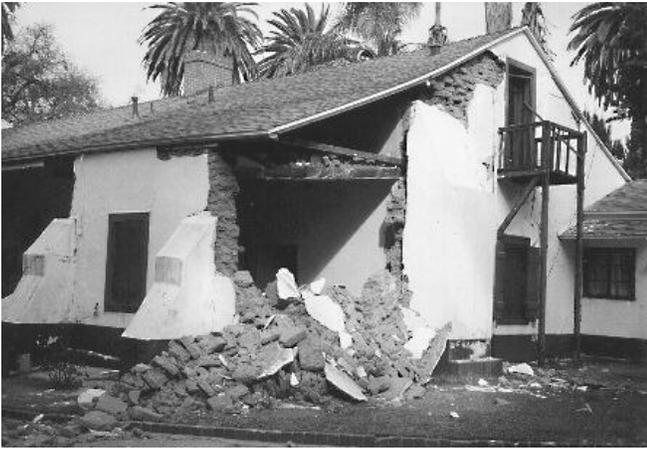
Figure 8.5
Collapsed wall of Ramona's room, Del Valle Adobe.

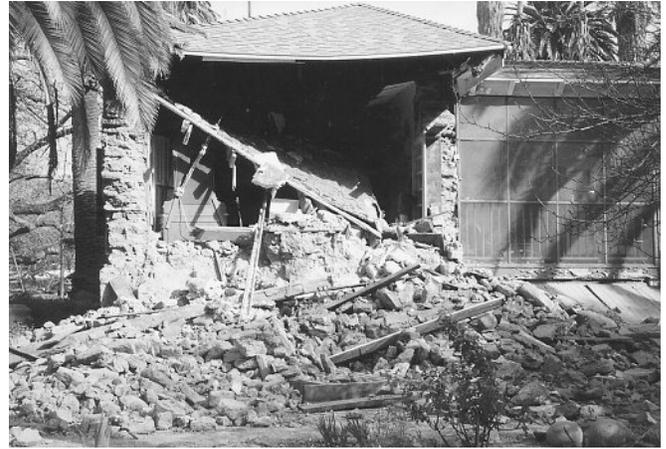
Figure 8.6
Collapsed southwest bedroom wall of Del Valle Adobe.

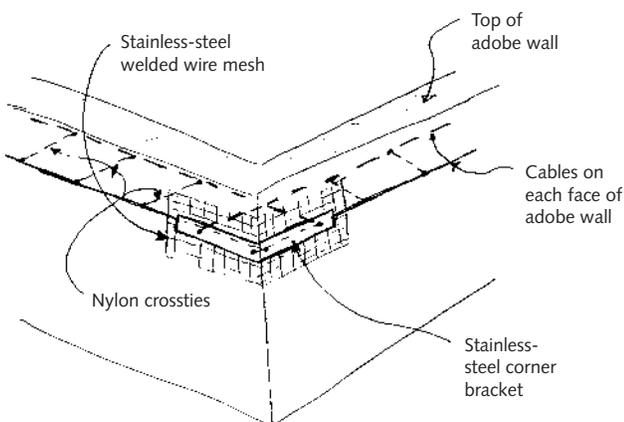
Figure 8.7
Horizontal cable-end connections used in the retrofit of Del Valle Adobe.

The end connections for the cables used at the Del Valle Adobe are shown in the schematic drawing in figure 8.7. The cables made straight runs and were terminated by threaded sections that were bolted to steel end plates. The plates were mounted over a layer of wire mesh; this helped reduce localized stresses in the adobe. Crossties made of heavy, solid nylon, electronic-type "cable ties" were installed through the wall along the lengths of the cables at intervals of about 1 m (3.3 ft.) on center to tie parallel cables to each other.

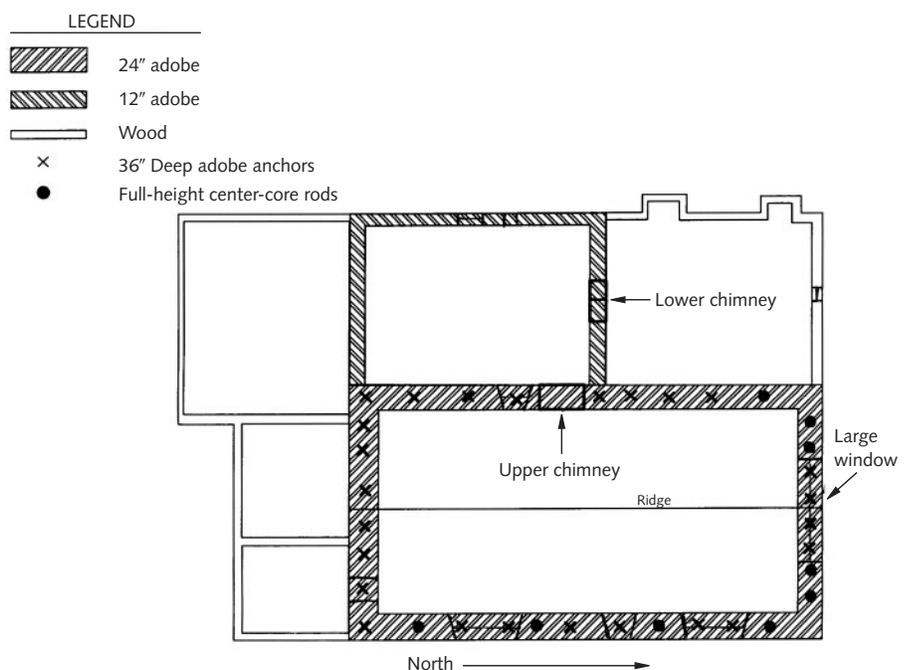
Figure 8.8
Floor plan of Casa de la Torre,
Monterey, Calif.

As of this writing, in addition to seismic retrofitting, Casa de la Torre was undergoing rehabilitation to reflect its 1924 reintegration by Oliver, who was the father of the historic preservation movement in Monterey. A plan drawing of Casa de la Torre is shown in figure 8.8 and photographs of the lower roof (west side) and the window wall and porch (north and east sides) are shown in figures 8.9 and 8.10, respectively. The dimensions of the east and west walls of the main section are $11.3 \times 4.3 \times 0.6$ m ($37 \times 14 \times 2$ ft.). The end walls, which are 6.1 m (20 ft.) wide, are gabled, and a loft covers about 30% of the south end of the main section.

The area most vulnerable to seismic damage appeared to be the north gable-end wall containing a large glass window. To strengthen and stabilize this wall, two center-core rods, 1.9 cm (0.75 in.) in diameter, were inserted vertically in the wall on each side of the window. The upper ends of the rods were threaded and bolted to the upper wood wall plate. The rods, which extended only to the top of the stone foundation, were grouted in place using a high-strength, cementitious grout. Center-core rods were also placed in each pier of the east wall (see fig. 8.8) because the freestanding porch roof provided little or limited support for this wall.

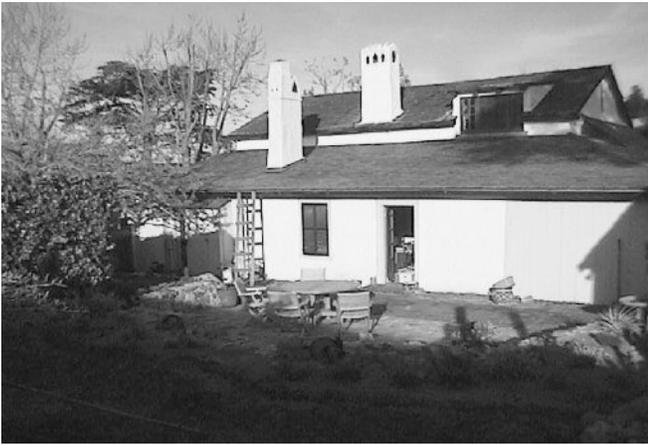
Figure 8.9
Casa de la Torre, west side view.

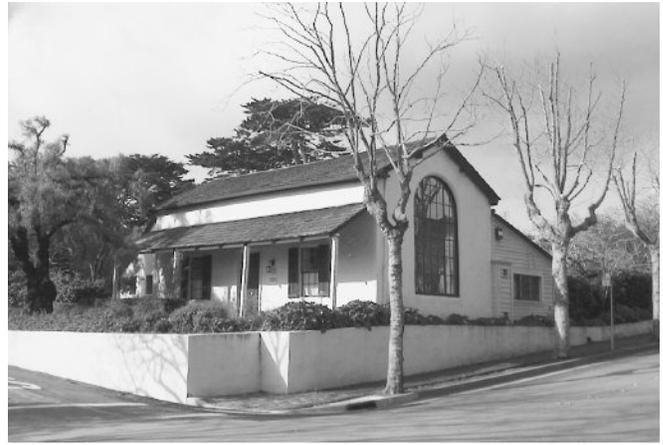
Figure 8.10
Casa de la Torre, north (window) and east walls (photo courtesy Tony Crosby).
